Rail Accident Investigation Branch

Rail Accident Report

**Person trapped in a train door and dragged at
Jarrow station, Tyne and Wear Metro
12 April 2012**

Report 26/2012
December 2012

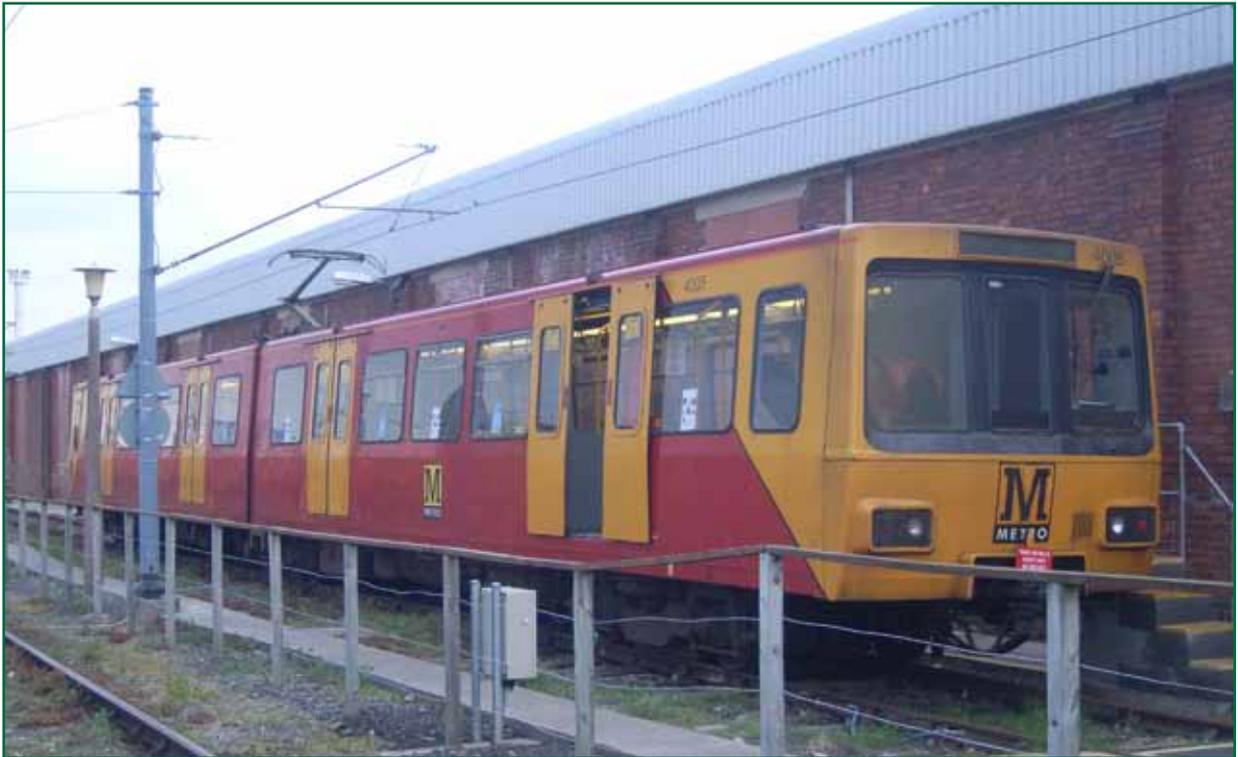
- 6 TWM trains comprise two-car electric multiple units, which receive power from 1500 V DC overhead contact wires, and have a maximum speed of 80 km/h. Each articulated car (figure 2) is 27.8 metres long and has a driving cab at each end and four pairs of passenger doors per side. The trains were manufactured between 1978 and 1981 by Metro-Cammell, in Birmingham. They were refurbished between 1995 and 2001 and are currently undergoing another refurbishment programme which commenced in 2010. The vehicle involved in this incident was car 4005 which first entered service in 1980 and was last refurbished in 2001.

Figure 2: Car 4005 involved in the incident (two such cars make up a TWM train)

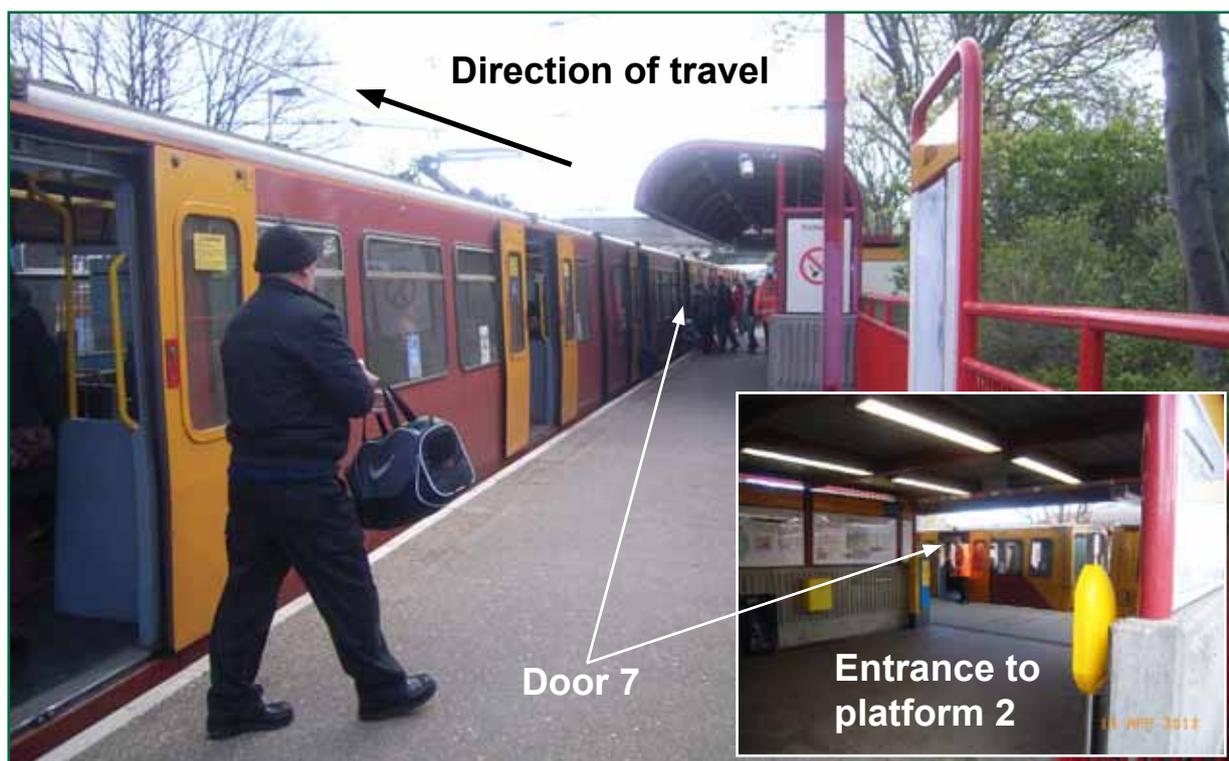
- 7 The location of Jarrow station on the network is shown in figure 1 and a closed circuit television (CCTV) image of the incident train approaching platform 2 is shown in figure 3. Platform 2 serves trains heading towards Newcastle Central station, and is on the left-hand side in the direction of travel (figure 4). Passengers reach platform 2 after passing through a small concourse. At the normal stopping position of trains, door 7 is closest to the concourse.

Figure 4: Platform 2 at Jarrow station

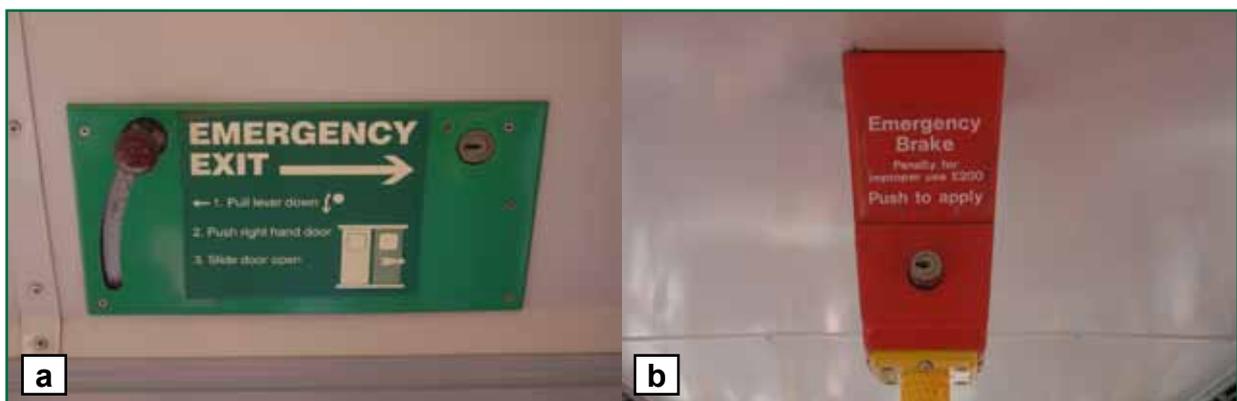
- 13 In the immediate vicinity of each doorway are two emergency systems; an emergency door release (EDR) and a passenger emergency button (PEB) both of which can be operated by passengers. The EDR (figure 6a) is located to the left-hand side of each doorway at head height. Its purpose is to allow the door closing force to be released in an emergency, such as a person becoming trapped in the doors. It is activated by pulling the lever downwards which then allows the right-hand door leaf to be pushed open manually. It also automatically cuts off traction power and activates the train brakes. The PEB is mounted at the top of a vertical grab pole in the middle of each doorway vestibule (figure 6b). It allows a passenger to stop the train in an emergency by pressing the button. Pressing the button cuts off traction power and automatically applies the train's emergency brake.

Figure 6: (a) Emergency door release; and (b) passenger emergency button

- 16 Video footage from the train's internal CCTV shows that passengers on board the train adjacent to door 7 realised what was happening. One passenger tried to prise open the door manually and when this was unsuccessful, he quickly activated the EDR (figure 6a) around 4 seconds after the train had started to move. A second or so later, another passenger pressed the nearby PEB (figure 6b).
