Rail Accident Investigation Branch

Rail Accident Report

Derailment of a tram at East Croydon 17 February 2012

Report 04/2013
March 2013

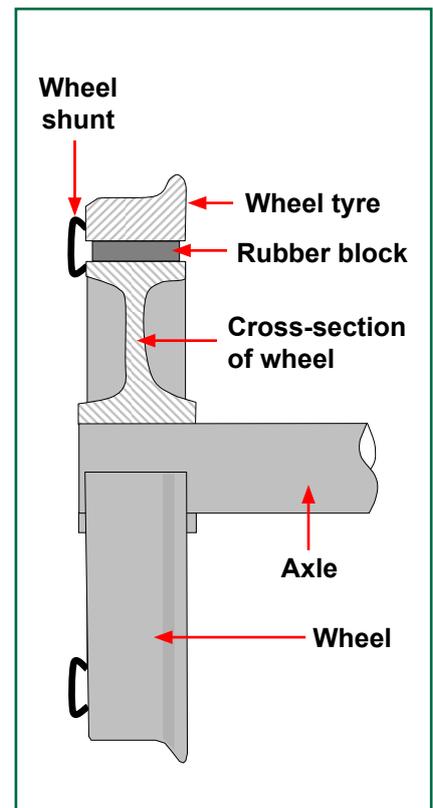
- 57 All axles on the CR4000 tram have *resilient wheels* with braided copper bonds (*wheel shunts*) on each wheel providing electrical continuity between the wheel hub and tyre (figures 13 and 14). Bombardier's maintenance specification for the CR4000 fleet states that wheel tyre to wheel tyre resistance should not exceed 0.01 ohms on a new bogie, or rise above 0.1 ohms in service. The wheel shunts are designed to provide an electrical path for traction current to return to the rails, and Bombardier stated that the requirement for the trams to operate track circuits was not specified when the trams were designed. At the time of the derailment, Bombardier's maintenance staff remained unaware that the wheel shunts performed both roles.

Figure 14: Part-section of wheel

58 The wheel tyre to wheel tyre resistance values for the leading bogie of tram 2538, tested in March 2012, and the remainder of the CR4000 fleet, tested in July 2012, are given in table 1. These results show that, although tram 2538's leading bogie conformed to Bombardier's own maintenance specification for in-service wheel tyre to wheel tyre resistance, its resistance was greater than the rest of the Croydon fleet by a factor of at least three. No explanation for this has been found by the RAIB, Bombardier or London Tramlink. The March 2012 and July 2012 testing, coupled with post-accident testing, shows that, although the track circuit did not respond to the incident tram, it would possibly have responded to other trams in the Croydon fleet at the time of the accident.
