Rail Accident Investigation Branch

Rail Accident Report

**Fatal accident at Gipsy Lane footpath crossing,
Needham Market, Suffolk
24 August 2011**

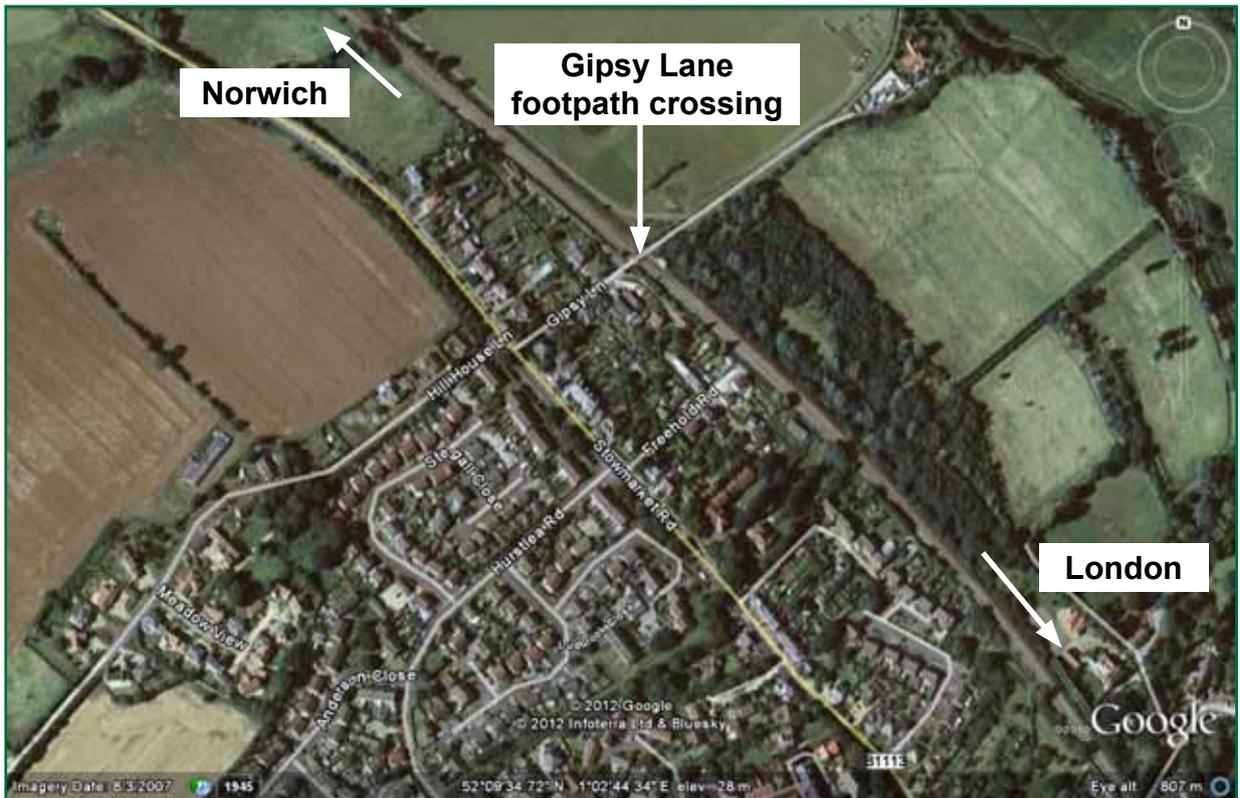
- 8 Gipsy Lane footpath crossing is located at 77 miles 64 chains¹ from London Liverpool Street station, on the northern outskirts of Needham Market, Suffolk. A residential area is located on one side of the crossing, and farmland on the other (figure 2).
- 9 The general layout of the crossing and key dimensions are given in figure 3. There are two railway tracks at the crossing and the maximum permitted speed for trains travelling in either direction is 100 mph (161 km/h).

Figure 2: Overview of Gipsy Lane footpath crossing and its immediate surroundings (courtesy of Google Earth)

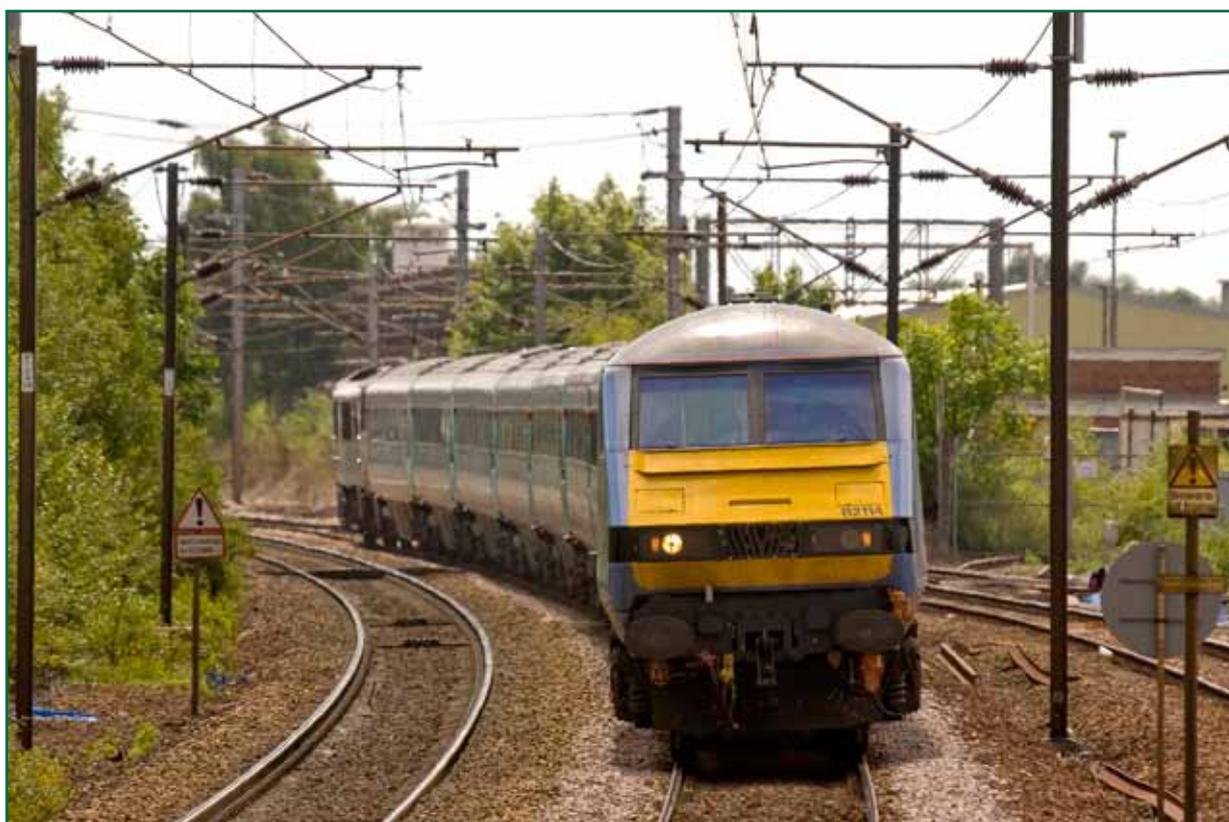
- 14 Train 1P28 was formed of a *Driving Van Trailer (DVT)* leading a *rake* of ten Mark 3 coaches being powered by a class 90 locomotive attached to the rear of the train (figure 4).
- 15 The RAIB found no evidence to link the condition of the train with the cause of the accident.

Figure 4: A DVT leading a train formed of Mark 3 coaching stock. A class 90 locomotive is attached at the rear of the formation (not the train involved or the location of accident) (image courtesy of Kev Gregory/Railway Herald)
