Rail Accident Investigation Branch

Rail Accident Report

Track worker struck by a train at Stoats Nest Junction 12 June 2011

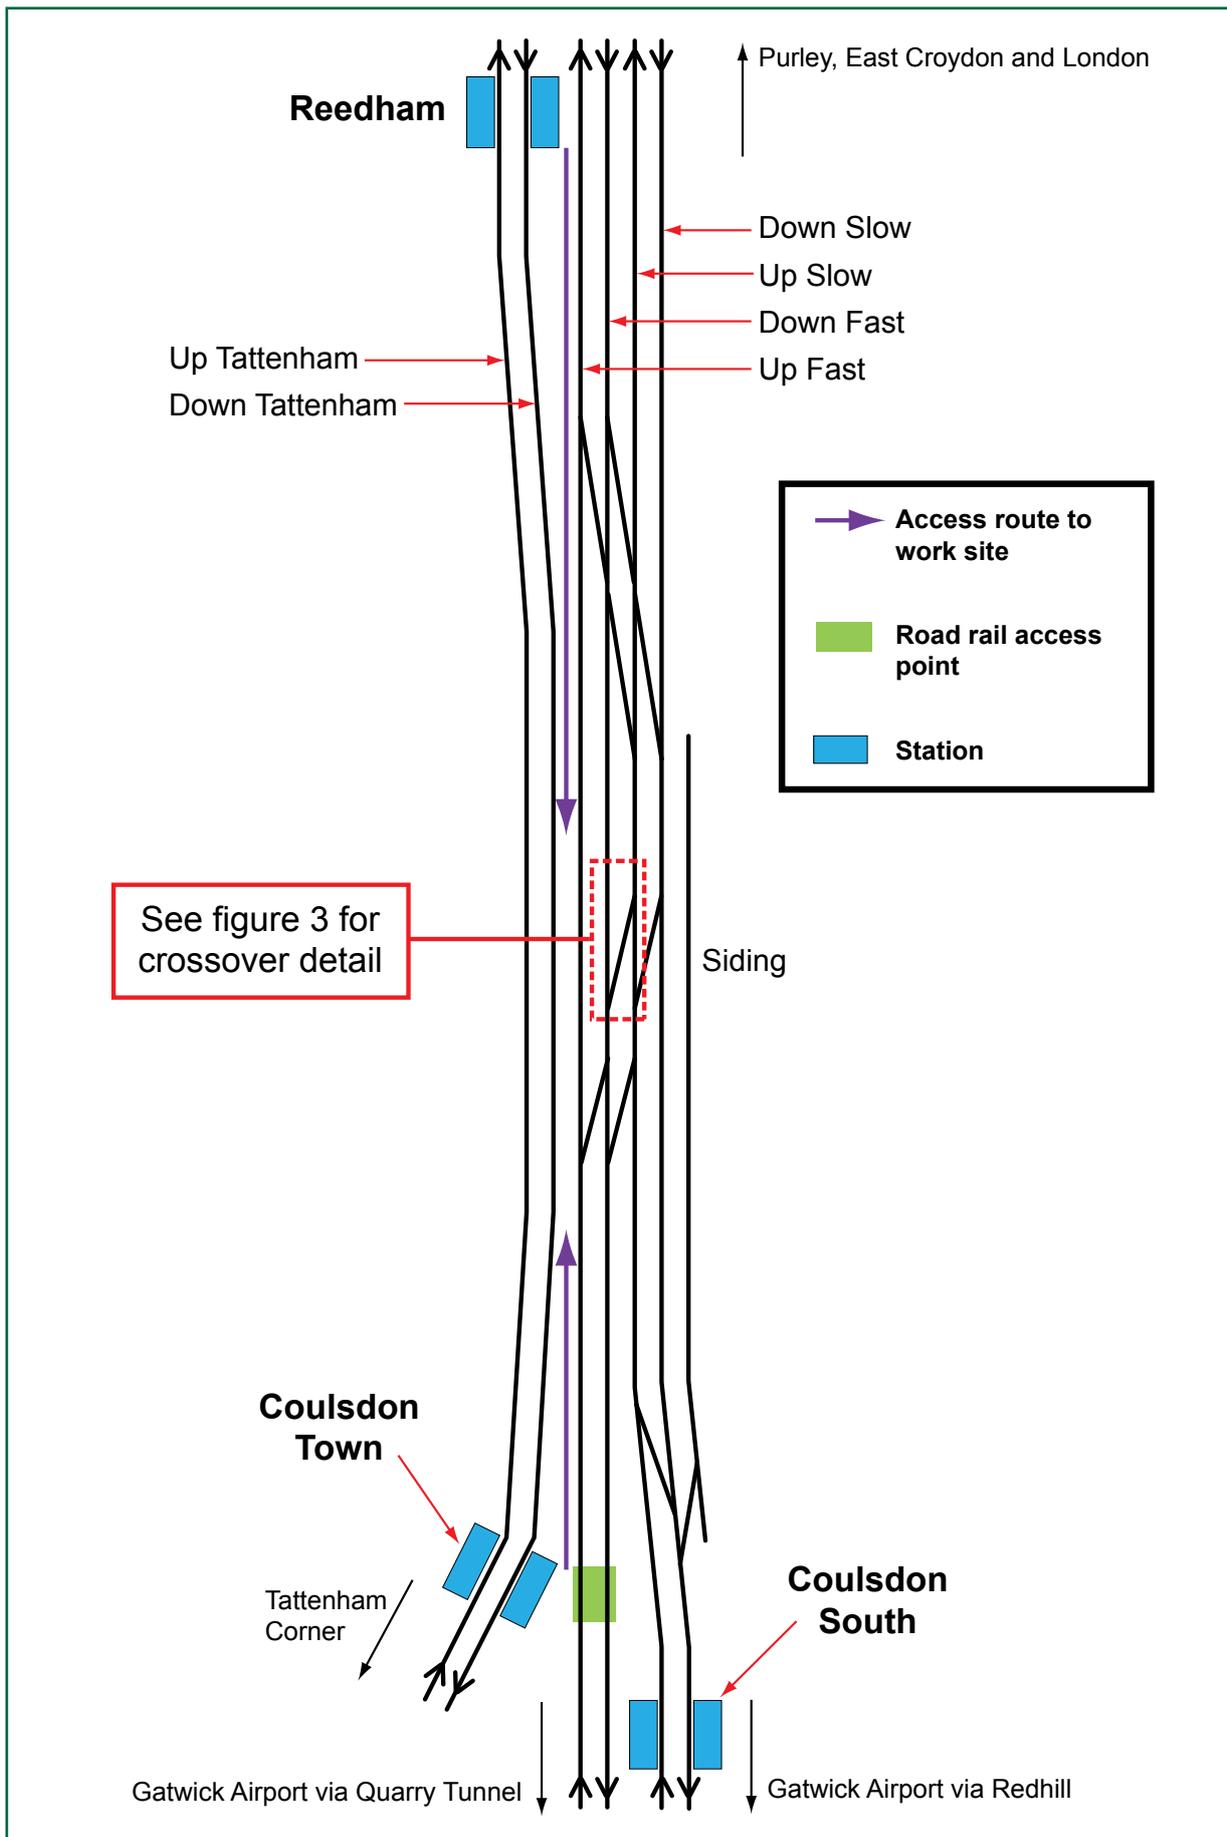
Figure 2: Track layout at Stoats Nest Junction

- 17 The route through Stoats Nest Junction is *quadruple track*, consisting of a pair of fast lines and a pair of slow lines. A series of *crossovers* connect the fast and the slow lines. There are also an additional two adjacent tracks, on the route to Tattenham Corner (figure 2).

- 36 The maintenance organisation at East Croydon depot had planned to replace the crossing of 1666A points, which was cracked, on the night of 11 June 2011. These points form part of a crossover between the down fast and up slow lines at Stoats Nest Junction (figures 2 and 3). This work was to be done during an engineering possession. Details of the possession arrangements are given in paragraphs 69 to 74.
