Rail Accident Investigation Branch

# Rail Accident Report

## **Safety incident between Dock Junction and Kentish Town 26 May 2011**

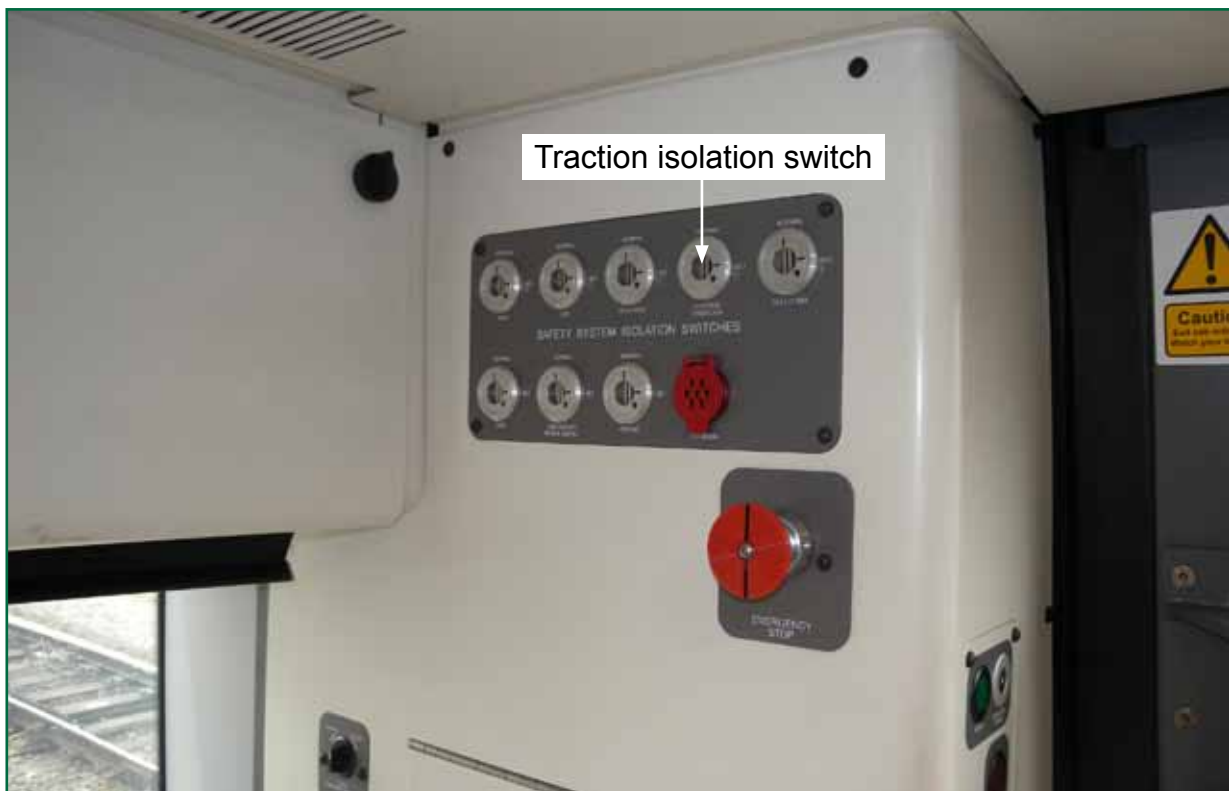
Figure 11: Traction Isolation Switch (TIS)

- 42 At 20:58 hrs the signaller (in consultation with FCC control) advised the fitter and the driver that if no solution could be found, and the driver could not obtain the door interlock, then the driver was authorised to operate the traction interlock switch. Operation of this switch would override the safety interlock and enable the driver to move the train. At approximately 21:00 hrs, the driver duly operated the traction interlock switch, and almost immediately afterwards applied traction to carry out a short 'pull test' which involved moving the train a distance of less than one metre to ensure that it was securely coupled. The train driver, who was focused on the task in hand, did not make any announcement to passengers that the pull test was to be undertaken. Had he done so, it would not have been heard in the rear eight coaches because the PA system was still not working. The driver was unaware that around 30 to 40 passengers from the two rear carriages had now decided to leave the train with some passengers getting off the train as it moved forward a short distance during the pull test. Other passengers were walking between the train and tunnel / cutting wall in the cess towards Kentish Town station.

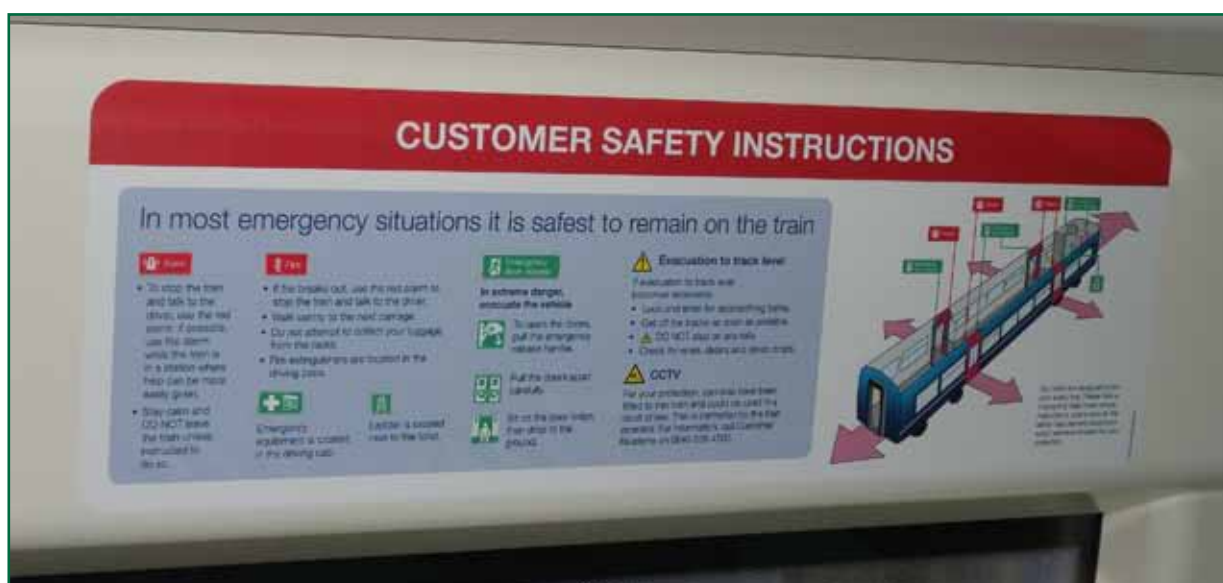
Figure 15: Guidance and passenger evacuation notices and pictograms above the train door

- 99 Such was the mood among passengers that doors were being re-opened as soon as the staff had returned to the front of the train. In turn, this resulted in further warning messages on the train management system display screen in the driving cab. This further delayed the movement of the train and increased the frustration of passengers, resulting in some of them leaving the train. Notices above the doors advise passengers to stay calm and not to leave the train unless instructed to do so, but there is also text and pictograms showing them how to evacuate themselves to track level (figure 15).

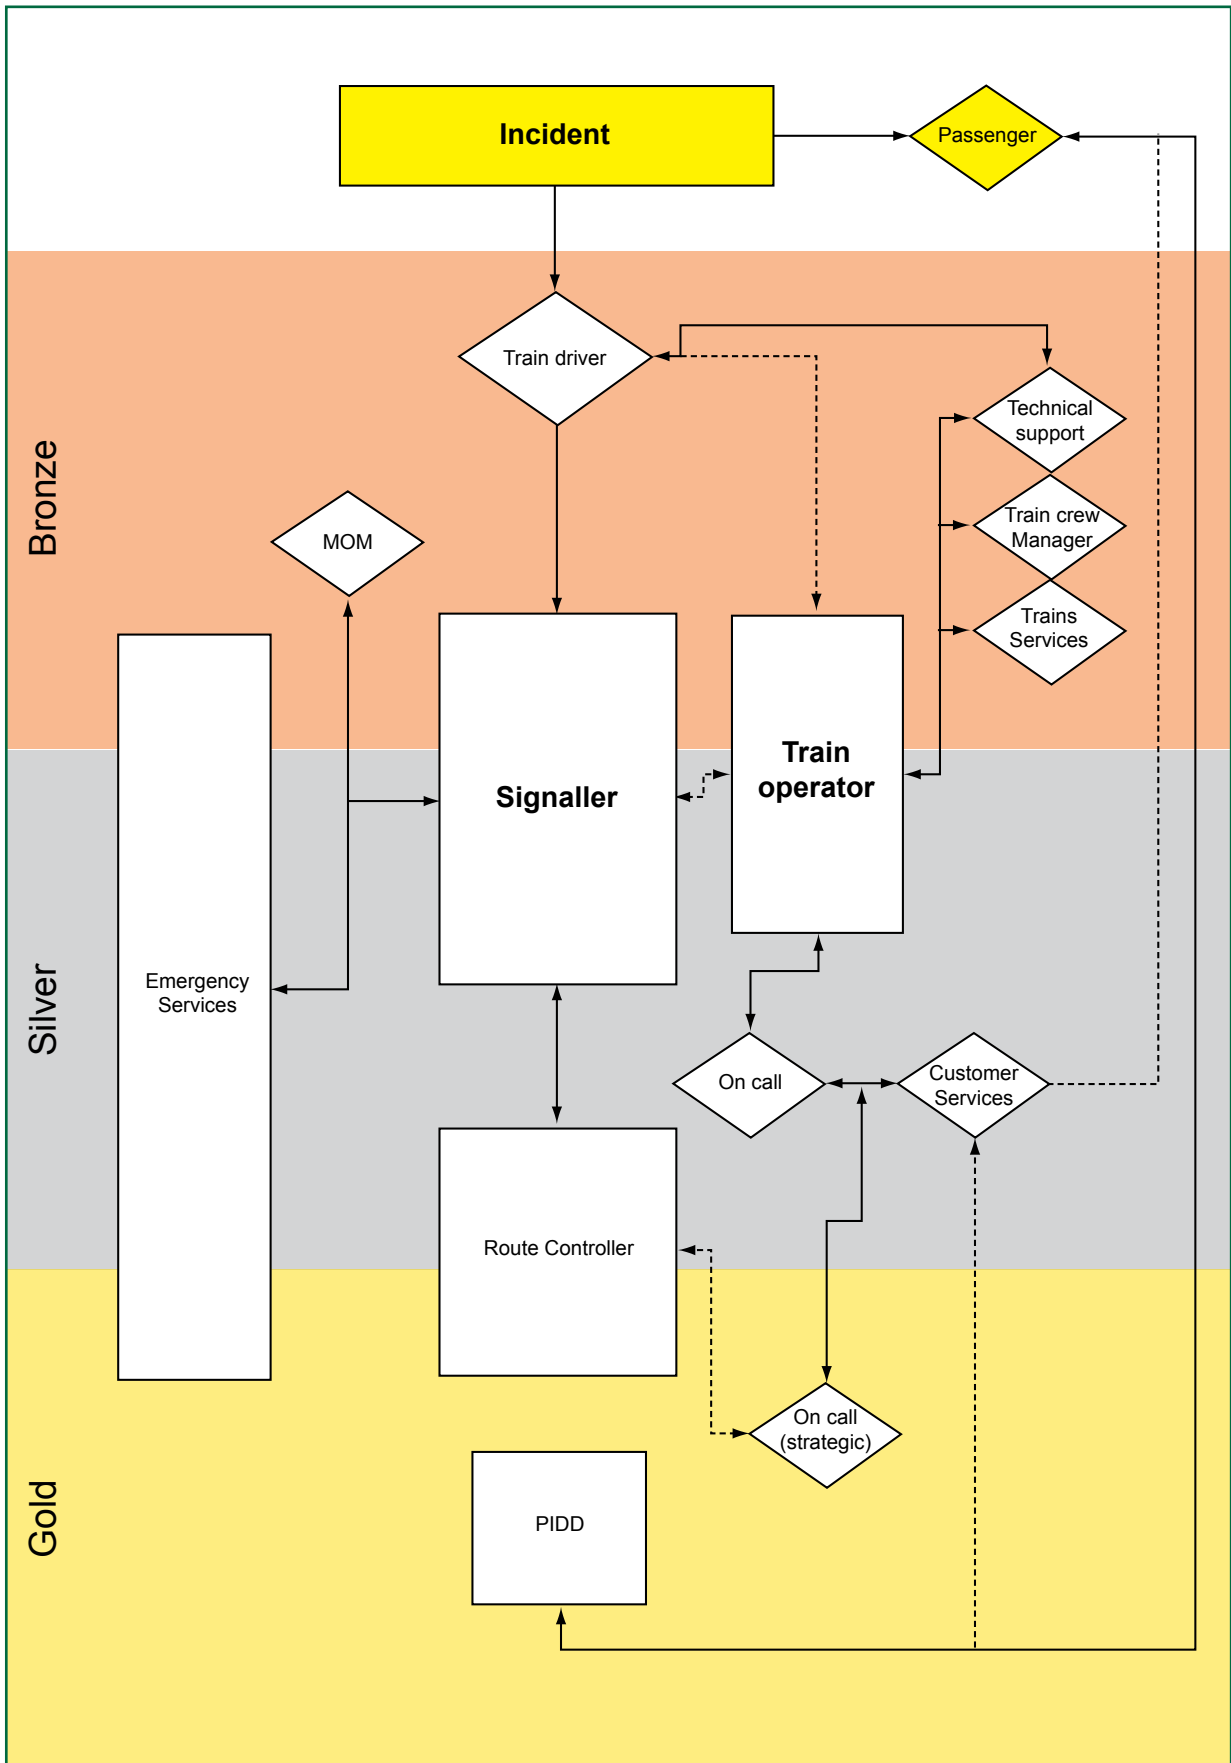
Figure 17: Stakeholders involved in the incident and operational (Bronze), tactical (Silver) and strategic (Gold) roles

- fleet technicians at Cauldwell depot, for technical matters in relation to the train.
- 120 Although the FCC controllers wanted to contact the driver at various times during the incident, they had no means of doing so as they did not have the driver's mobile telephone details. Even if the controllers had wanted to assume strategic control of the incident, they would have had difficulty doing so because of their inability to talk directly to the driver of the train (figure 17).

- 121 When the signaller took the decision to evacuate train 1W95 at 19:47 hrs (paragraph 38), nobody in FCC was aware that he had taken such a decision, even though FCC would have had a key role in managing such an evacuation.

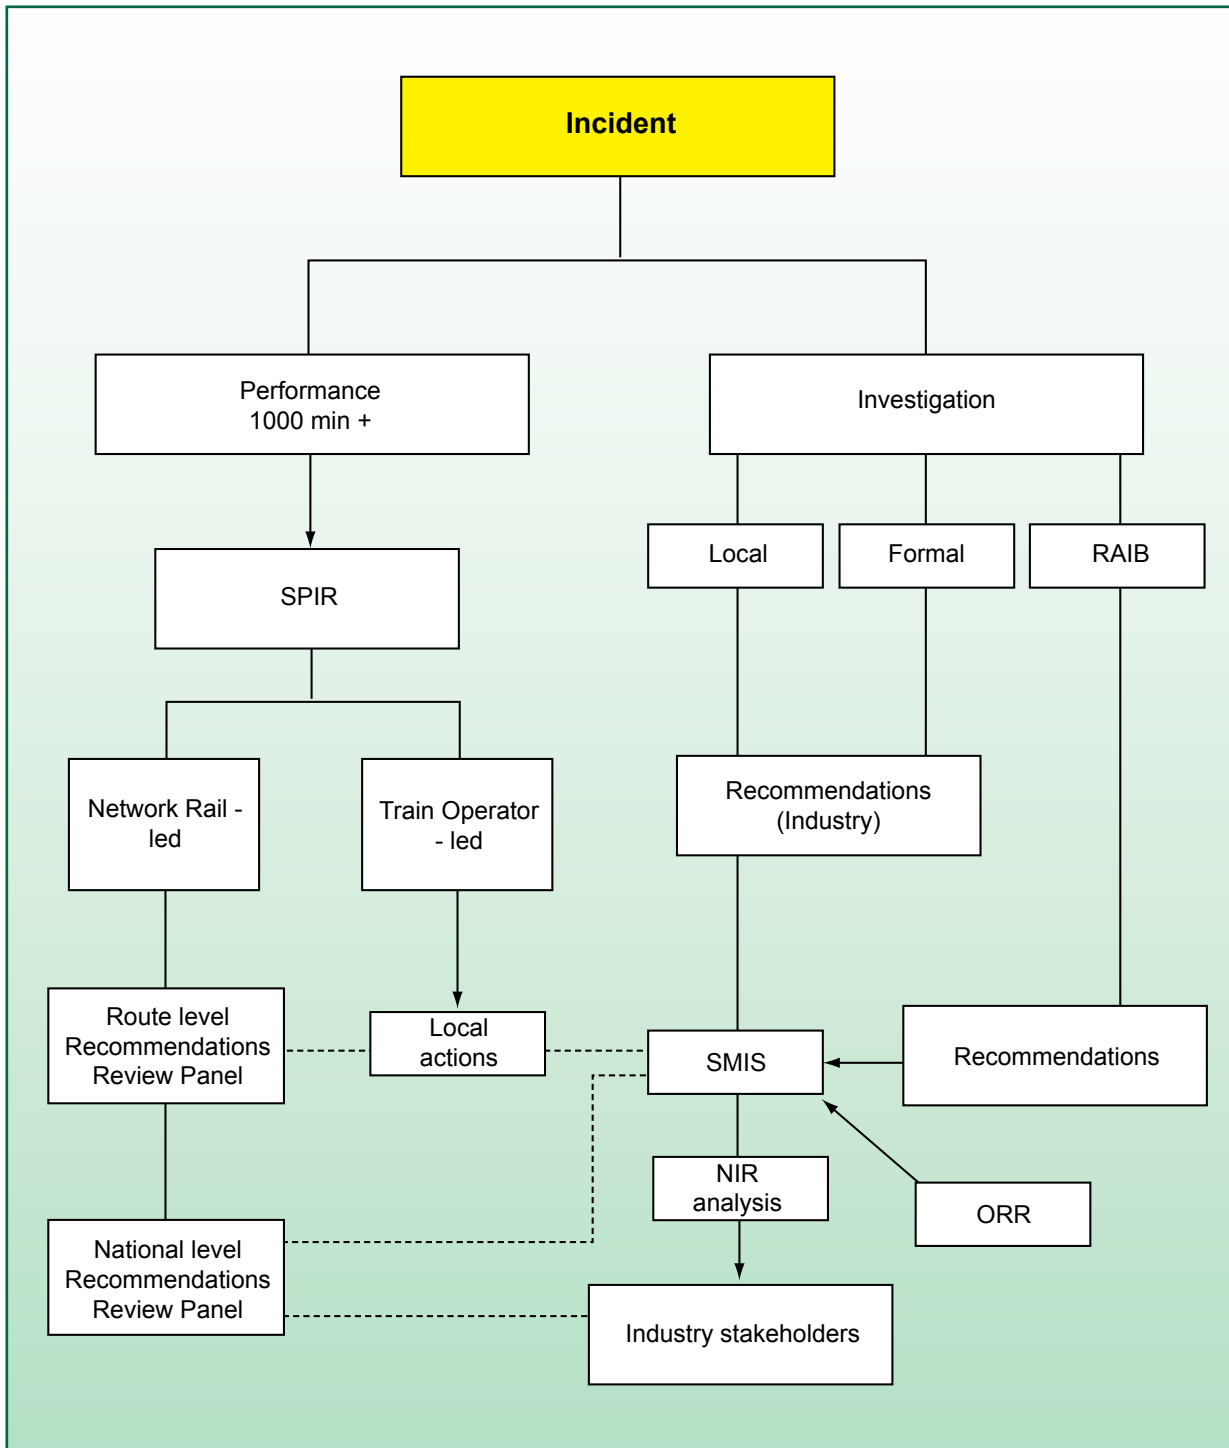
Figure 18: SPIR and SMIS process diagram

- 170 The members of staff who attend SPIR meetings are drawn from a variety of roles and skill levels and evidence shows that valuable safety learning does result from such meetings, but the information which is generated is not shared across the rail industry. The process requires SPIR groups to report their findings to the Area or Route Managers and to update:

- 171 Although it is not prohibited, there is currently no requirement for SPIR reports to be input to SMIS. It is up to the individual route where the SPIR report was produced to decide whether a safety lesson has been identified and how to share the safety lesson with the railway industry or if the safety lesson is to be changed into a safety recommendation. The RAIB reviewed the SMIS and SPIR data relating to the incidents at Foxtton, Leagrave, and Elstree where train evacuations had taken place and safety lessons had been identified. SMIS contained a summary of each incident, but no details of lessons learnt or recommendations made from such lessons. The Farringdon incident (2010) was not recorded on SMIS. There was no local investigation into the incidents and therefore no visible safety learning.
