Rail Accident Investigation Branch

Rail Accident Report

Detachment of a cardan shaft at Durham station 10 April 2011

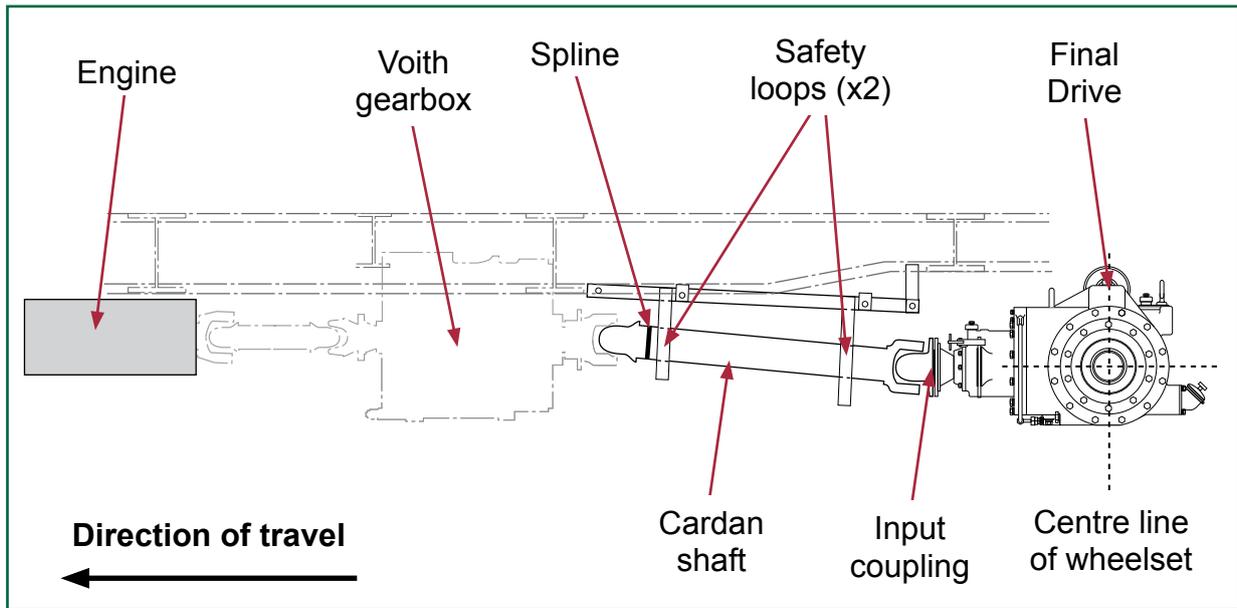
Figure 3: Drive arrangement on Class 14x

- 9 The train involved was formed of two 2-car class 142 units (figure 1). The shaft detached at the trailing end of the third vehicle and was not held up by its *retention devices* (in this case two *safety loops* – figure 3). The detached cardan shaft came to rest between the rails of an adjacent line after damaging the underside of the third and fourth vehicles, piercing the fuel tank on the fourth vehicle and releasing around 500 litres of diesel fuel onto the railway.
- 10 Unaware of what had occurred, but alerted by an un-commanded brake application and the engine warning light illuminating on his cab console, the driver stopped his train on the approach to signal T291, 2 miles (3.2 km) outside Durham station (figure 2).

118 An effective retention system for a cardan shaft would need to contain the energy stored in a large mass rotating at high speed. The two safety loops fitted to unit 142045 were to the original design for class 142/0 dating back to the mid-1980s. There was no specific load case in any of the standards applicable in the mid-1980s to cover the design of the cardan shaft safety loops. This situation remained the same in 2011. In order to accommodate the cardan shaft movement and its inclination, the loops are at different heights (figure 3). The loops are made of 10 mm steel plate, 50 mm wide welded to the underside of the vehicle body.
