Rail Accident Investigation Branch

Rail Accident Report

Two incidents involving track workers between Clapham Junction and Earlsfield 8 March 2011

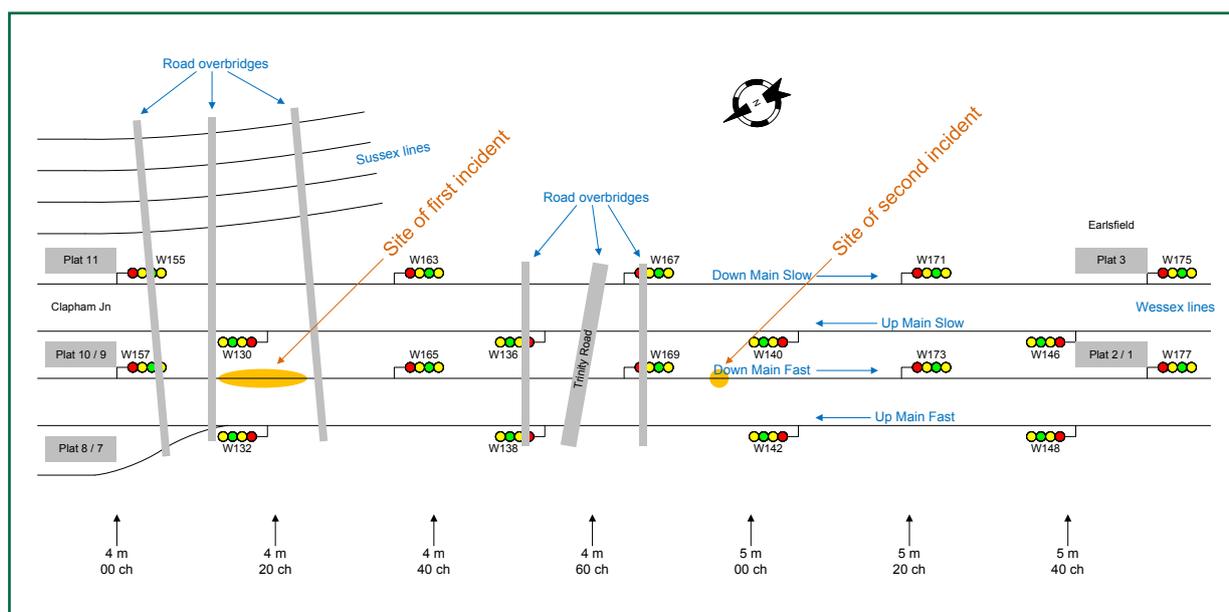
Figure 4: Track layout showing the Wessex lines between Clapham Junction & Earlsfield

- 12 Between Clapham Junction and Earlsfield stations, there are four main lines. From East to West, these are the Down Main Slow and Up Main Slow (speed limit 60 mph (97 km/h)) and the Down Main Fast and Up Main Fast (speed limit 75 mph (121 km/h)). The track layout is shown at figure 4. South of Earlsfield station, the Up Main Slow line crosses over the fast lines, so that the order changes from Down, Up, Down, Up (\rightleftarrows), to Down, Down, Up, Up (\rightleftarrows). Some witnesses said that this change of order caused them confusion about the direction of traffic on the lines involved in the incidents.

- 14 Prior to the incidents, all of the four Wessex lines shown in figure 4 had been closed to traffic due to an *engineering possession* between Waterloo and Wimbledon which had been taken in accordance with module T3 of the *Rule Book* (GE/RT8000/T3). This was scheduled to apply from 00:40 to 04:55 hrs; details were published in *Weekly Operating Notice* Ref. P2010/1374825. There had been two *work sites* within the possession; the Wimbledon work site extended from 3 miles 78 chains (Clapham Junction) to 7 miles 0 chains (Wimbledon).
