Rail Accident Investigation Branch

Rail Accident Report

**Collision between an articulated tanker and a passenger train at Sewage Works Lane user worked crossing, near Sudbury, Suffolk
17 August 2010**

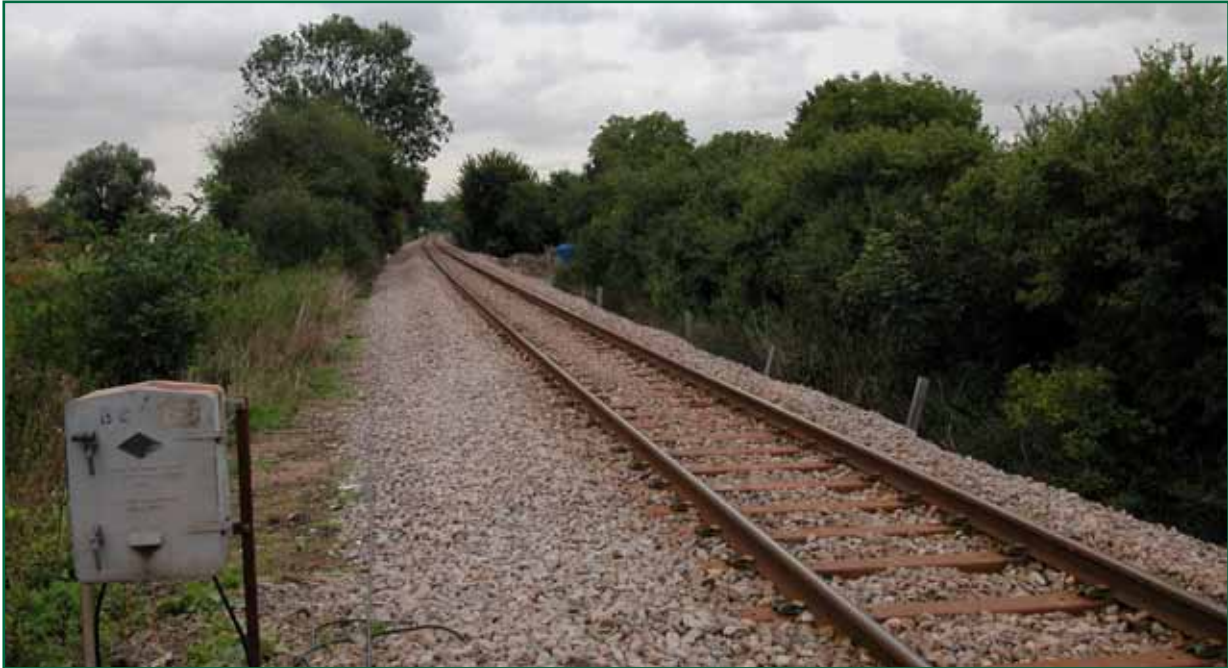
- 29 At approximately 17:00 hrs the tanker approached Sewage Works Lane UWC and then travelled over the crossing. The tanker driver did not call the signaller for permission to cross on his inward journey. The loading of the tanker within the sewage works was completed by around 17:25 hrs and the driver prepared his vehicle for departure and then returned towards the crossing, proceeding through the crossing gates and reaching the railway line (figure 5) at 17:33:30⁵ hrs.

Figure 5: View from Sewage Works Lane UWC looking towards Shalfords UWC and Sudbury.

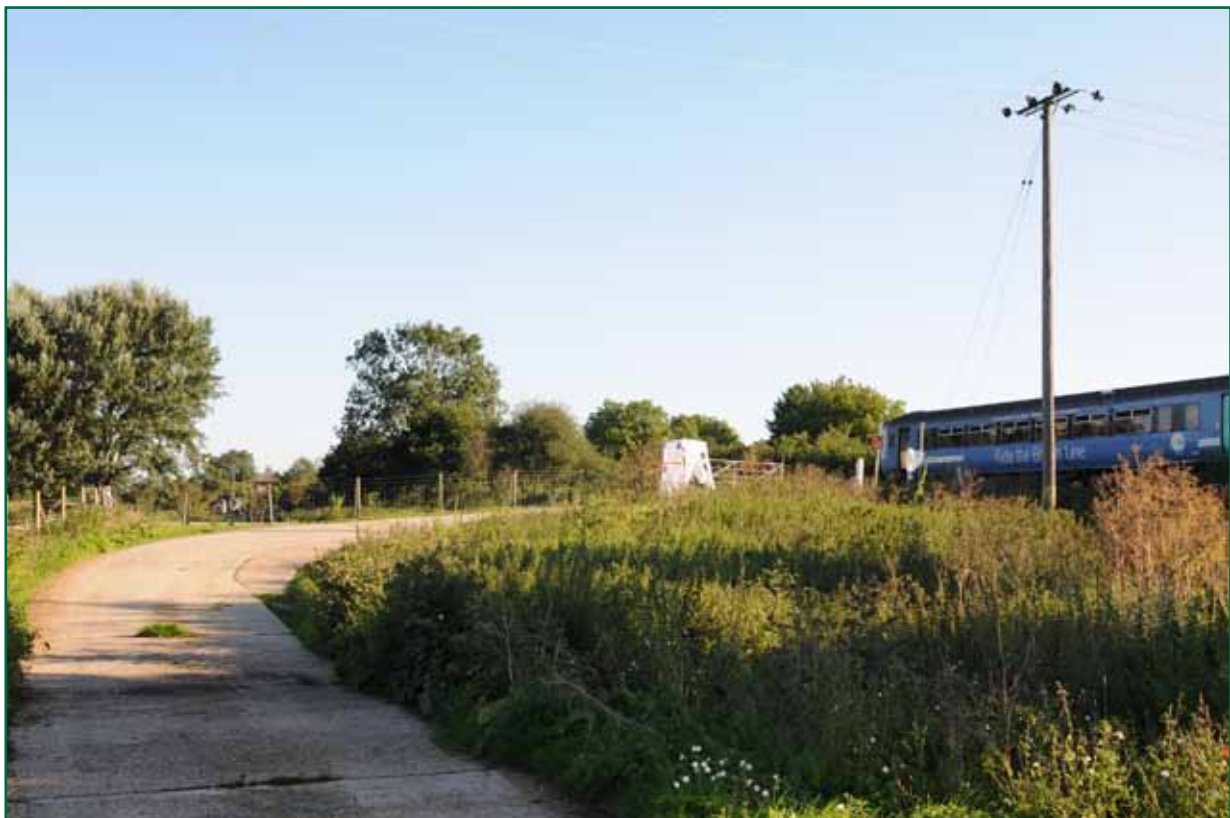
Figure 7: View of the crossing from the exit of the sewage treatment works.

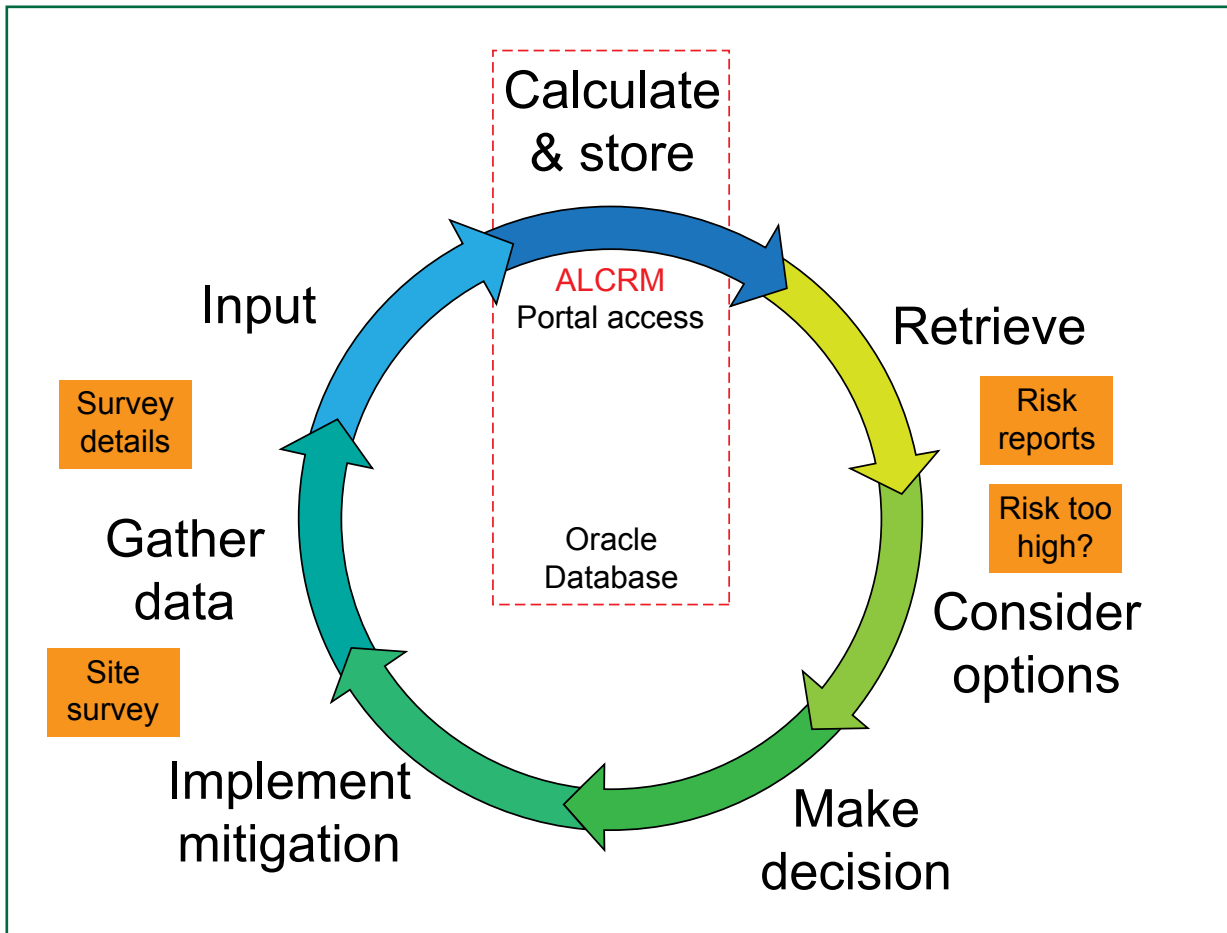
130 The gathering of data as an input to the risk assessment process for Sewage Works Lane UWC was characterised by errors and omissions in the information recorded and the predictable risk arising from the long waiting times for road vehicles at the crossing was not taken into account. This was an underlying factor in the accident on 17 August 2010.

Figure 11: Diagram showing the business process in risk assessment of level crossings.

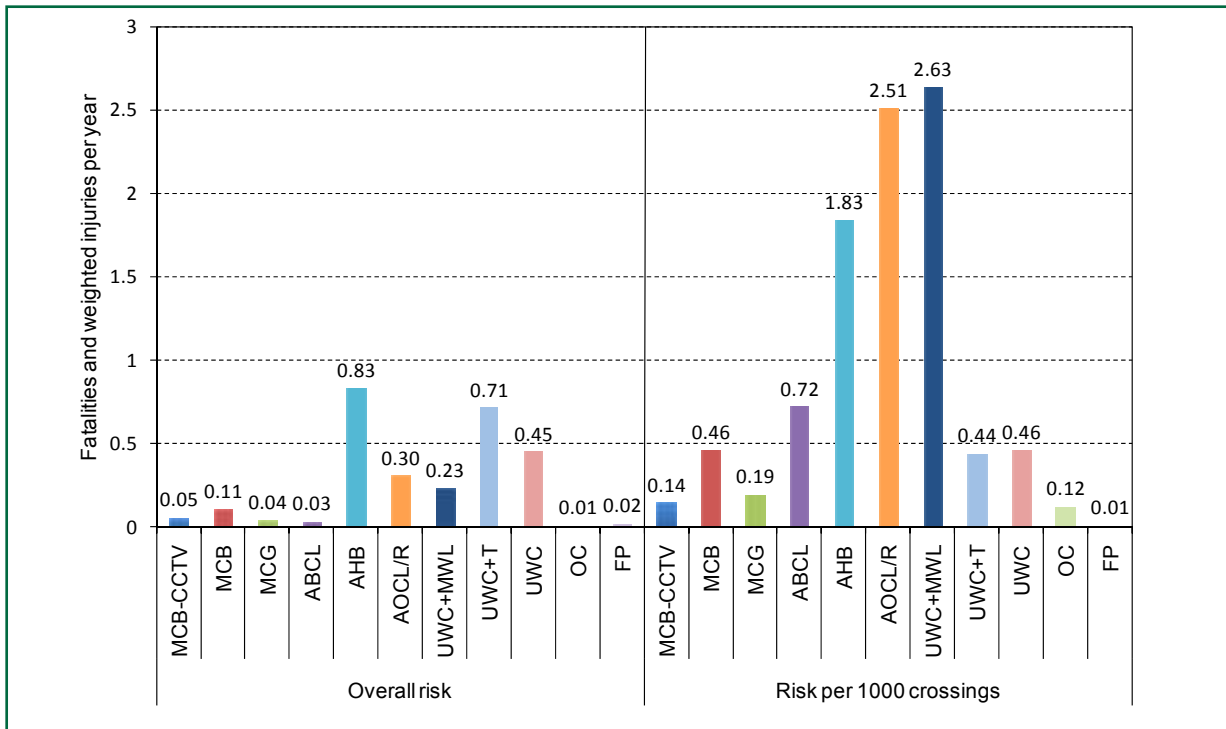
180 Figures 17 and 18 below are extracts from the special topic report and show the number of collisions that have occurred at different types of crossing in a ten year period and the risk arising from those collisions. The figures show that user worked crossings with telephones have the third highest number of collisions when compared with all other types of crossing and contribute the second highest level of overall risk, although they drop in rank to 7th when the figures are normalised by the number of such crossings on the network. Figure 18 also shows that the normalised risk at UWCs equipped with miniature stop (warning) lights is approximately six times higher than that at UWCs equipped with telephones. Miniature stop lights are normally provided on crossings with a higher level of underlying risk, often arising from much higher usage than applies at most UWCs. It should not be the case that risk will increase if miniature stop lights are provided at a crossing that has hitherto only been equipped with telephones. This has now been recognised by the railway industry (see paragraph 184 and its associated footnote).

Figure 18: Risk from trains striking road vehicles, based on data contained in RSSB's Safety Risk Model, Version 6 (reproduced courtesy of RSSB)

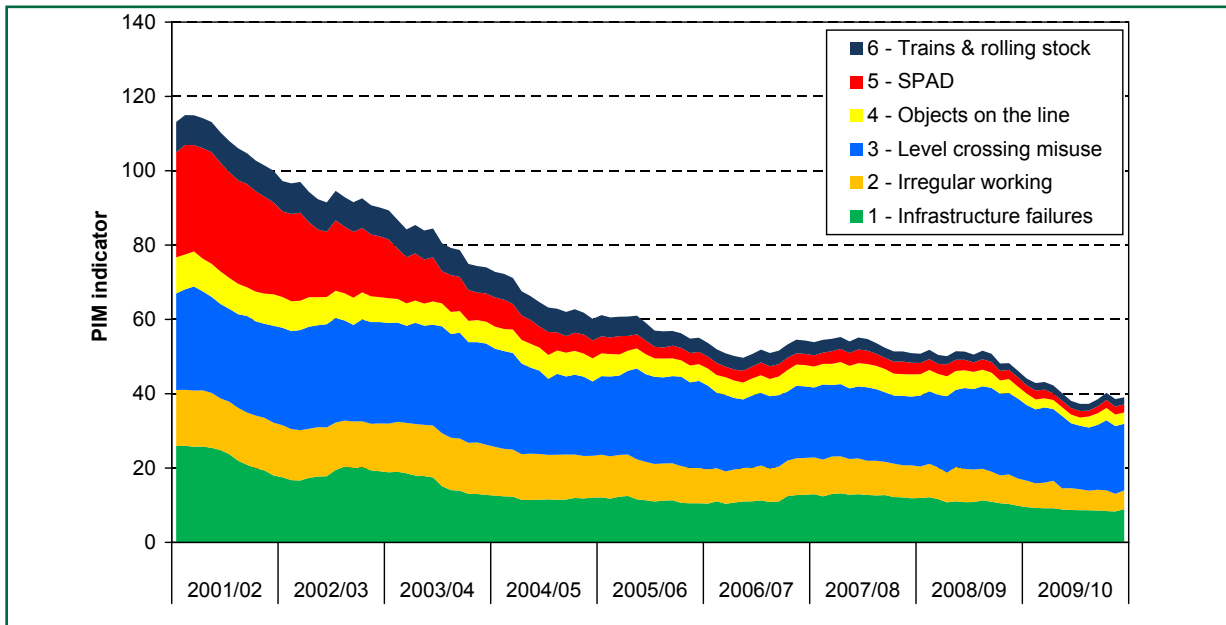
181 While the railway industry has made significant progress in reducing risk in a number of categories in the last ten years, risk from level crossing misuse (by members of the public) has seen a smaller reduction in risk in the same period. This is illustrated in figure 19 below, reproduced from the RSSB's Annual Safety Performance Report 2009/2010¹⁶.

Figure 19: Trends in train accident risk 2001-2010¹⁷ (reproduced by courtesy of RSSB)
