Rail Accident Investigation Branch

Rail Accident Report

Runaway of an engineering train from Highgate 13 August 2010

13 August 2010

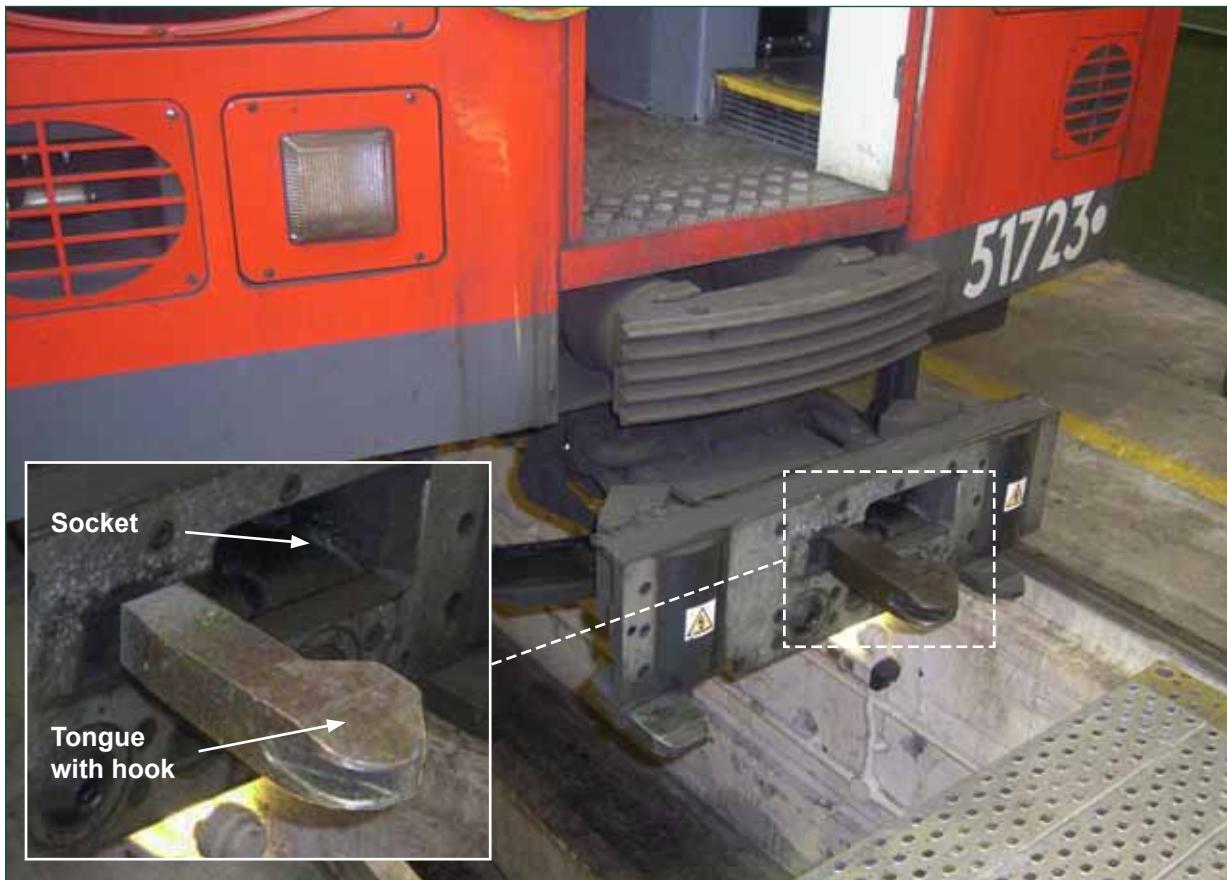
Figure 10: Wedgelock coupler.

119 The wedgelock coupling is the standard coupling for London Underground passenger trains. When coupled to another passenger train, the faces of these couplers are fixed rigidly to each other using hooked tongues inserted into sockets (figure 10). Two horizontal hinges (ie hinges allowing horizontal rotation) are needed to allow vehicles to negotiate horizontal curves and two vertical hinges are needed for vertical curves (figure 11). Each wedgelock/car body connection provides one horizontal hinge and one vertical hinge. The nominal centre of a wedgelock coupler is 395 mm above the *running rail*.

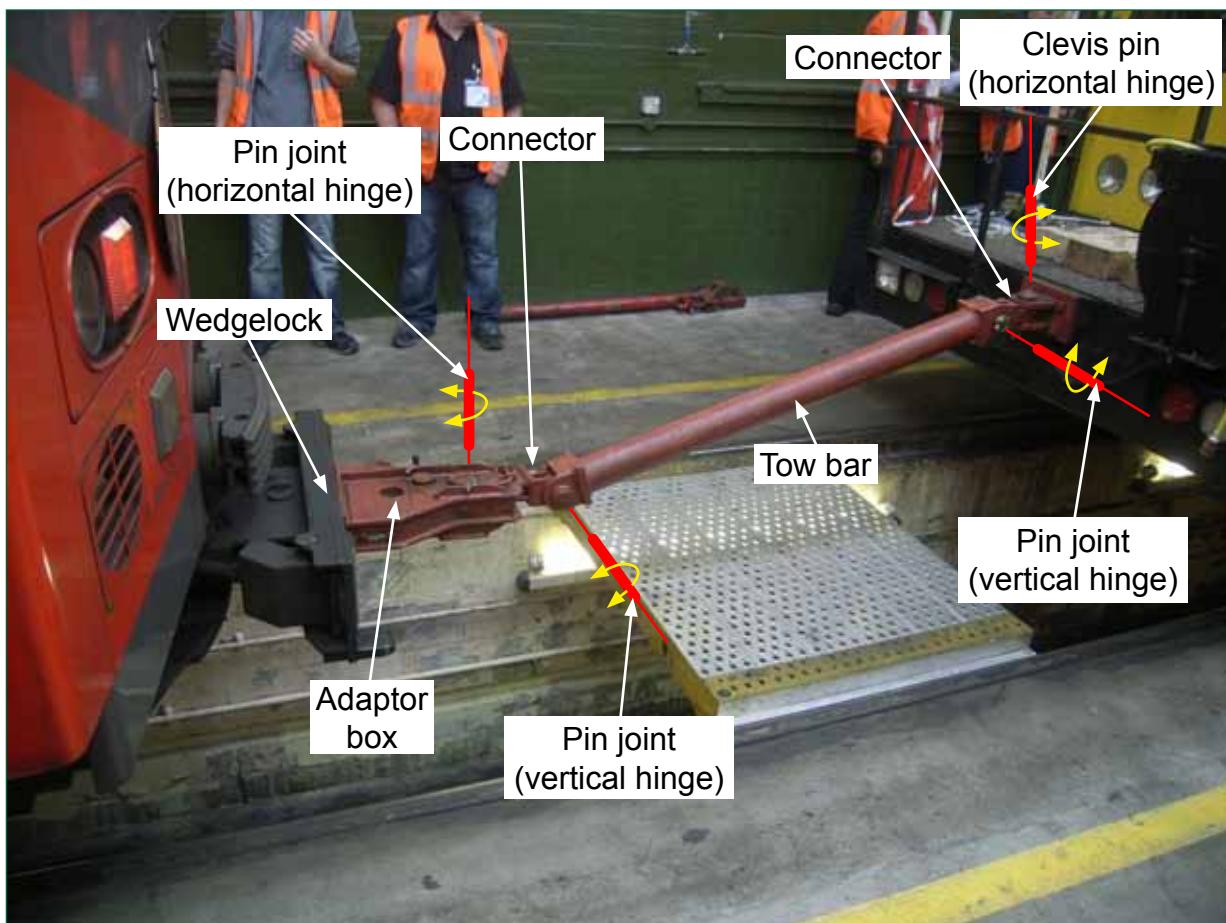
Figure 12: Emergency coupler components.

121 The emergency coupler comprised an adaptor box and a tow bar with hinged connectors at each end (figure 12). In use, the adaptor box was rigidly connected to the wedgelock coupler on the assisting train. A hinged connector linked the adaptor box to the tow bar. Horizontal rotation was permitted at the pin linking the connector to the adaptor box; vertical rotation was permitted by the pin linking the connector to the tow bar. The second hinged connector linked the tow bar to the clevis pin on the RGU. The pin linking the connector and tow bar allowed vertical rotation; the connection to the clevis pin allowed horizontal rotation.

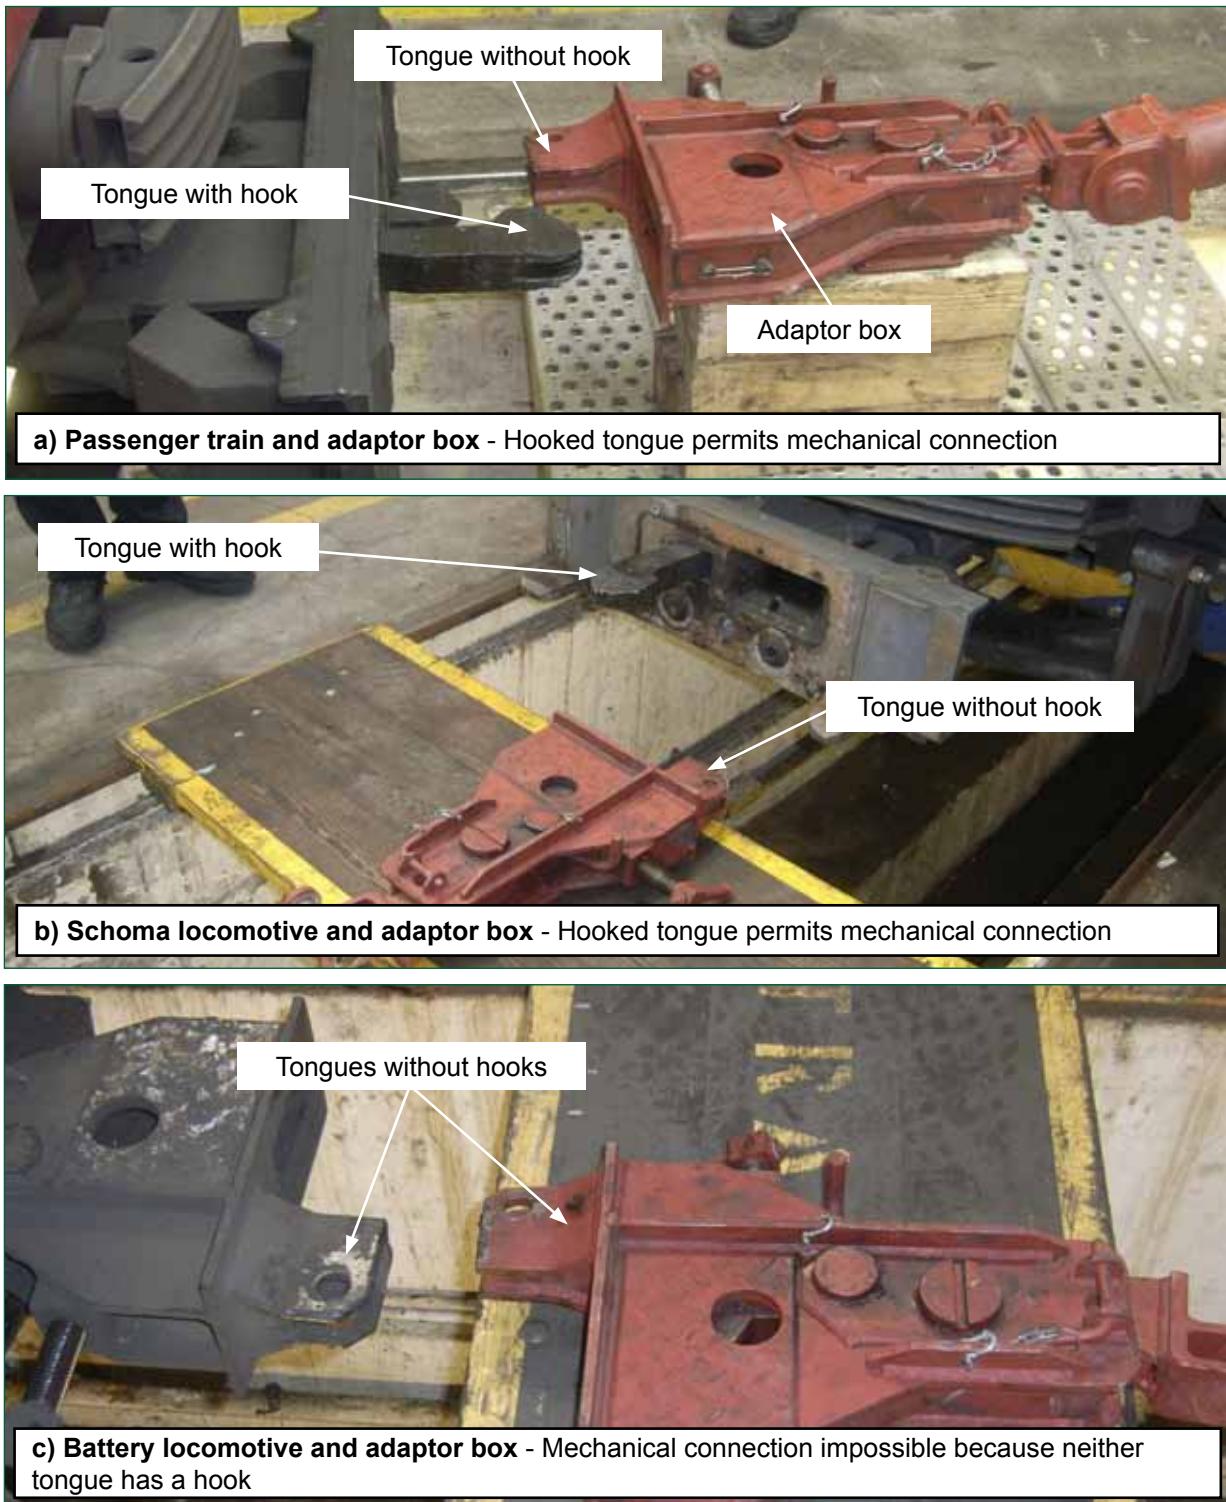
Figure 19: Coupler compatibility.

- 145 The Rolling Stock Project Engineer summarised his work in a memo dated 22 October 2002 and addressed to Rolling Stock Asset Engineer 1. This stated "A tow bar is carried at either end of the vehicle to facilitate emergency rescue of the vehicle. This has been tried at Lillie Bridge depot using a Schoma locomotive. In operation, a battery loco will be held on permanent standby at the nearest possible location." Investigations by RAIB have shown that this would not have been practicable – all battery locomotives in service during, and since, 2002 have lacked the hooked tongue necessary to couple with the emergency coupler's adaptor box (figure 19).

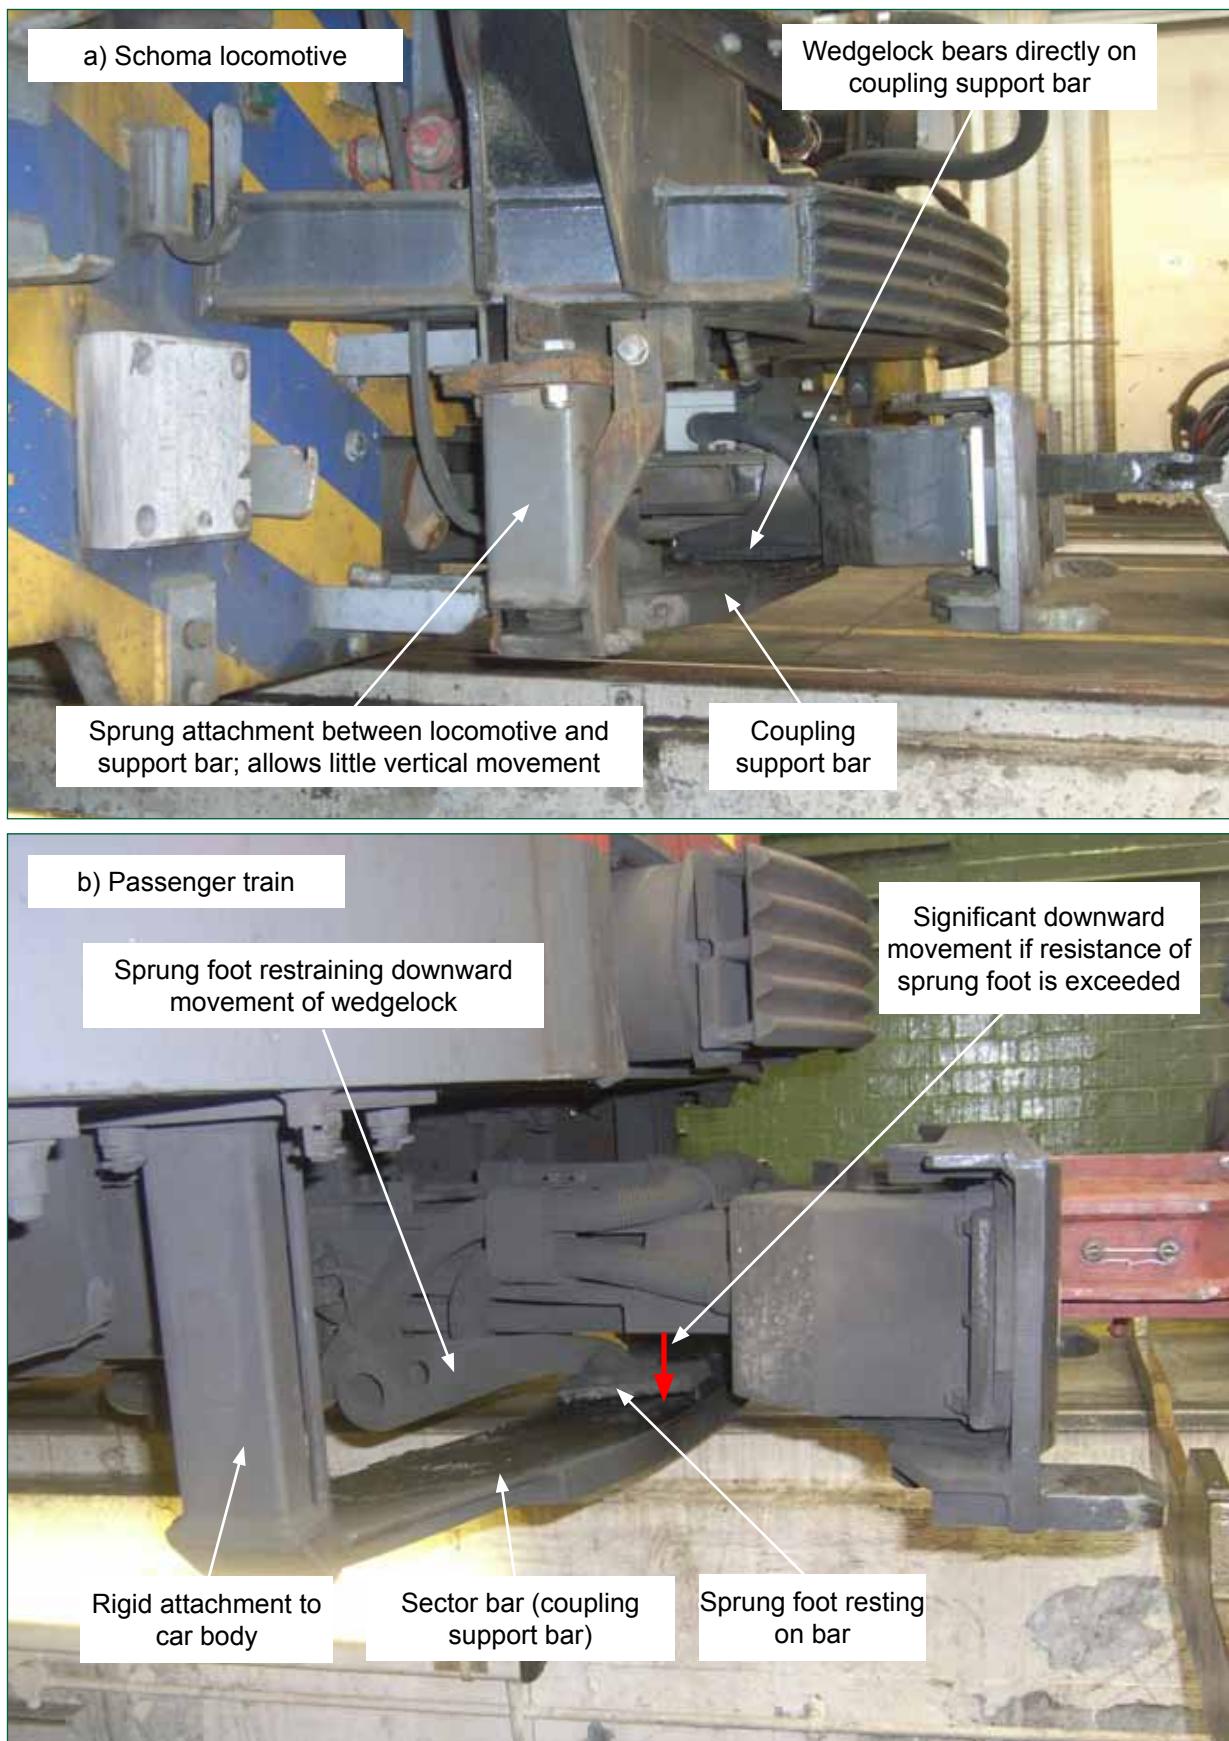
Figure 20: Wedgelock vertical rotation.

- 161 The excessive downward movement of the emergency coupler when used with passenger rolling stock (paragraphs 125 and 167) did not occur during the acceptance testing. This is because the wedgelock on the Schoma was prevented from significant downward rotation by direct contact with a horizontal bar immediately beneath the coupler. The bar is relatively stiff and is supported on springs attached to the locomotive body (figure 20). The springs allow only the relatively small downward coupler movement needed when negotiating vertical curves (paragraph 119).

- 162 On a passenger train, spring loaded feet are attached to the wedgelock. These bear on a horizontal sector bar which is less stiff than the corresponding horizontal bar on the Schoma locomotive. The spring loaded feet and the horizontal sector bar are intended to carry the weight of the wedgelock when the coupling is not being used (figure 20). They provided less resistance to downward coupling movement than the corresponding arrangement on a Schoma locomotive.
