# Rail Accident Report

**Fatal accident at Moreton-on-Lugg,  
near Hereford,  
16 January 2010**

# Fatal accident at Moreton-on-Lugg, near Hereford, 16 January 2010

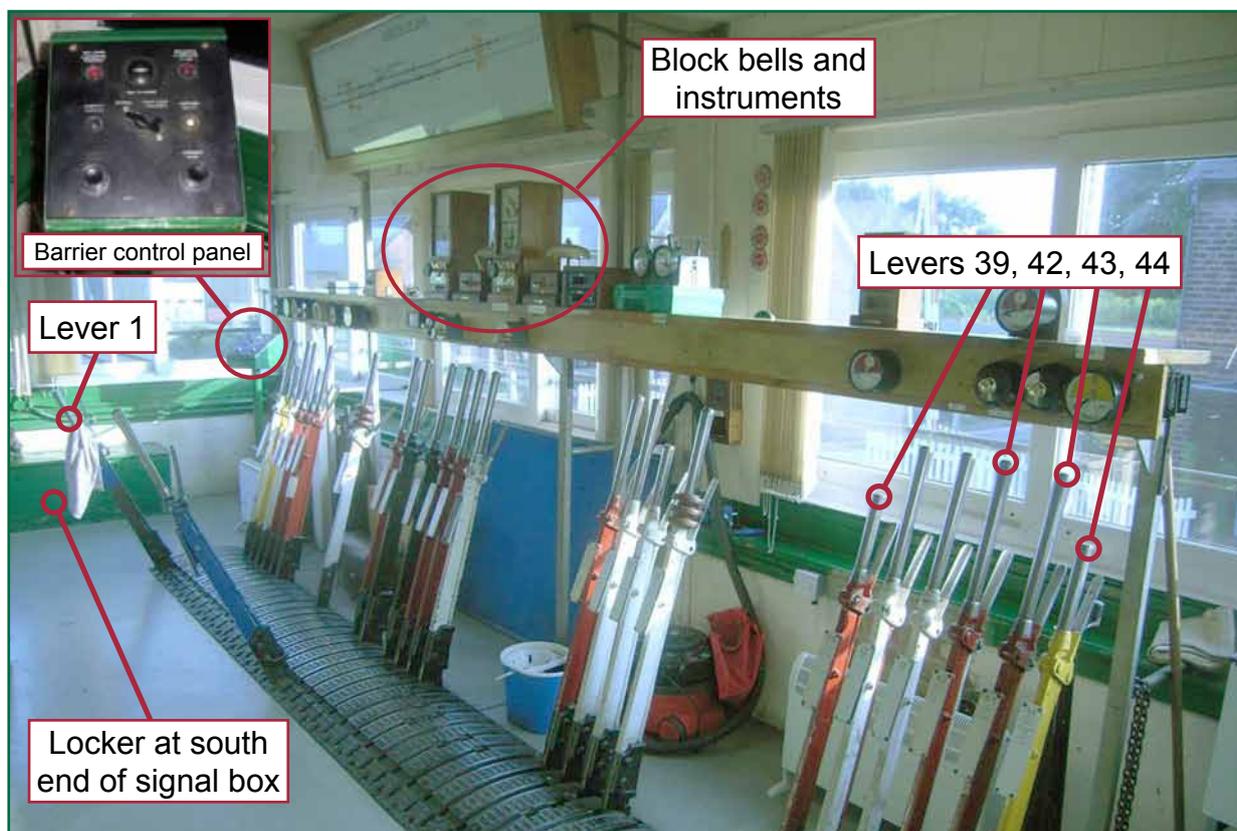
Figure 7: Signalling and level crossing controls in Moreton-on-Lugg signal box

- 30 The signaller controls the signals and *points* from a *lever frame*; there are 15 levers currently in use. The barrier control panel (paragraph 26) is located to the south side of the frame, between the road and lever 1. Lever 1 provides the interlocking between the railway signals and the barrier controls. The signaller pulls it so that, via the electrical interface (paragraph 26), the barrier control panel is made active. The signaller can only push lever 1 back (*replacing* it in the frame) if the barriers are fully down. There are *block instruments* on a shelf over the frame for *offering* and *accepting* trains to and from Hereford and Leominster (paragraph 15). The controls are shown in figure 7.

- 70 Having been accepted by the signaller at Moreton-on-Lugg, train 1V75 passed the section signal at Leominster, LE27, at 10:22:31 hrs.
- 71 Just over a minute later, at 10:23:41 hrs, the signaller received a telephone call from Ox Pasture Farm No.1 user-worked crossing. The caller wanted to take sheep over the railway line. The signaller asked him how much time he required. The caller replied that he needed five or ten minutes. The signaller refused him permission, and he told him he would have to wait as a train from Leominster (train 1V75) was on its way. He asked the caller to call back after the train had gone past. The call ended at 10:24:08 hrs. The signaller then got the occurrence book for the user-worked crossing, he recalled that it had probably been on the lower shelf of the small desk (paragraph 32). When doing this, he noticed the three previous entries were all requests for 'sheep'. He repeated the ditto-marks under the last entry, and recorded '10:24' for the time of the call and when permission was refused, and five minutes for the 'time required for movement', figure 10. The signaller left the occurrence book open, so he could complete the entry when the caller had crossed, on a storage locker at the south end of the signal box, under the window overlooking the road and the level crossing (figure 7).

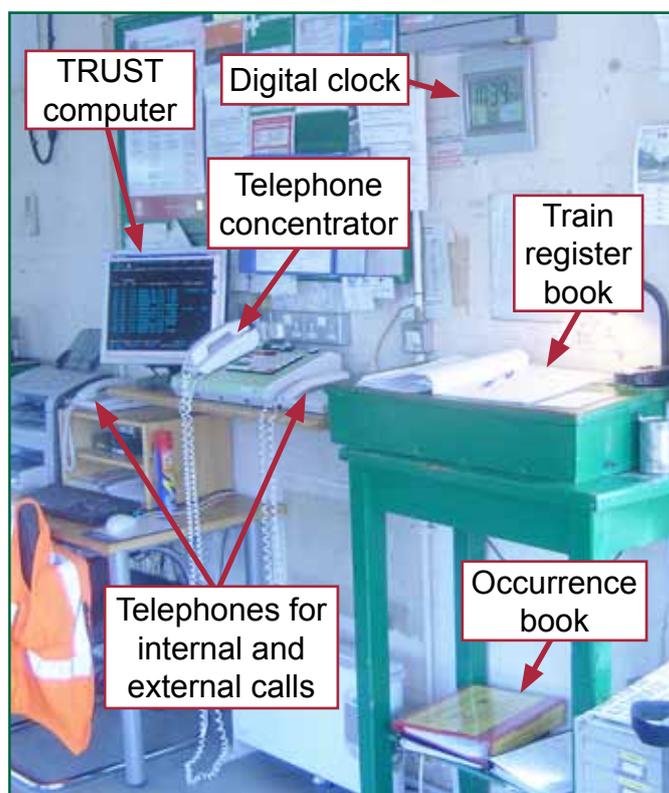
Figure 8: Desk, telephones and other equipment on east side of signal box

- 32 The *train register book*, which the signaller uses to record train movements, is kept on a small desk on the east side of the signal box (opposite the levers); above it is a digital clock. There are three telephones near the desk. Two are for external and internal calls to the signal box. The third is the *telephone concentrator* that is used for calls from operational telephones, including those in Hereford and Leominster signal boxes and adjacent to local signals. The telephone concentrator is also used to receive calls from four remote level crossings in the area: Ox Pasture Farm No.1, Dolmeadow and Wellington (paragraph 14), and a user-worked crossing south of Moreton-on-Lugg, Lyde Court. The *occurrence book*, which signallers use to record calls from the crossings, is normally kept on the lower shelf of the small desk used for the train register book. To the left of the telephone concentrator is the *TRUST* computer which gives the status of approaching trains: this is presented as the time of arrival, departure or passing at a number of reporting points (for instance stations, signal boxes and junctions).

- 112 He took the call, and, rather than turning and looking at the block instruments behind him to determine the status of approaching trains, he consulted the TRUST computer that is directly adjacent to the telephone concentrator (figure 8). It seems it was then that he became conscious of the significance of train 1W85, and that, because it was not far away, there might not be enough time for the sheep to cross. TRUST information at the time showed that train 1W85 was delayed passing Tram Inn, and had not yet arrived at Hereford. He thought that there could be enough time if the caller could cross quicker than his estimate (he was aware that the occurrence book showed that three previous requests for crossing sheep had been achieved in less than five minutes, figure 10). However, he was also mindful that the TRUST information might not be accurate, and wasn't certain if 1W85 had, by now, arrived at Hereford.

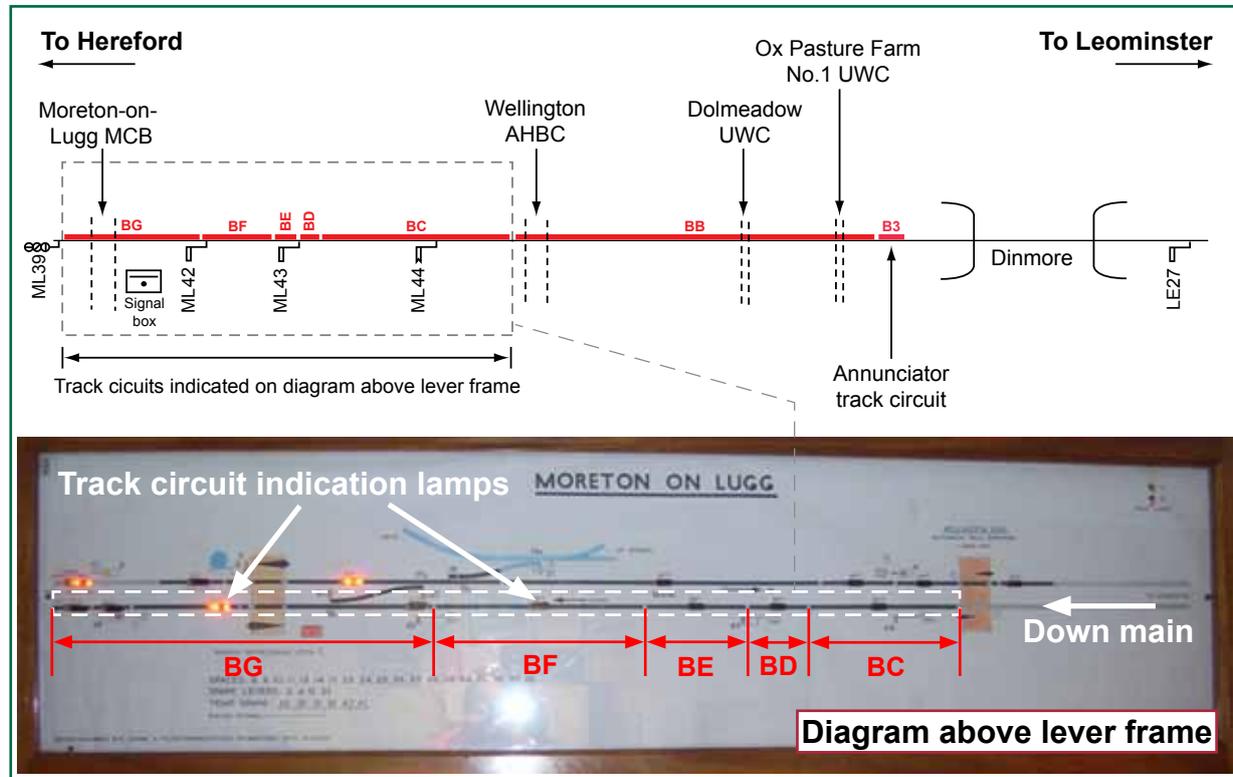
Figure 9: Signalling on the down main approaching Moreton-on-Lugg (not to scale)

34 Figure 9 shows the layout of the signalling on the down main between Leominster and Moreton-on-Lugg, the line on which train 1V75 was approaching. It also shows the location of the track circuits and their indication on the diagram in the signal box (paragraph 31).
