# Rail Accident Report

## Collision at Exeter St Davids station 4 January 2010

Report 10/2010  
June 2010

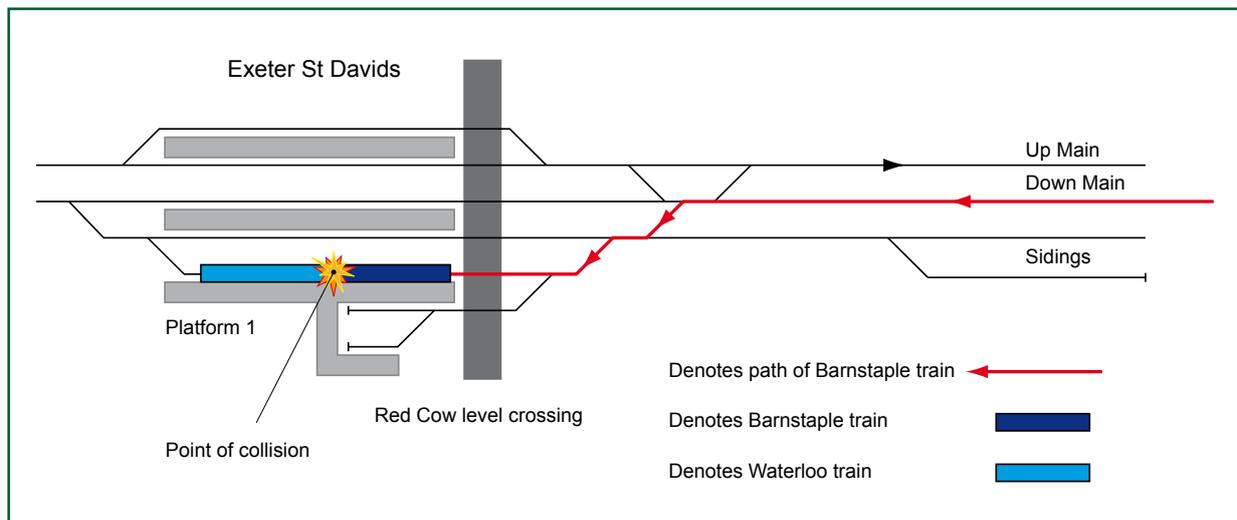
Figure 2: Layout of track and path of train involved

6 At around 19:25 hrs on 4 January 2010, a passenger train from Barnstaple arriving in platform 1 at Exeter St Davids station collided with the rear of another passenger train which was stationary in the platform (see figures 1 and 2).

- 15 On the immediate approach to platform 1 from the east end of the station, trains pass over Red Cow closed circuit television (CCTV) level crossing (see figure 2). This level crossing is situated on a busy road linking the A377 with the Exwick area of Exeter.

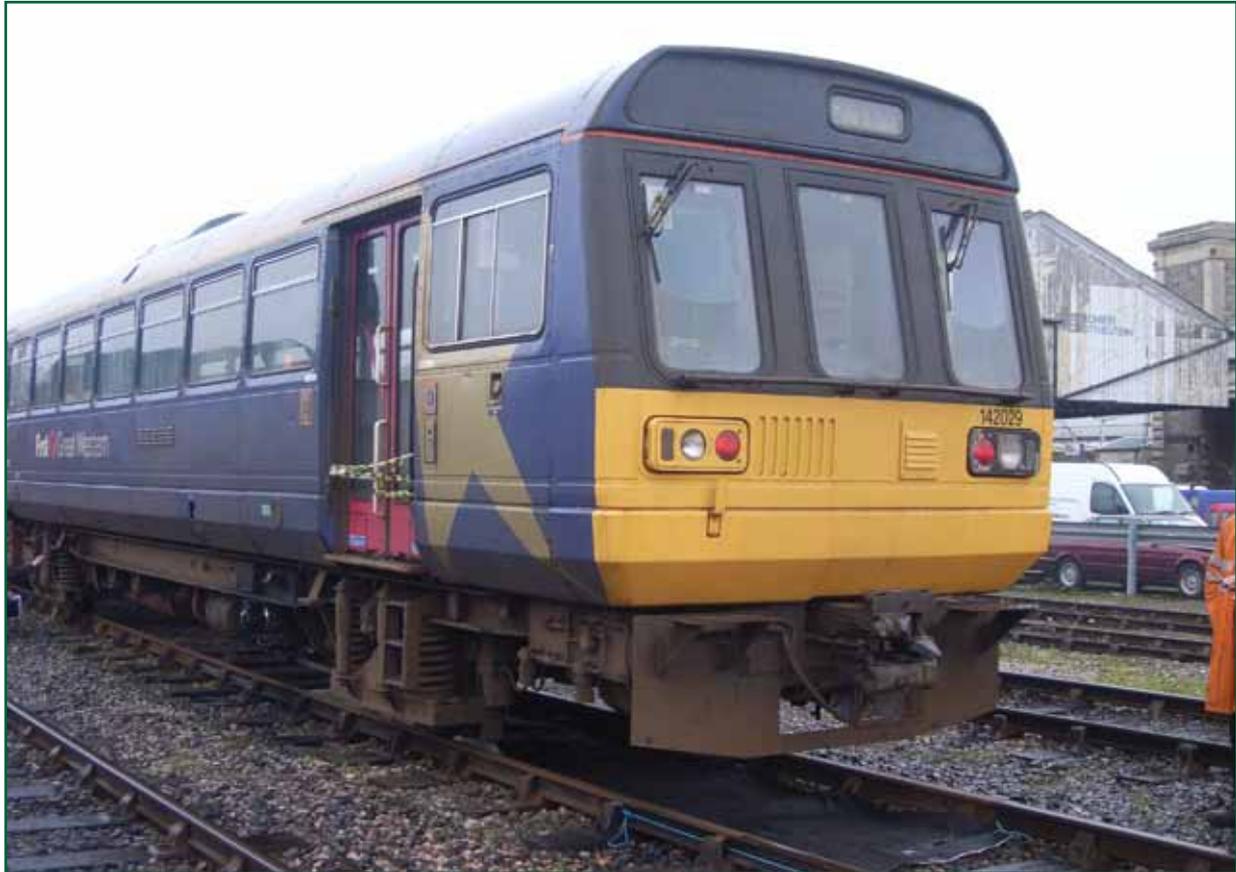
Figure 3: Class 142 'Pacer' unit involved in the accident at Exeter St Davids

- 18 The train from Barnstaple was formed of a class 142 'Pacer' diesel multiple unit (see figure 3). The train comprised two vehicles. It was around 31 metres in length and weighed 50 tonnes. There were 12 passengers and two members of crew on the train.

- 19 Each vehicle on a class 142 unit has one axle at each end; a total of 4 axles per two-car unit. The trains are equipped with a three-step brake<sup>1</sup> that applies directly to the train wheels.
- 20 The Waterloo train was formed of two class 159 diesel multiple units coupled together to form a six-car train. The length of this train was around 135 metres and it weighed around 230 tonnes. There were nine passengers and two members of crew on the train.
