Rail Accident Investigation Branch

Rail Accident Report

Derailment at Hampton Loade, Severn Valley Railway 28 September 2009

Report 07/2010
April 2010

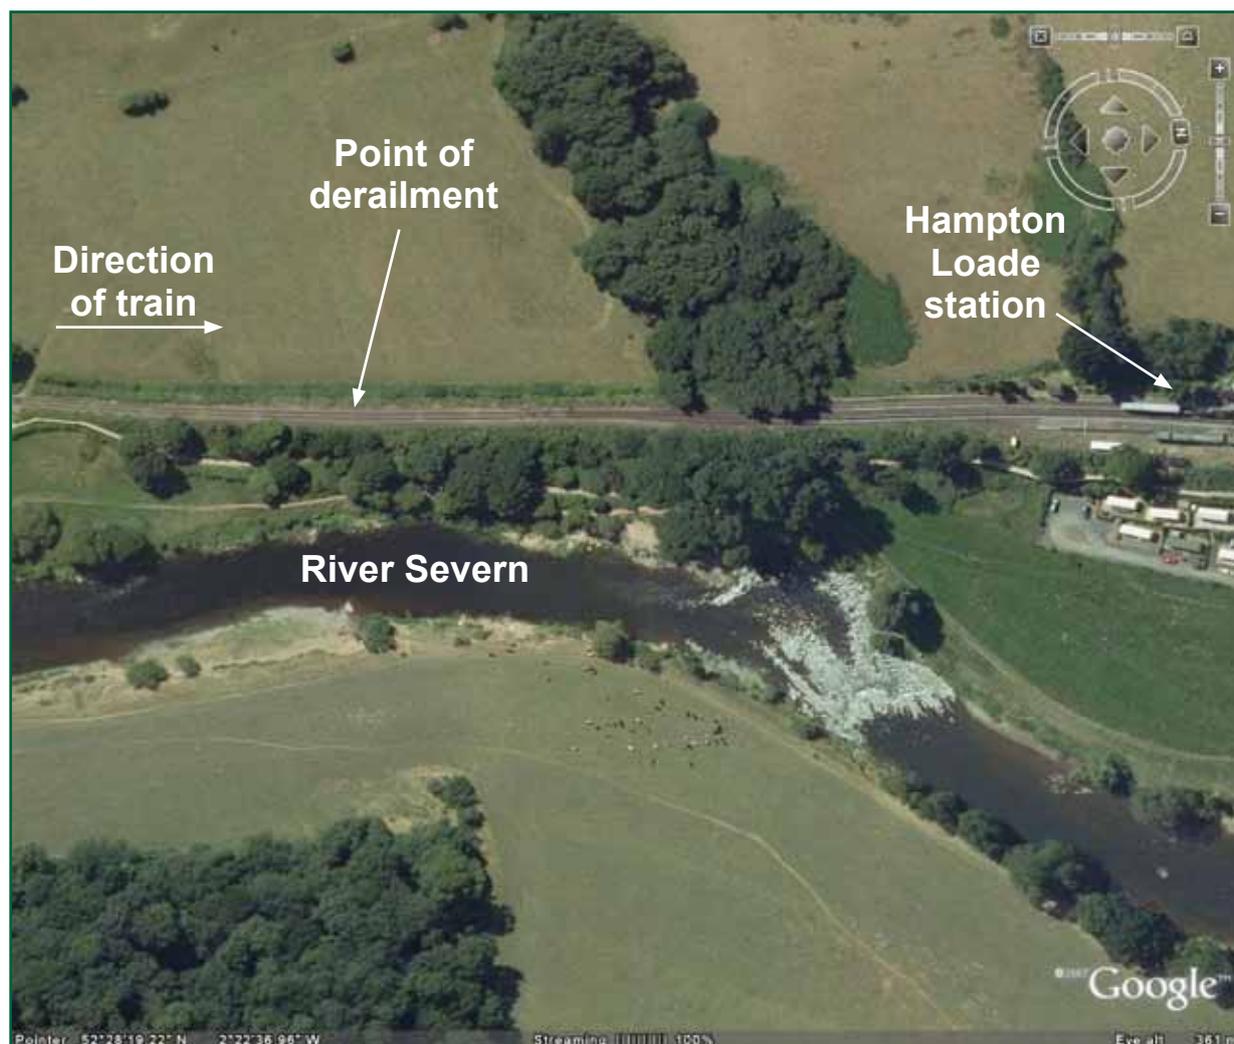
Figure 2: Aerial view of the site (courtesy of Google Earth)

- 7 The train was slowing down to stop and was travelling at less than 10 mph (16 km/h) at the time the derailment occurred on *plain line* to the south of the station (figure 2). Significant damage was caused to the track and the tender. The *points* at the south end of the loop at Hampton Loade were damaged beyond repair and the line was closed for five days while repairs were carried out to reinstate a single line through the station. This prevented trains from passing at this station pending replacement of the points.
