Rail Accident Investigation Branch

Rail Accident Report

Derailment of a passenger train near Cummersdale, Cumbria 1 June 2009

Report 06/2010
March 2010

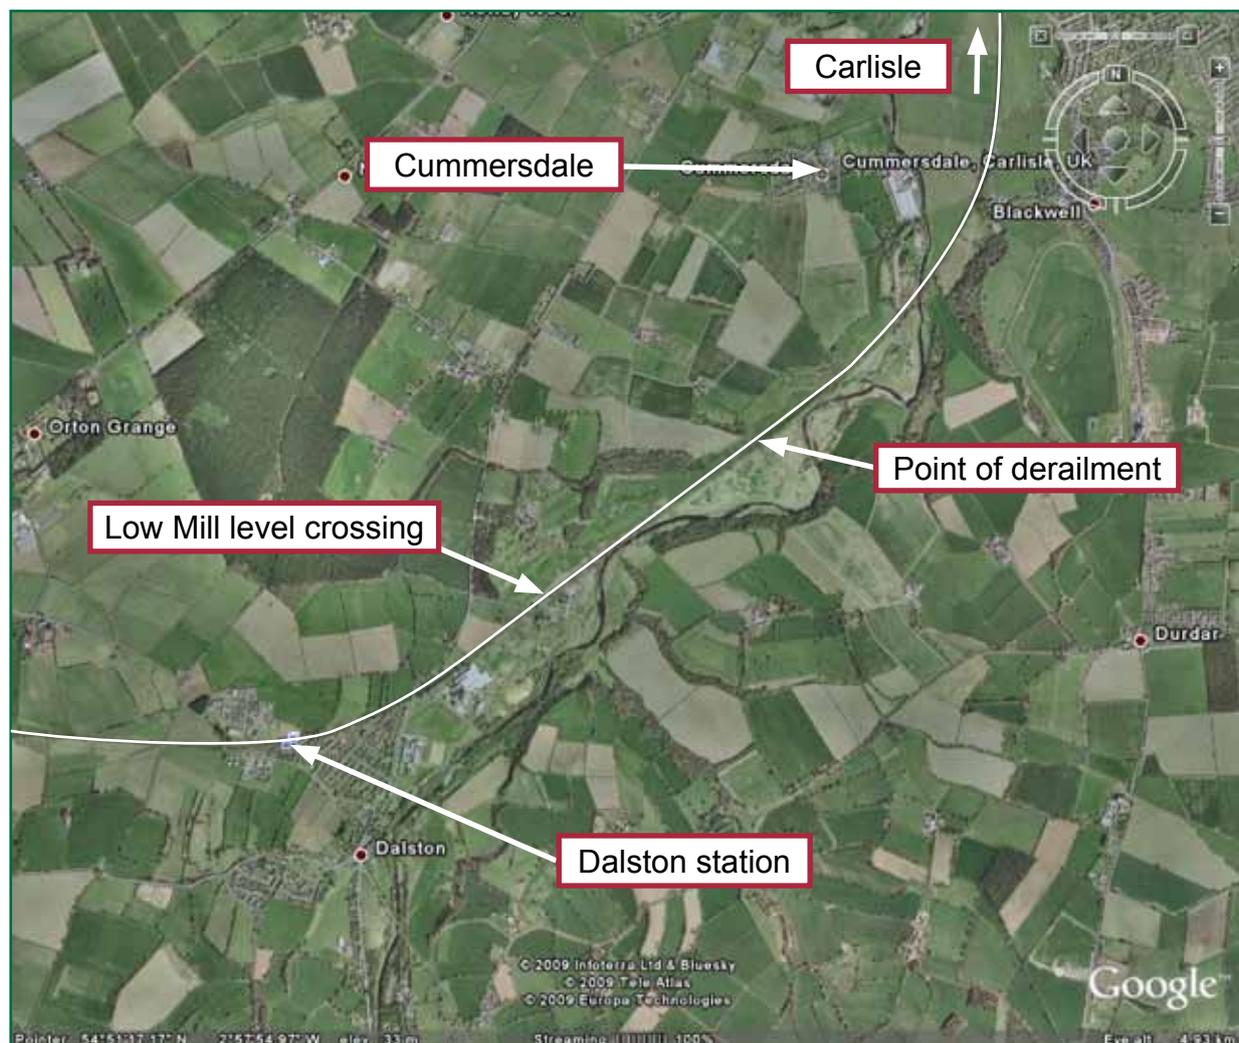
Figure 1: Location of the derailment between Dalston and Cummersdale

- 5 On 1 June 2009, at approximately 14:20 hrs, train 2C31, which formed the 13:05 hrs Whitehaven to Carlisle service, was travelling on the Maryport and Carlisle section of the Cumbrian Coast line, heading towards Carlisle. The driver of train 2C31 had been requested to visually examine the line between Dalston and Cummersdale near Carlisle (figure 1) to find a defect in the track which had been reported by the driver of the preceding train, 2C47, to the signaller. While scanning the line, the driver of train 2C31 noticed a severe track buckle approximately 200 metres ahead. He applied the emergency brake but was unable to stop before the buckle. The leading bogie of train 2C31 derailed and ran on for approximately 25 metres. The trailing bogie was not derailed.
