Rail Accident Investigation Branch

Rail Accident Report

Near-miss at Hanger Lane junction 27 March 2009

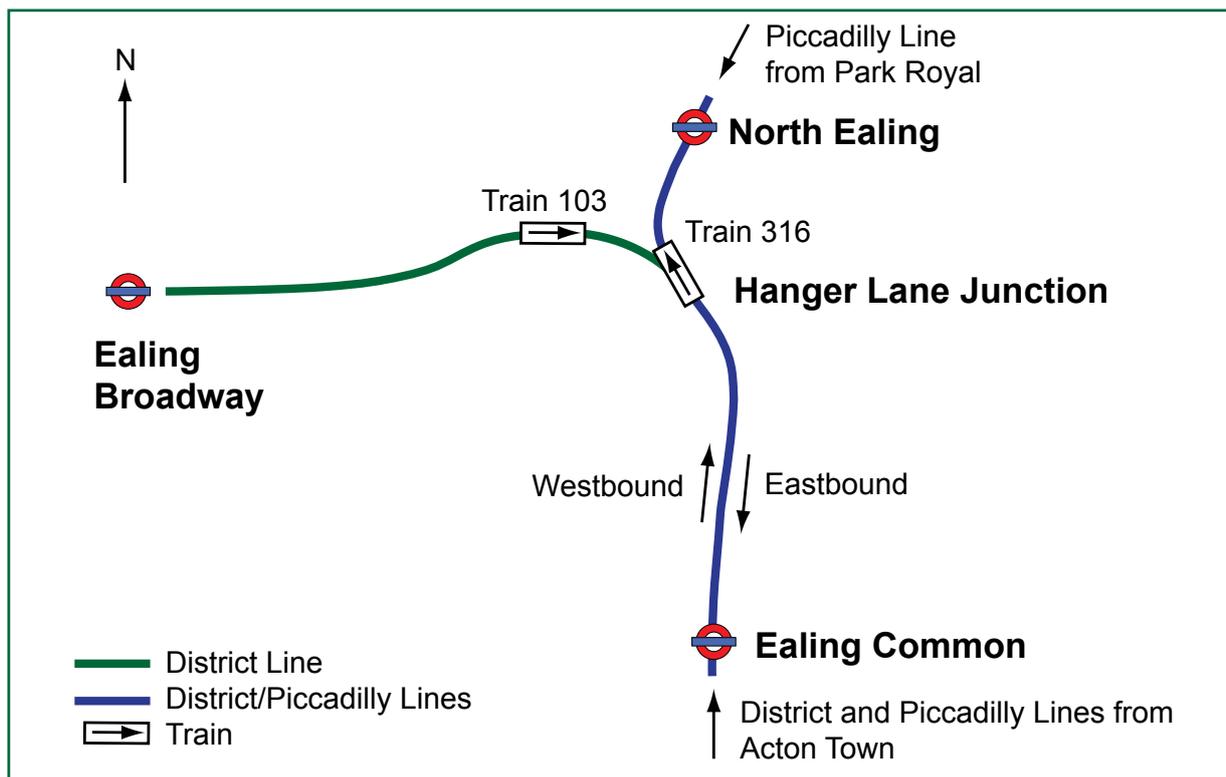
Figure 2: Simplified map of Hanger Lane junction showing position of trains during incident

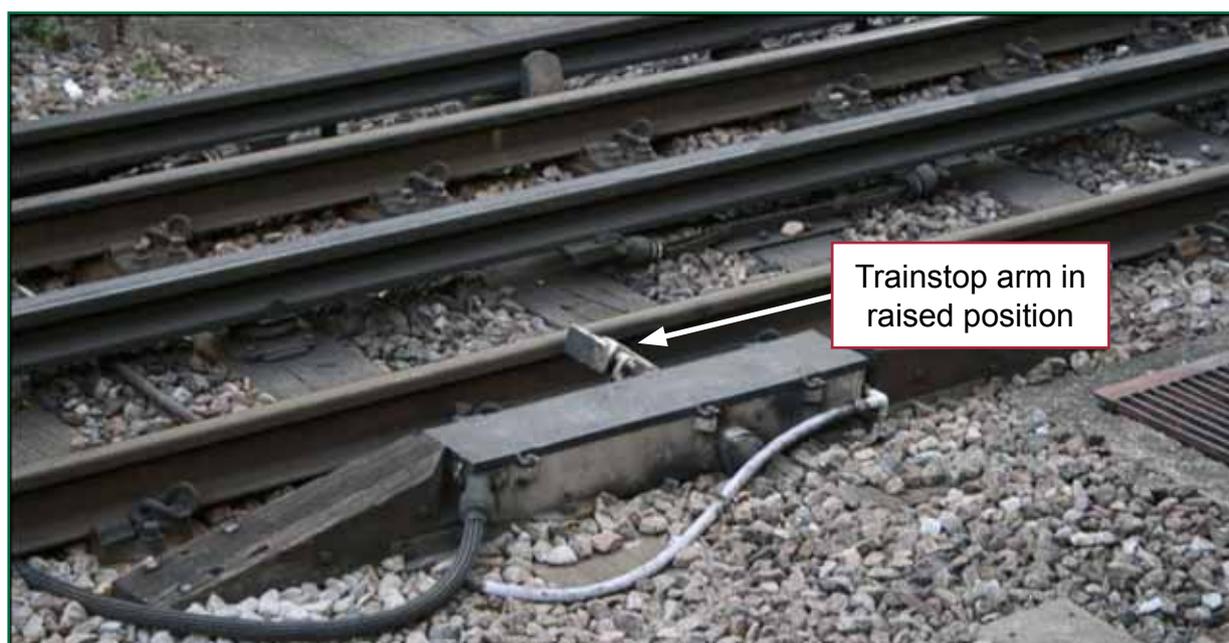
- 24 Trains operating on the District and Piccadilly lines are fitted with *tripcock* equipment which works in conjunction with the signalling system. A *trainstop* is a device comprising a short arm which is raised when the signal is showing red (figure 3). If a train passes a signal at danger, the trainstop makes contact with the tripcock arm on the train which automatically applies the train's emergency brake. The tripcock equipment can be reset by the train operator following activation after the signaller has given authority to do so. After the tripcock has been reset, a timer limits the train to a maximum speed of 8 mph (13 km/h) for three minutes.

Figure 3: Trainstop in the raised (stop) position (photograph courtesy of LUL library)

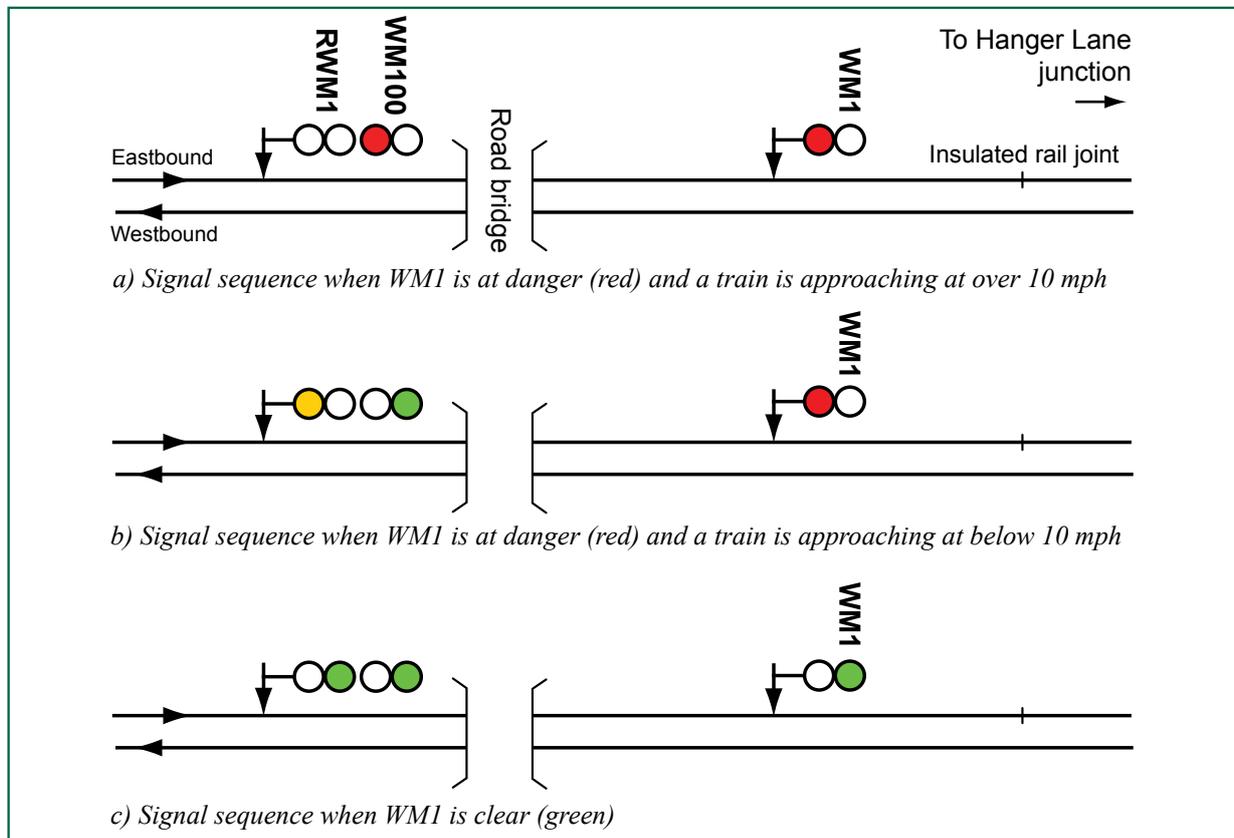
Figure 4: Signal sequence for an eastbound District Line train approaching Hanger Lane junction

- 36 At 17:21 hrs, train 103 departed from Ealing Broadway. As the train approached Hanger Lane junction, the train operator observed signal WM100 displaying a red aspect, which indicated that signal WM1 was also at danger. He slowed the train to below 10 mph (16 km/h). This was detected by the signalling system which allowed signal WM100 to clear to a green aspect and signal RWM1 to yellow (figure 4).

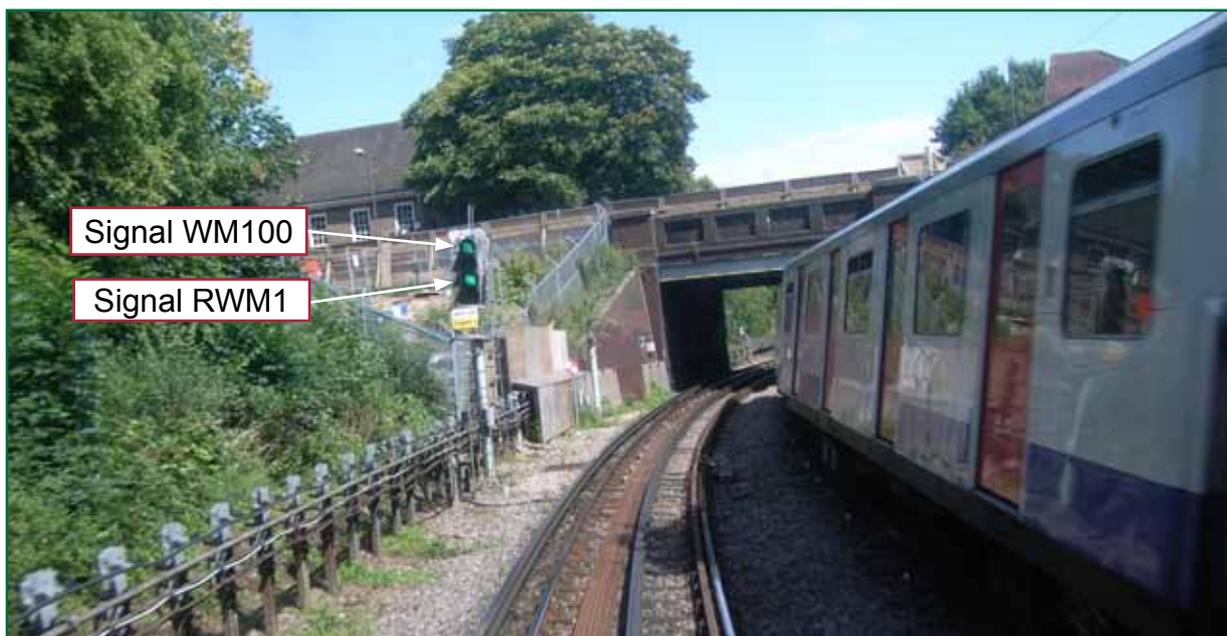
- 26 Signal WM1 is preceded by signals WM100 and RWM1. Those two signals are located 74 metres before signal WM1 and mounted together (figures 4 and 5). They provide a train operator with information on the status of signal WM1:

- Signal RWM1, mounted below signal WM100, is a *repeater signal* for signal WM1. This signal is designed to show a yellow aspect if signal WM100 is showing green but signal WM1 is at danger, or a green aspect if signal WM1 is green. It shows no aspect if signal WM100 is at danger. Signal RWM1 is provided to assist a train operator if the sighting of signal WM1 becomes obstructed when a train is approaching on the opposite line due to curvature of the track.

Figure 5: Signal WM100 mounted above signal RWM1. Signal WM1 is beyond the road bridge ahead

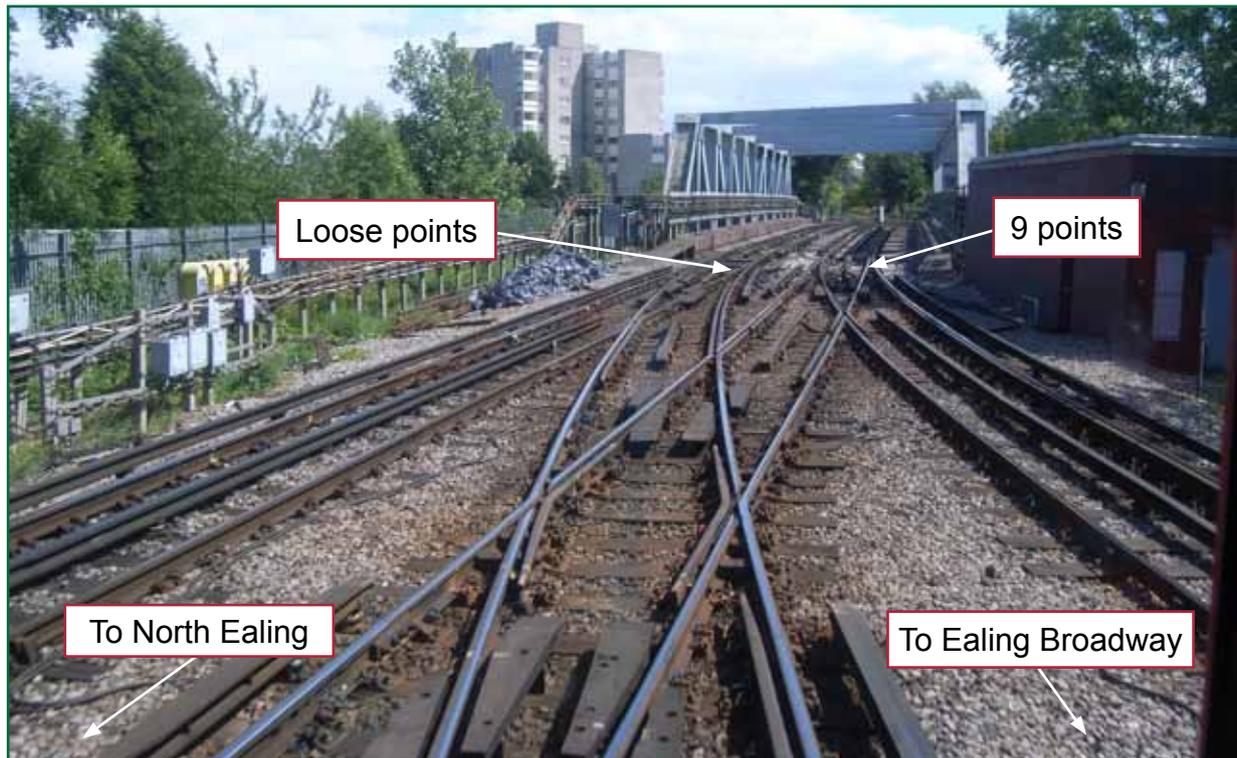
Figure 7: Hanger Lane junction viewed from eastbound District Line

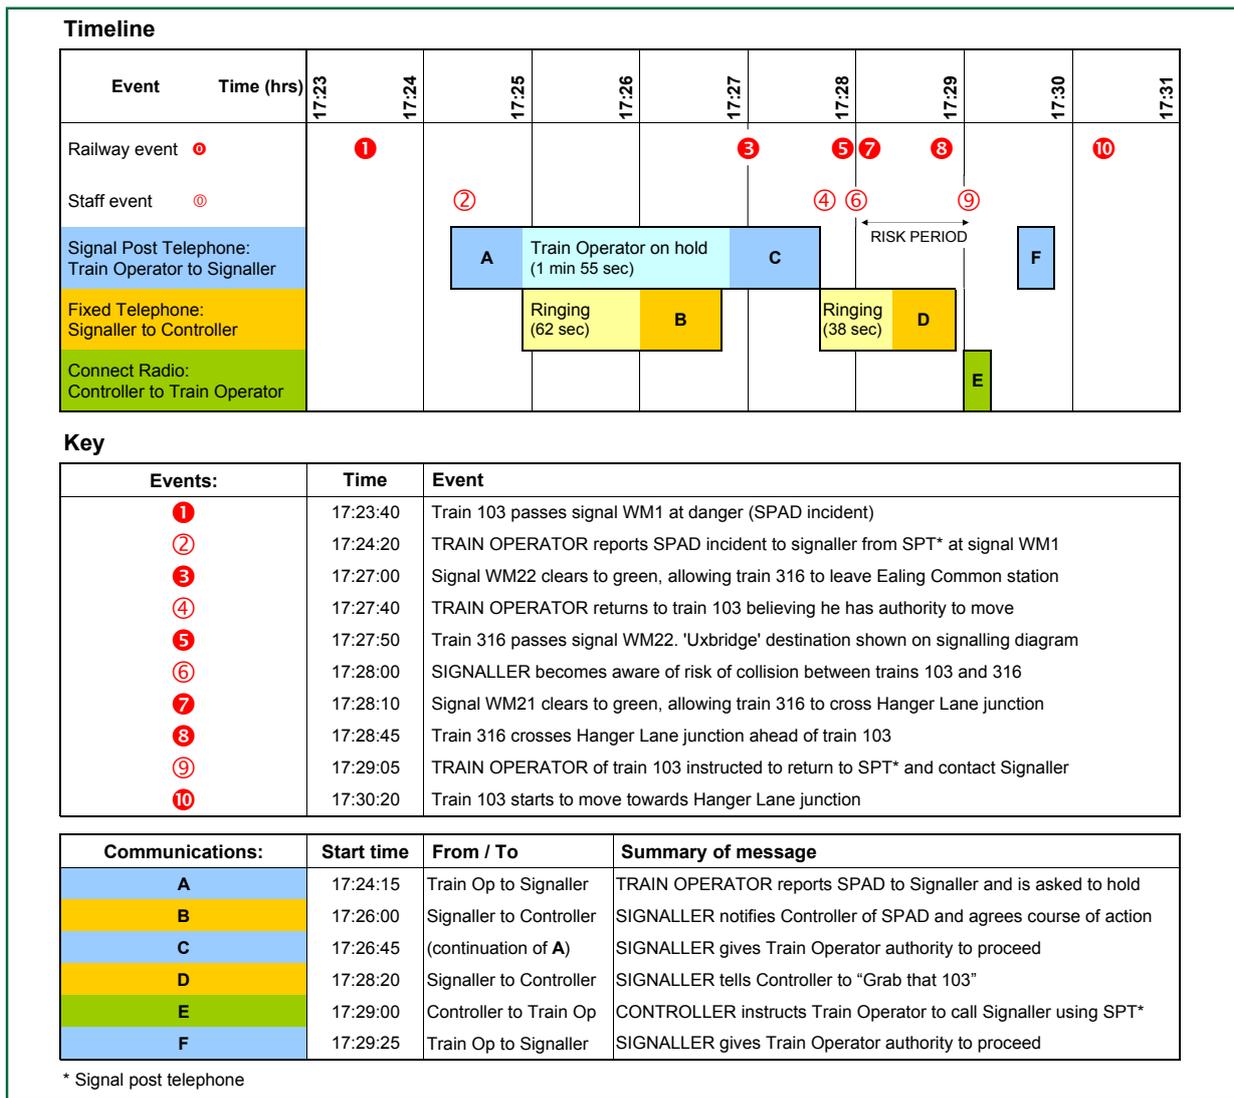
- 47 The train operator returned to the cab of train 103 and reset the train's tripcock apparatus before preparing to move his train.
- 48 At 17:27:40 hrs, the signaller instigated a second telephone call to the District Line controller to confirm the actions taken and conclude the incident. The controller was still busy with the Sloane Square incident and did not answer for 38 seconds (figure 9).

Figure 9: Time-line diagram showing chronological relationship between key events

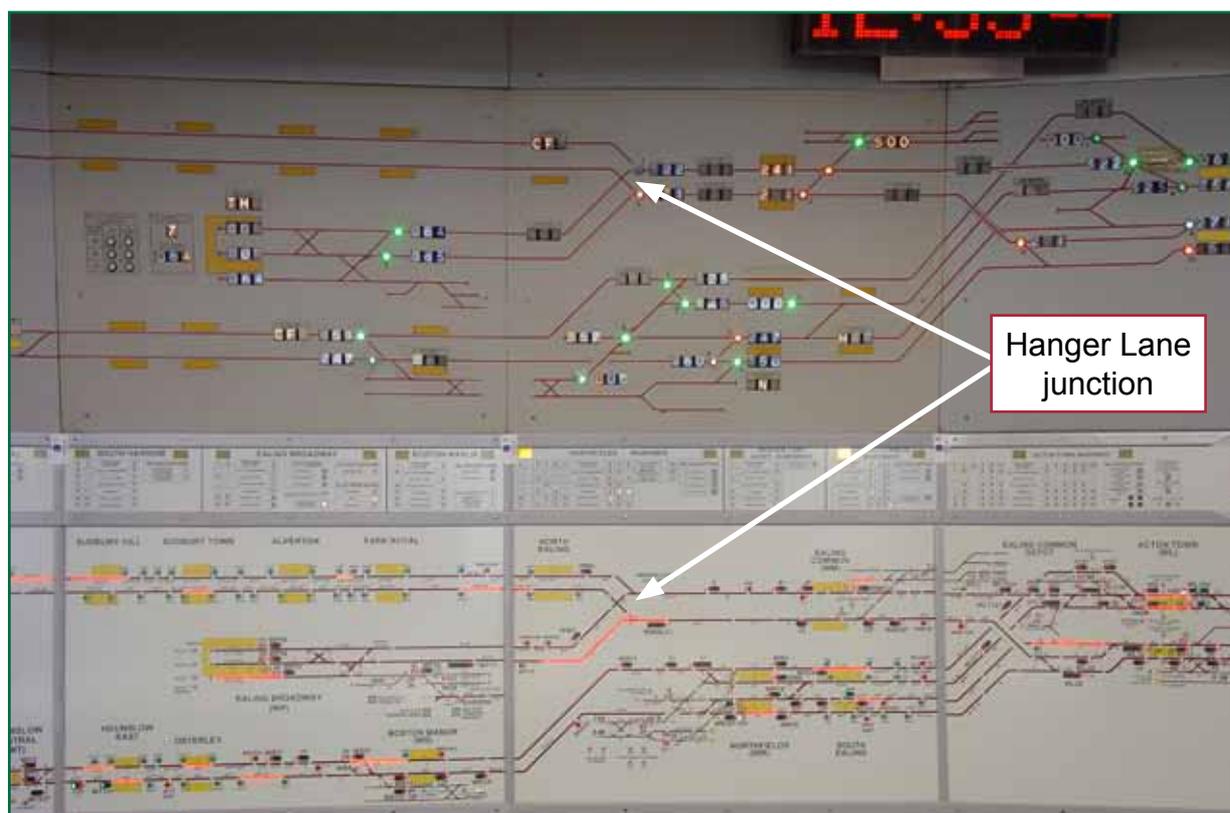
- 49 At 17:27:50 hrs, train 316 passed signal WM22. Its position was automatically updated on the large signalling diagram in front of the control desk (figure 10). The display panel above it also lit at the same time to show the train's destination as 'UX' for Uxbridge, both displays being visible to anyone within that part of the control room. An off-duty signaller who was seated close to the signaller observed this and drew the signaller's attention to train 316. The signaller, who had already been waiting for the controller to answer for 20 seconds, was startled by this. He was aware that there was the potential for a collision and his first action was to check the signalling diagram to see whether train 103 had moved.

Figure 10: Display panel (top) and signalling diagram within the Earls Court control room
