Rail Accident Investigation Branch

Rail Accident Report

**Collision with debris from bridge GE19 near
London Liverpool Street
28 May 2008**

Report 22/2009
August 2009

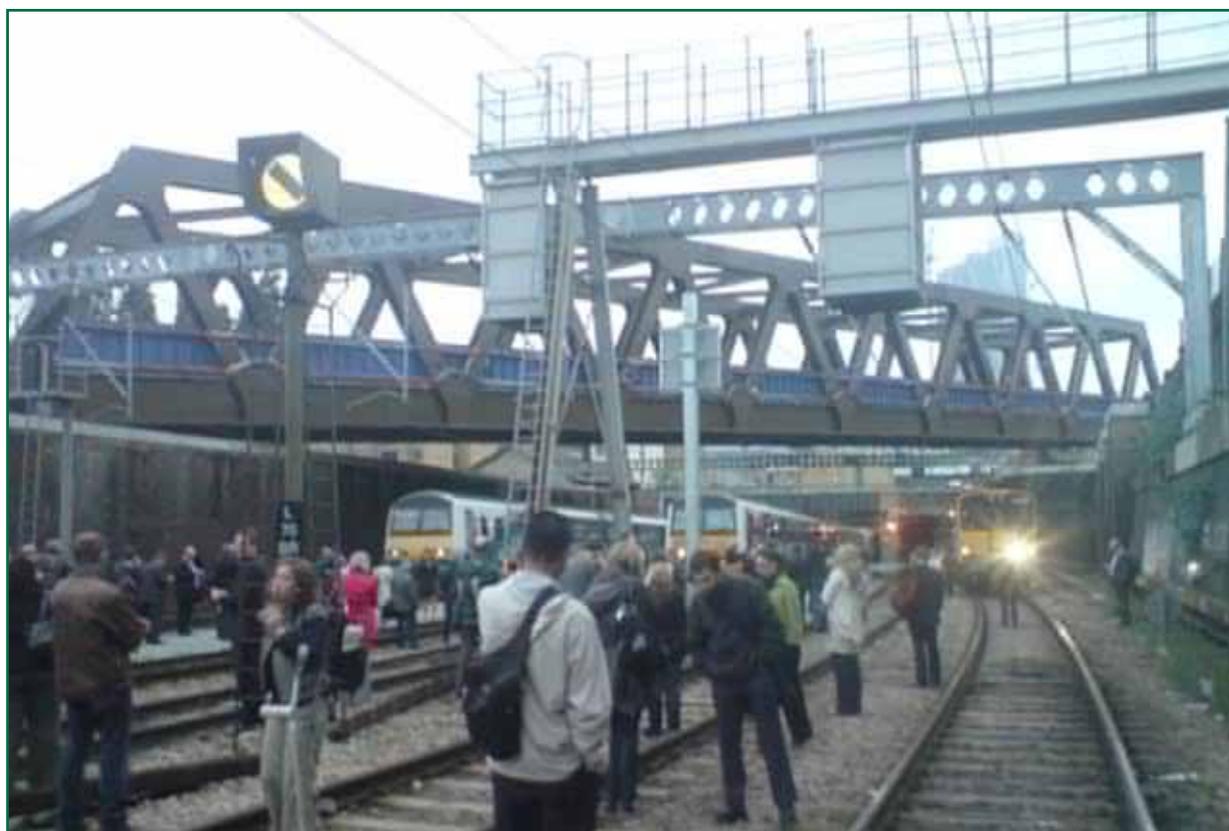
- 16 Concern over the immediate safety of the structure led to the signaller stopping all trains between Liverpool Street and Bethnal Green stations at 19:20 hrs, and an *emergency isolation* being taken at 19:34 hrs. A total of nine trains became stranded and over 1000 passengers were evacuated on foot along the track to the nearest station (Figure 2).

Figure 2: Photograph taken by an evacuating passenger at about 19:45 hrs looking back towards Liverpool Street. Bridge GE19 is in the background (Photograph: WENN)

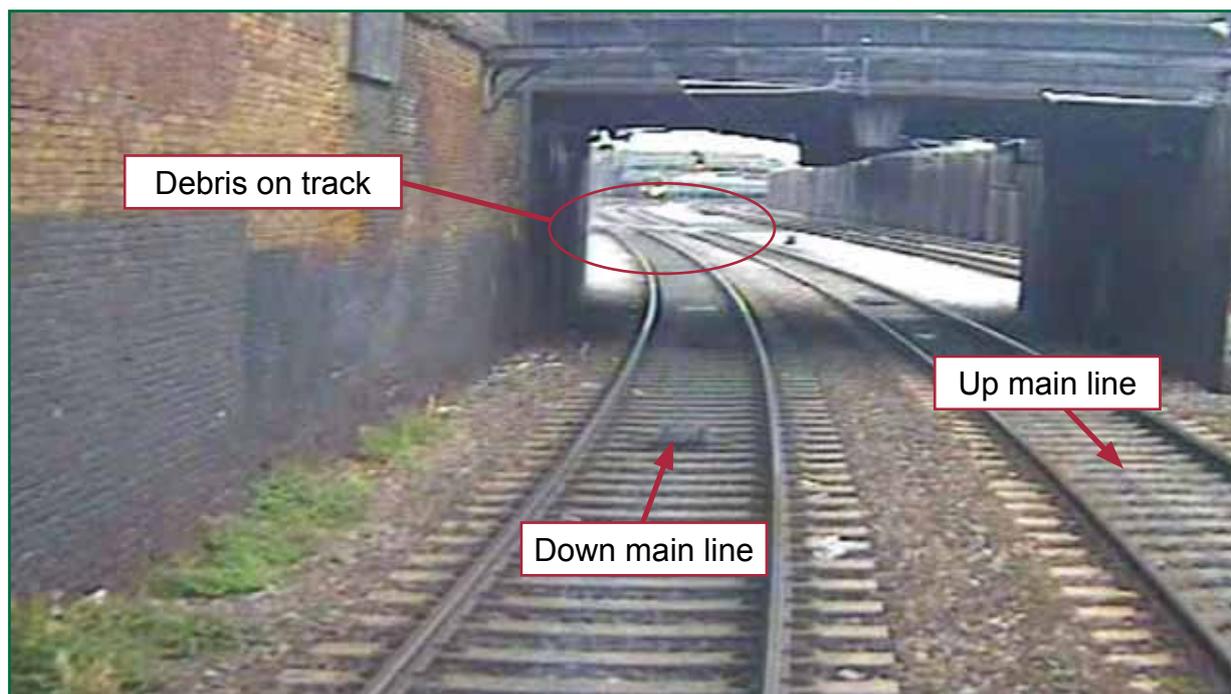
Figure 4: Image from CCTV equipment fitted to train 1K12, six seconds before collision with debris

- 41 Once the power supply was restored, train 1K12 accelerated to 30 mph. The driver's first sighting of debris on the track occurred six seconds before impact, his visibility being restricted by a left hand bend and the abutment of the existing Brick Lane bridge (Figure 4). The driver was also aware of a cascade of water falling from the structure.

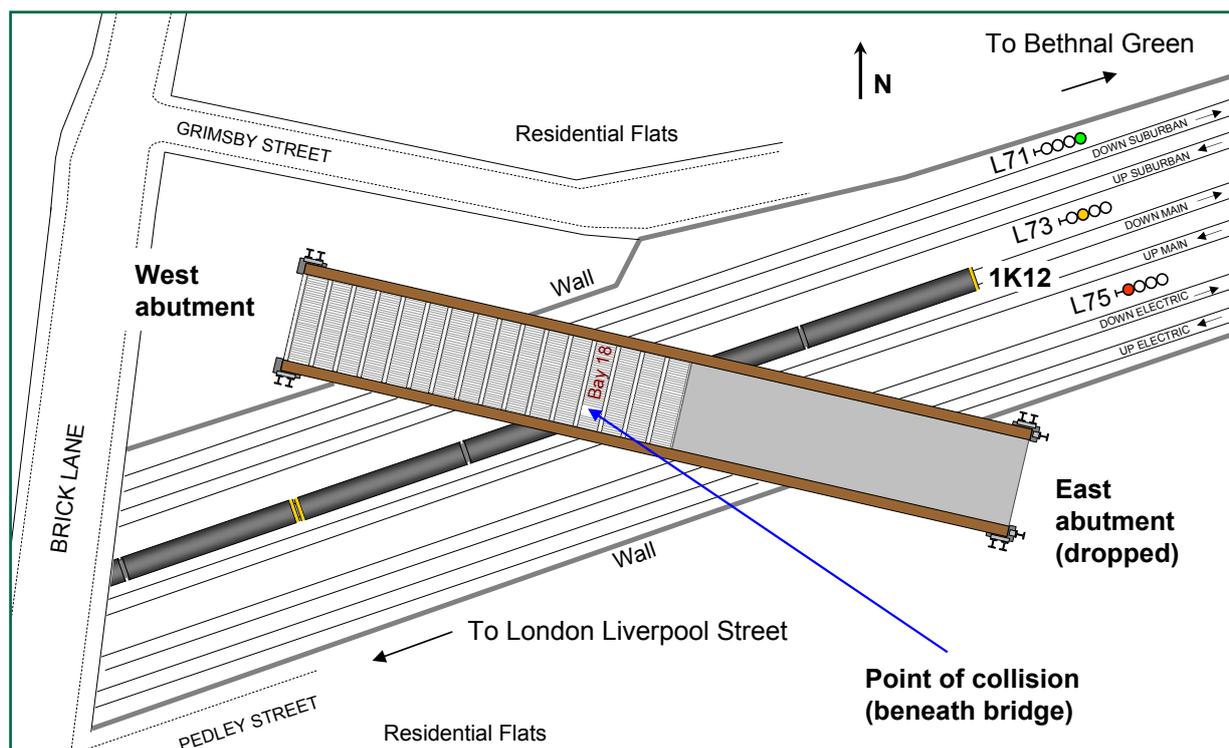
- 45 When the call resumed, the driver informed the signaller that residents of a block of flats close to the railway were leaning from their windows and shouting to him "bridge is broken". The driver informed the signaller that his train was partly under the bridge (Figure 7). At 19:21 hrs, with the scale of the incident becoming more apparent, the signaller took the decision to stop trains on all lines and informed the driver of 1K12 that no more would be run until he had inspected the track and bridge and reported back. During the radio call, two trains passed train 1K12 on the suburban lines. Neither sustained damage.

Figure 7: Situation at 19:18 hrs with train 1K12 stopped partly beneath bridge GE19

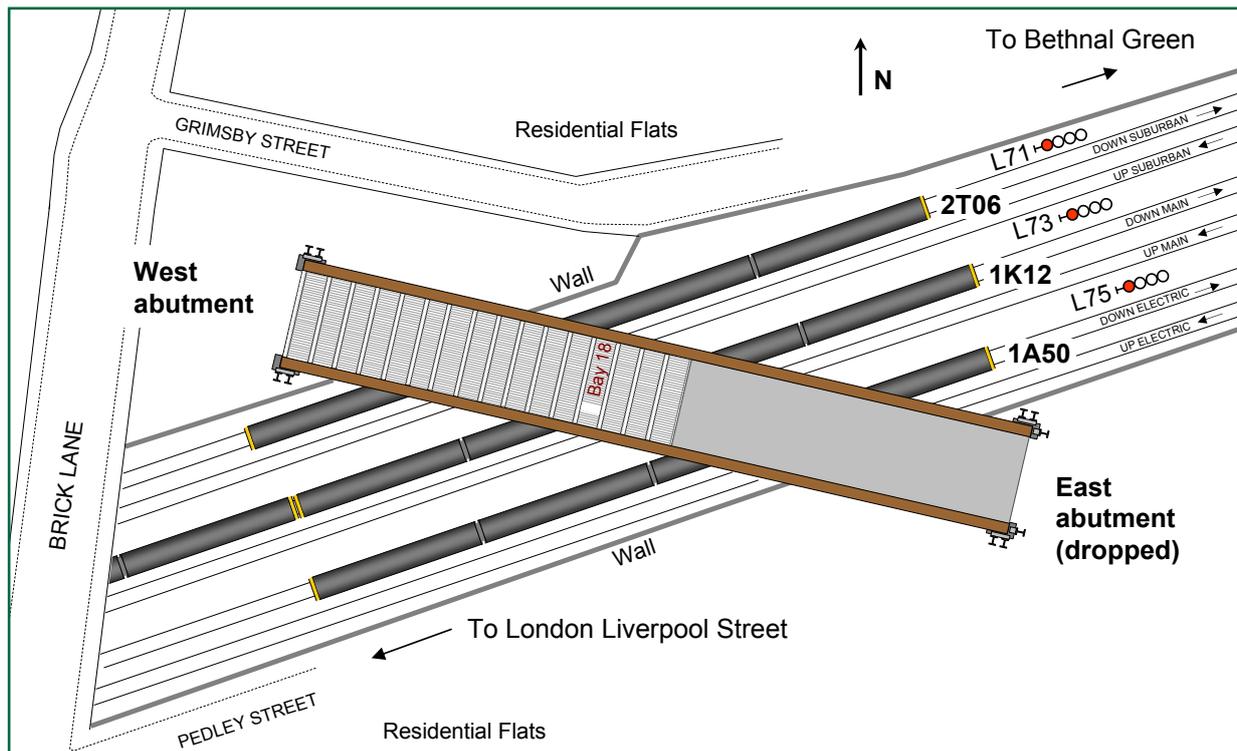
- 48 Two trains had departed Liverpool Street at 19:18 hrs: train 1A50 for Harwich via the down electric line; and train 2T06 for Chingford via the down suburban line. Both trains were travelling towards bridge GE19 when the signaller took action to stop all trains, and drew to a halt alongside train 1K12 at signals L75 and L71 respectively (Figure 8).

Figure 8: Situation at 19:22 hrs with three trains now stationary beneath the bridge

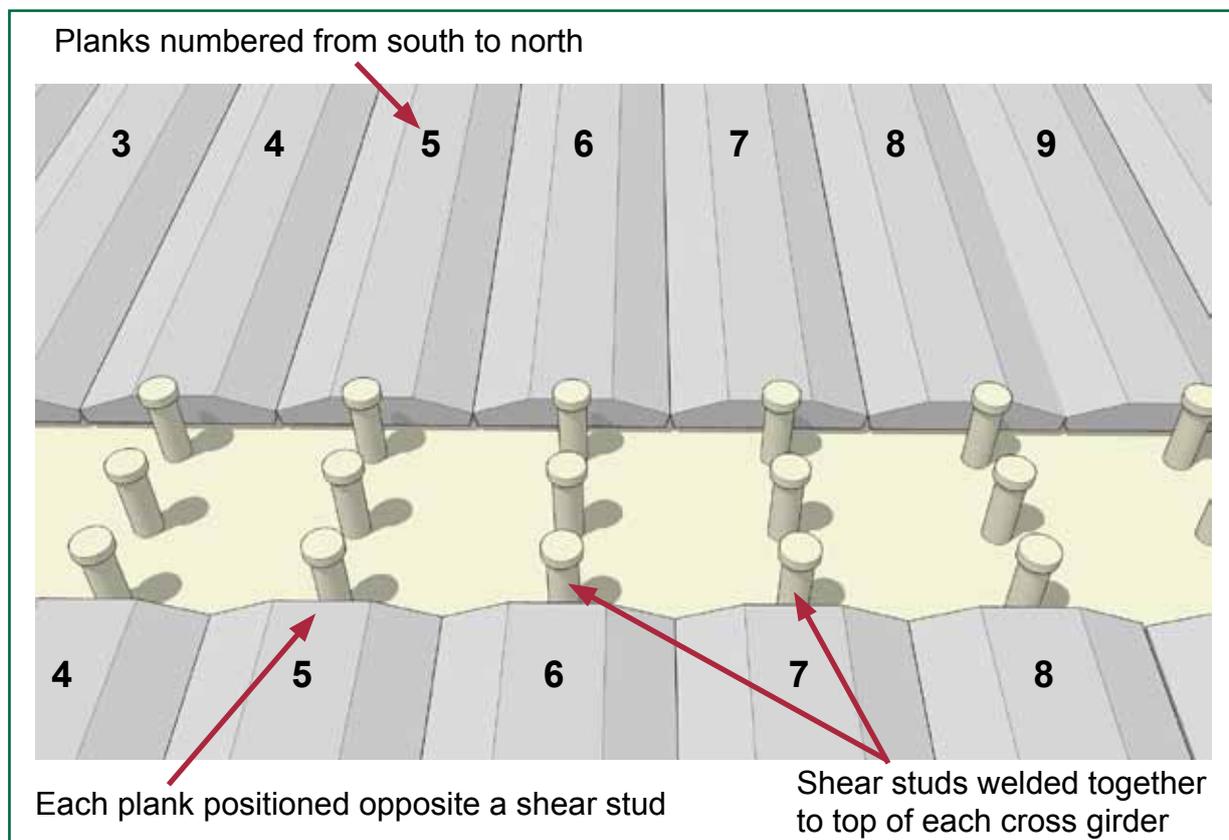
- 161 The width of the deck was not designed as a multiple of the width of a standard permanent formwork plank. This meant that a gap would result at each side of the deck if the permanent formwork planks were installed in accordance with the design, unless extra-wide planks were ordered from the manufacturer. The design aligned the permanent formwork planks with shear studs welded to the top flange of each cross girder (Figure 16), although this was not apparent unless several drawings were compared.

Figure 16: Schematic diagram showing a typical deck bay, and the as-designed relationship between shear studs and permanent formwork planks

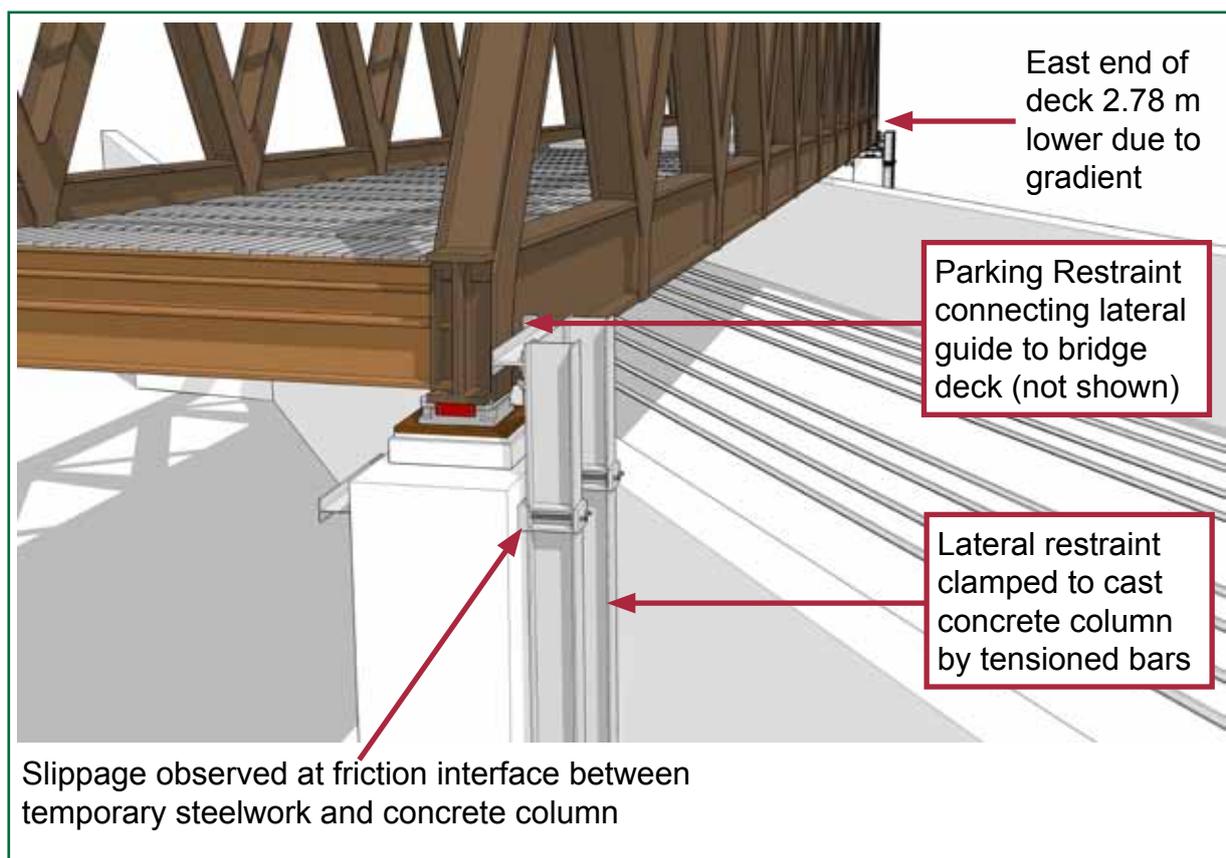
- 175 On 16 May, Fairfield Mabey's senior site manager examined the connections between the lateral restraint supporting the parking restraint and the concrete abutment columns and observed rust marking on the concrete (Figure 18). The deck remained supported on PTFE-faced slipper pads at this time, and the marks indicated to him that the parking restraint had slipped by 10-15 mm allowing the deck to move down the slope towards the east abutment. He was satisfied that further movement was unlikely after the tensioned bars came into contact with the side of the ducts (paragraph 128a). However, he was aware that the deck might need repositioning as a consequence, and mentally assessed this to be a low risk activity and within the experience of the site team. The matter was not reported to BB-CJV or Network Rail, and was not referred to the temporary-works designer.

Figure 18: Schematic diagram showing location of parking restraint at the west abutment, acting as a temporary fixed bearing.

- 207 Fairfield Mabey first became aware of deck movement on 16 May when the senior site manager observed slippage and rust staining at the connection between the lateral restraints, to which the parking restraints were attached, and the concrete columns at the west abutment (paragraph 175 and Figure 18). As the parking restraints on each side of the bridge were physically independent of each other, both needed to move to allow the deck to move.

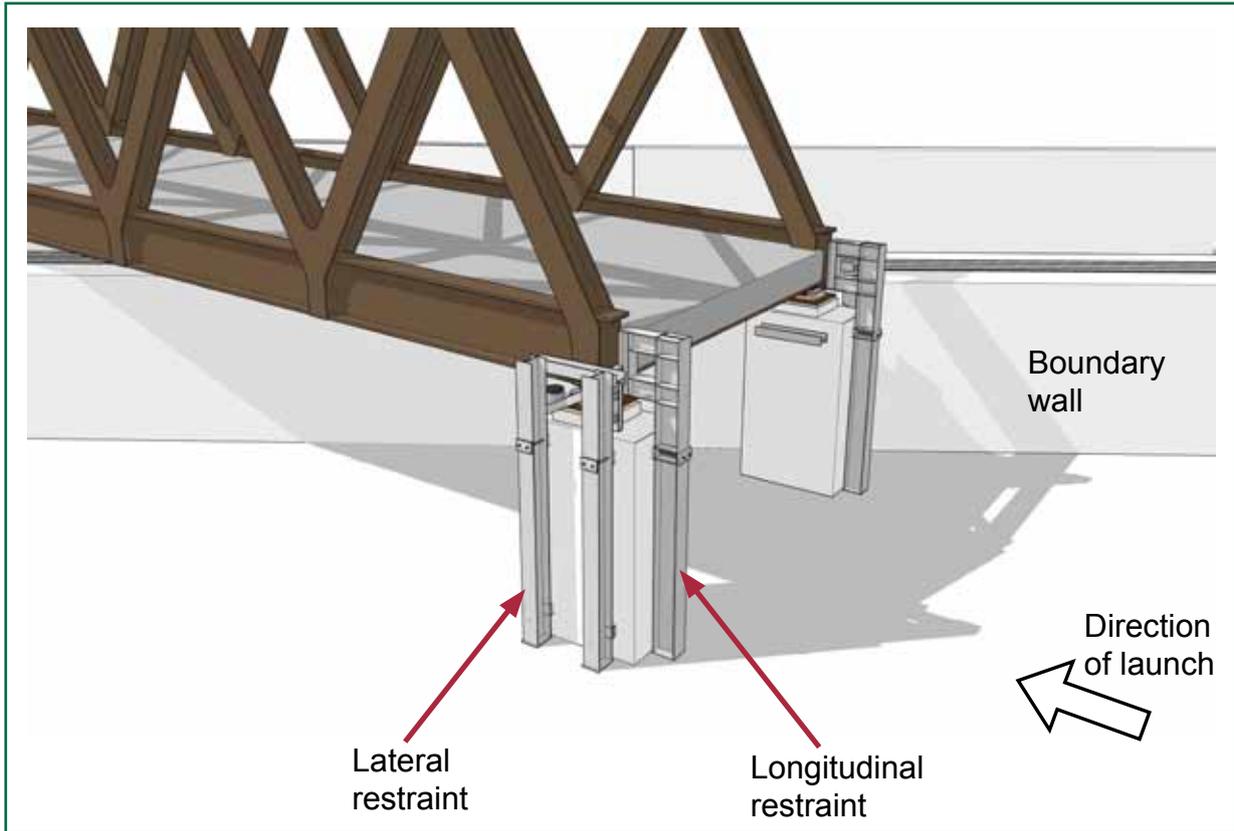
- c. Longitudinal jackdown restraint (longitudinal restraint): required to prevent the deck moving downhill during the jack down phase as the parking restraints were unsuitable for this purpose. This restraint was to be provided by steel columns attached to the rear of the east abutment, but they could not be erected until part of the *rocker box* had been removed due to the relatively narrow width of the concrete columns (Figure 19 and Appendix D).

Figure 19: Schematic diagram showing temporary works at the east abutment following erection of the longitudinal restraints.

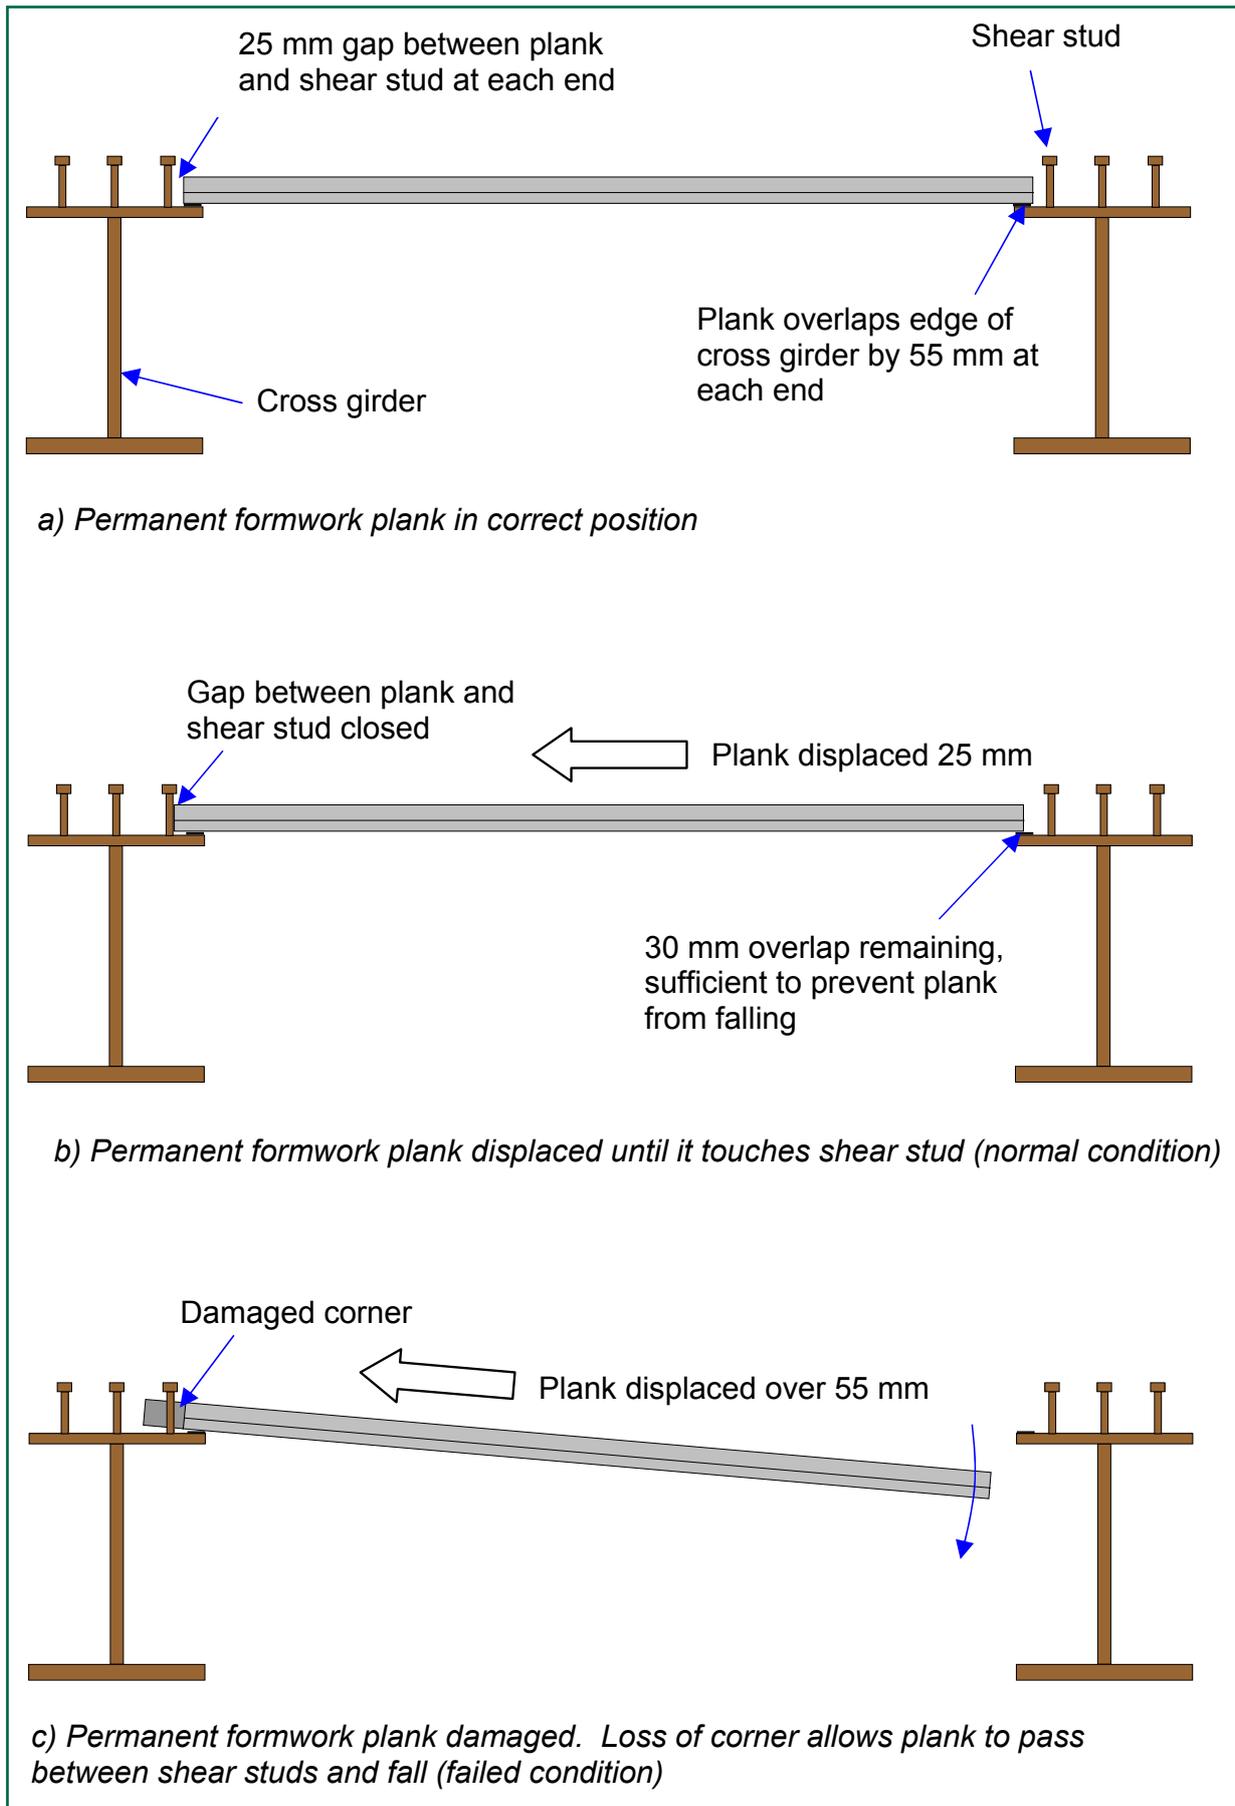
- 264 The modified layout required planks to be placed in groups, with a series of 40 mm gaps distributed across the deck. These gaps were to be spanned with uPVC strips, designed for this purpose. The original design aligned the centre of each plank with a shear stud, but the modification caused some planks to be off-set against the shear studs. While the purpose of the shear studs was to ensure that there was a good connection between the deck concrete and the cross-girders, they provided a useful secondary function by limiting the longitudinal movement of the permanent formwork planks (Figure 26).

Figure 26: Schematic diagram showing effect of shear stud in restraining movement of a permanent formwork plank.

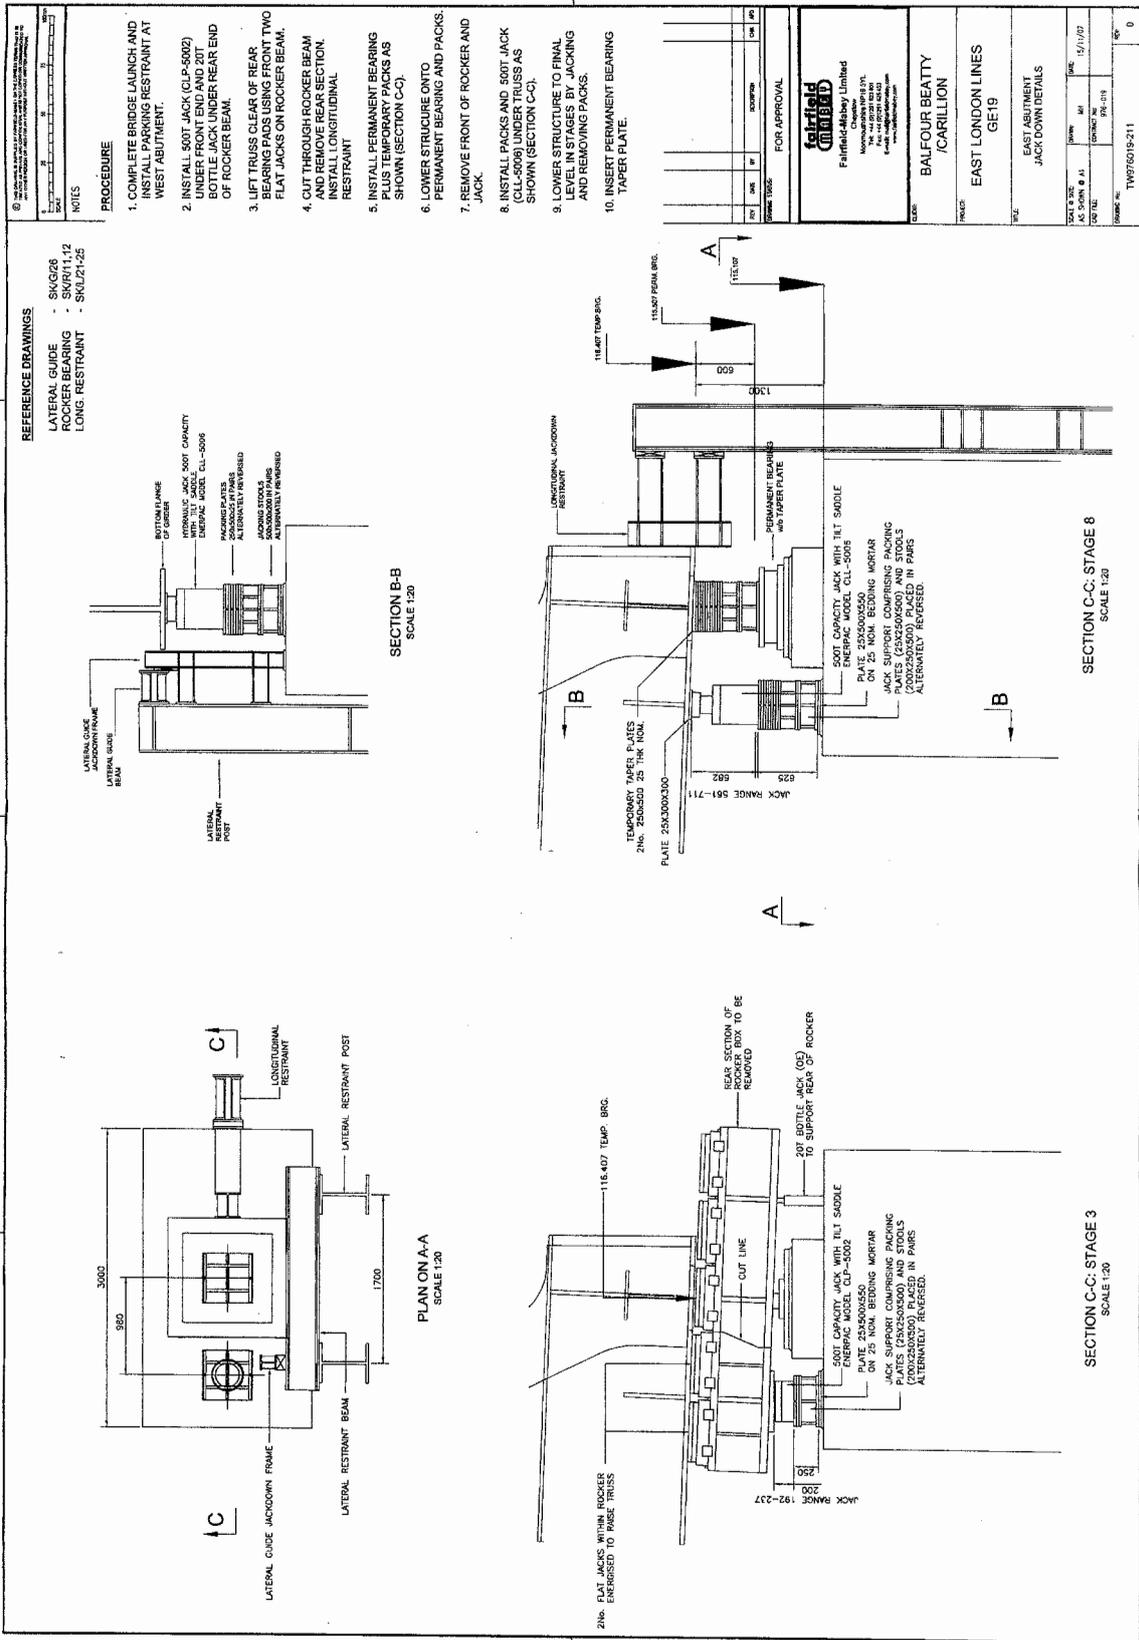
Appendix D - Temporary Works Drawings 211 and 212

1 Drawing 211 shows the temporary works at the east abutment including the longitudinal restraint (Section C-C: Stage 8)

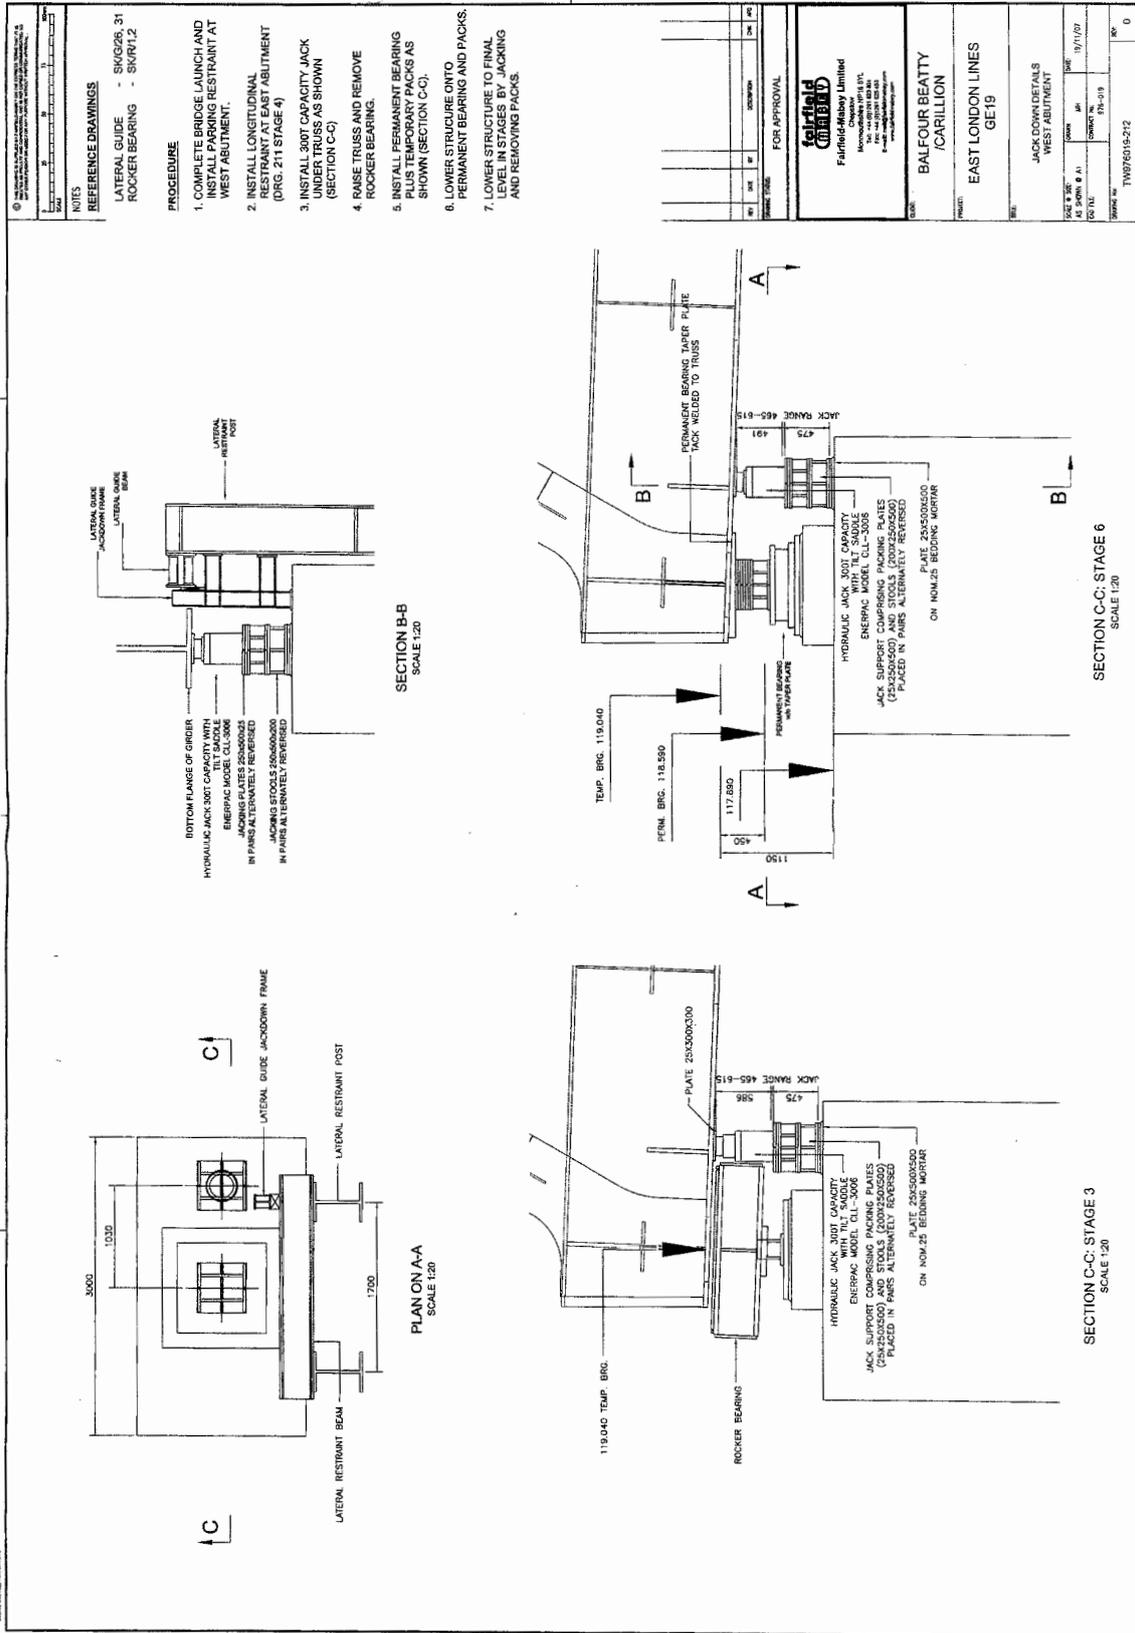
2 Drawing 212 shows the temporary works at the west abutment.
