# Rail Accident Report

## Freight train collision at Leigh-on-Sea 26 April 2008

# Freight train collision at Leigh-on-Sea, 26 April 2008

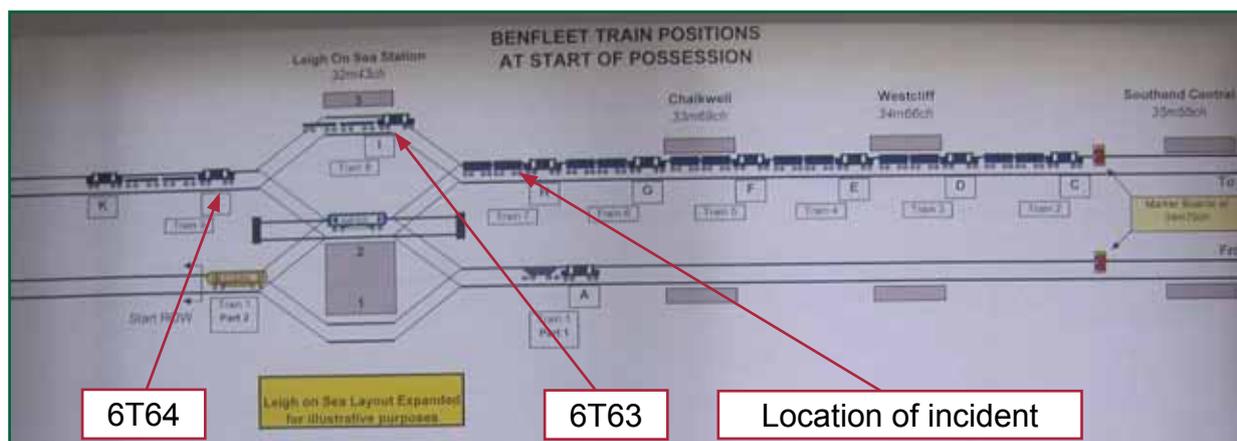
- 228 All staff arriving on site were instructed by Balfour Beatty to book on at the site offices at Leigh-on-Sea station. The train plan within the office was used as a visual aid to brief staff on the chronological order of train movements and the weekend possession. The diagram was endorsed 'not to scale' as it did not reflect the mileage, or the final positions of the trains in relation to the stations. The position of train 6T63 was shown as Leigh-on-Sea station when its actual physical location was beyond the curve on the approach to Chalkwell station. No guidance was given to staff on the location of the train and the visual briefing may have led some staff to wrongly assume the location of train 6T63 shown on the diagram was correct when it had actually been stabled further east towards Chalkwell station. However, in view of the train driver's fatigued state, and consequent inability to fully react to the instructions given to him, the train plan used for the briefing was neither causal nor contributory to the incident (Figure 11).

Figure 11: Photograph of the possession plan used for site briefings at the booking on point at Leigh-on-Sea

- 238 The train plan within the office was used as a visual aid to brief staff on the chronological order of train movements and the weekend possession. The diagram was not to scale and did not reflect the final positions of the trains in relation to distances in miles and chains, or to the stations. The visual briefing may have led some staff to wrongly assume the location of 6T63 was shown as correct, when it had actually been moved to a different location (paragraph 228 and Figure 11).
