Rail Accident Investigation Branch

Rail Accident Report

Runaway of a road-rail vehicle at Glen Garry 5 December 2007

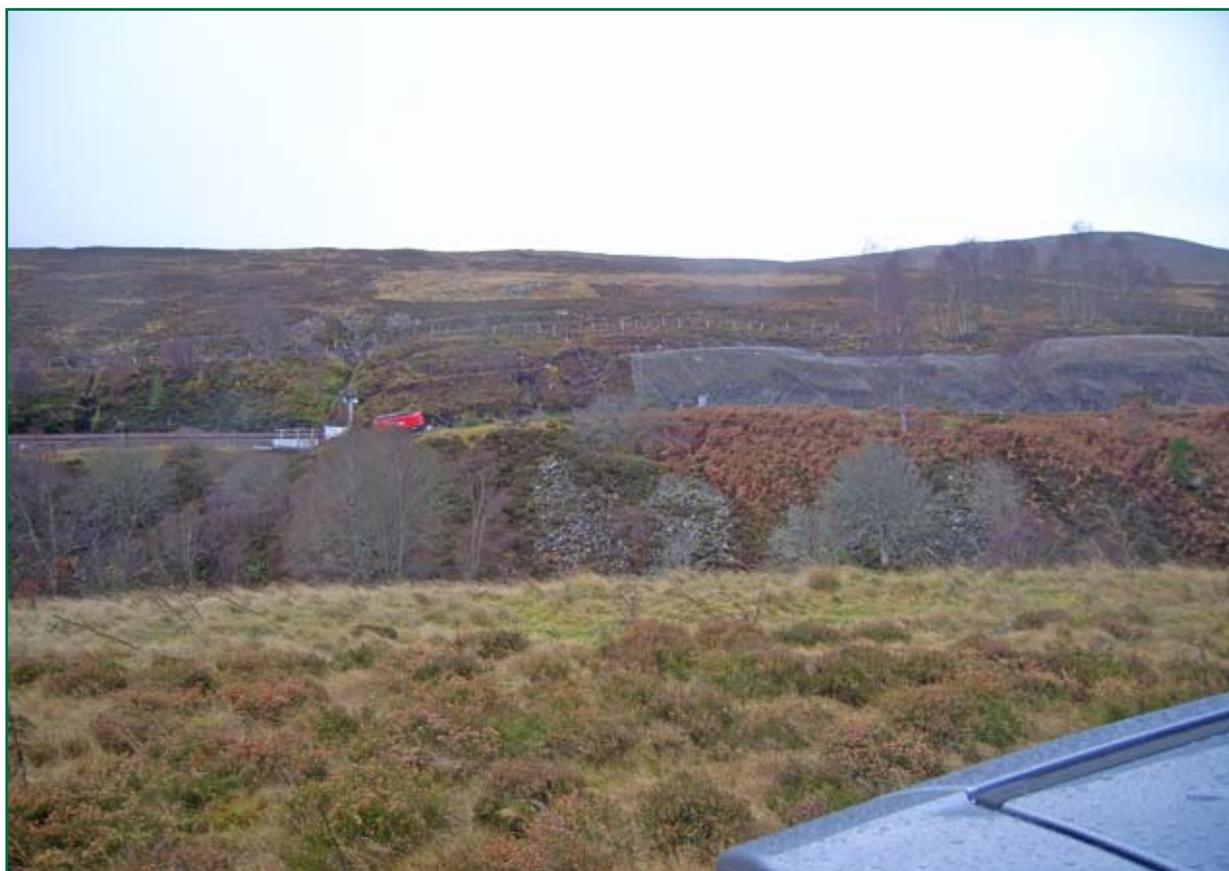
Figure 4: Incident site viewed from the opposite side of the glen

- 30 The site of the incident was in Glen Garry, 46 miles 1080 yards (74.58 km) from Perth, between Blair Atholl and Dalwhinnie stations.
- 31 The line at the incident site is on the west side of the river valley. There is no road access to this side of the valley and the nearest road-rail access point is at Red Van road rail access point, which is 2.4 miles (3.8 km) further up the valley to the north.
- 32 The site compound and messing facilities for the repair works were situated on the east side of the river and pedestrian access to the track was provided by a footbridge over the river. All plant and materials for the repair works were brought to site by rail using RRVs.

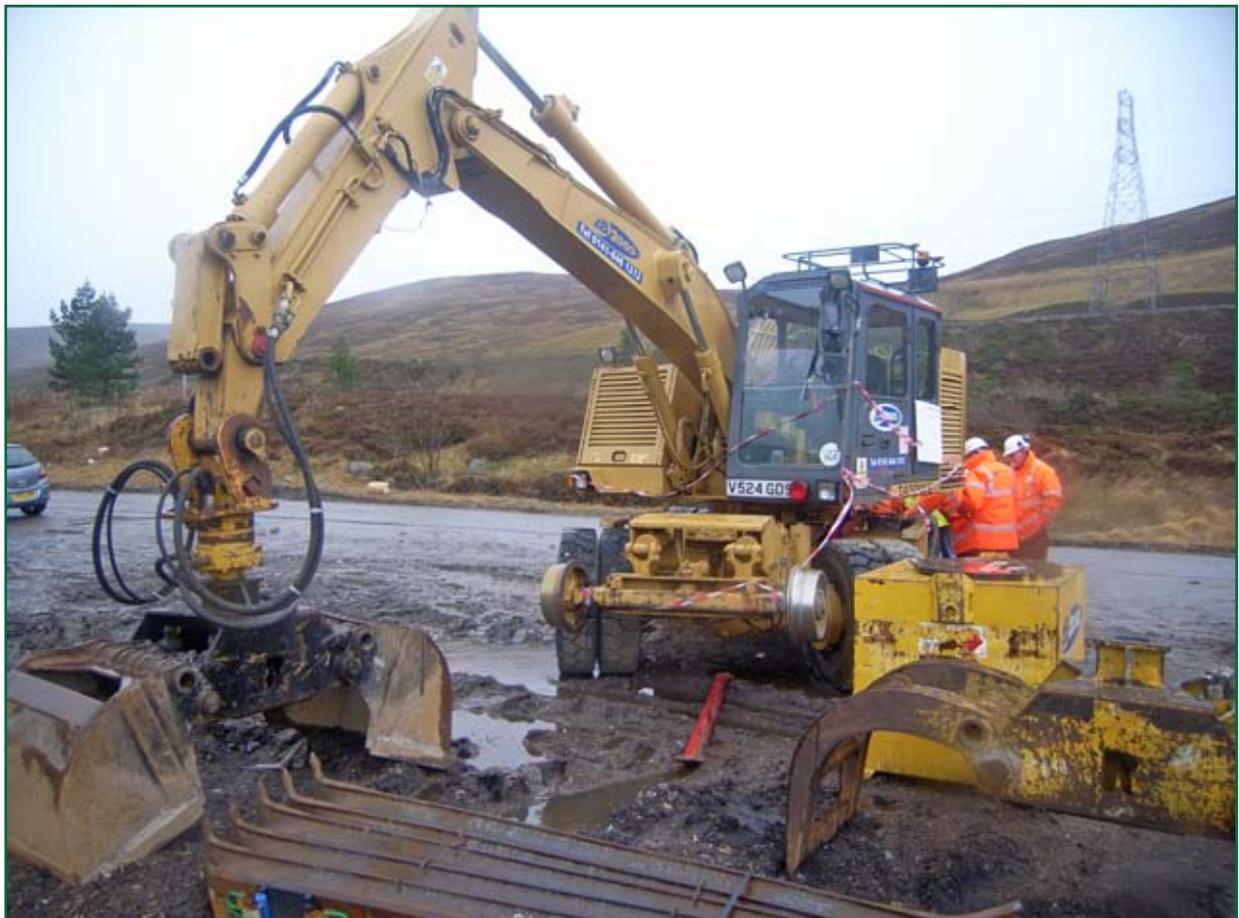
Figure 5: Colmar T4300FS RRV

- 34 The RRV that ran away was a 'high ride' 360 degree wheeled excavator manufactured by Colmar Ltd (type T4300FS). The RRV was fitted with a *clam shell grab* and was towing a *Philmor trailer* fitted with a load carrying box. The load carrying capacity of the trailer was eight tonnes and its tare weight was two tonnes, giving a maximum total weight of ten tonnes. The load carrying box was loaded with stone gabion filling material, two filled gabions, some gabion mesh and various items of small equipment and materials. The total weight of the trailer and its load was estimated to be between nine and ten tonnes. The actual weight of the trailer's load was not recorded. Figure 5 shows the RRV parked at Red Van road rail access point.

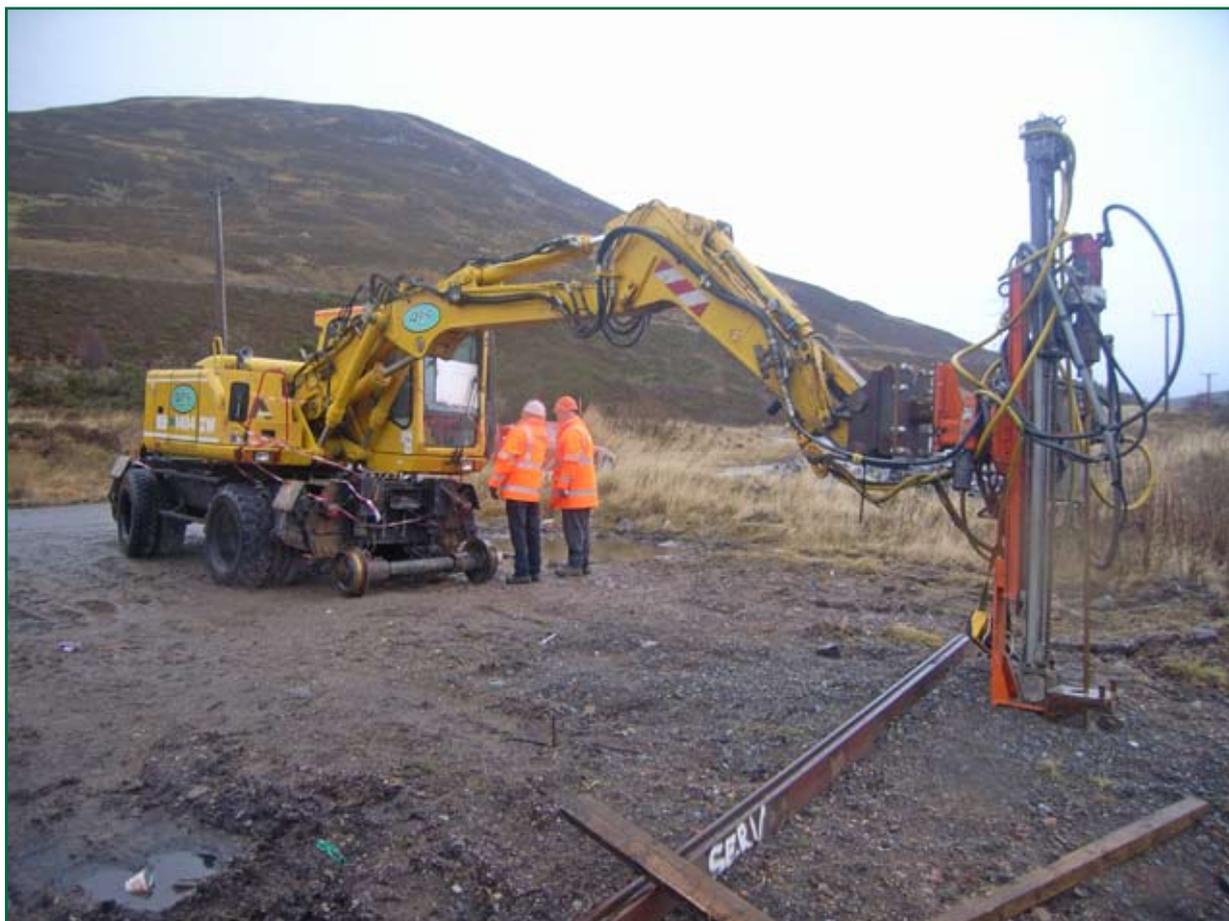
Figure 6: Atlas 1404 RRV

- 35 The stationary RRV was a 'low ride' 360 degree wheeled excavator manufactured by Atlas (type 1404). The machine was fitted with a drilling mast and rock drill. Figure 6 shows the RRV parked at Red Van road rail access point.

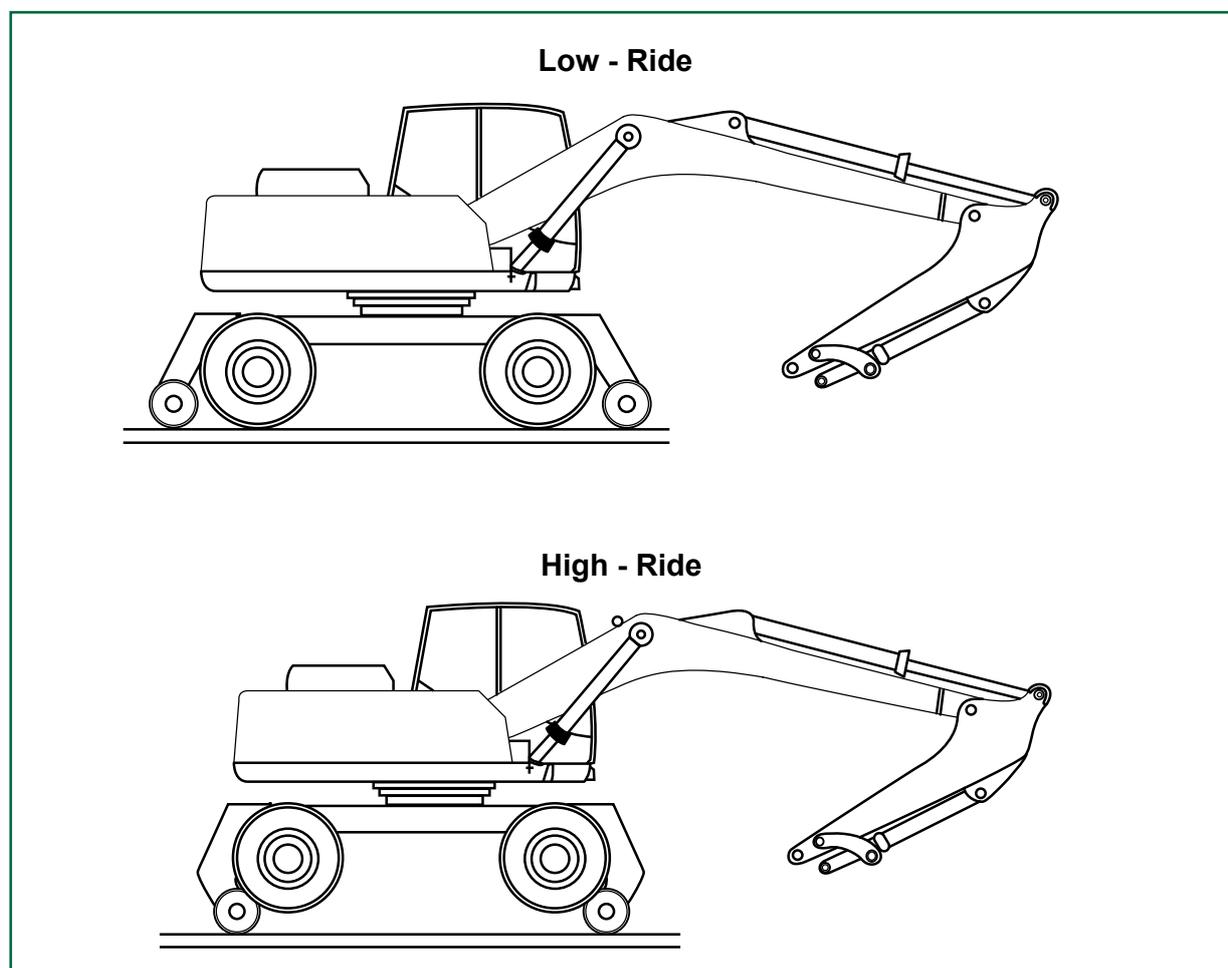
Figure 8: High ride and low ride RRV's

- 71 After railway privatisation, the use of RRVs expanded substantially as contractors new to the rail industry started to use them for infrastructure work. These machines were mostly converted from existing road-based machines by adding rail wheel running gear. Some of these new machines were of the low ride design but most were of the high ride type. The high ride design involves the use of idler rail wheels which are driven by friction from the road tyres. The road wheels are lifted completely clear of the rails and all traction and braking effort is transmitted by friction from the rubber tyre to the steel rail wheel, then by friction between the steel rail wheel and the rail. The Colmar RRV involved in the Glen Garry incident was a high ride machine. Figure 8 shows the principle of operation of high ride and low ride RRVs.
