Rail Accident Investigation Branch

Rail Accident Report

Runaway and collision at Armathwaite 28 January 2007

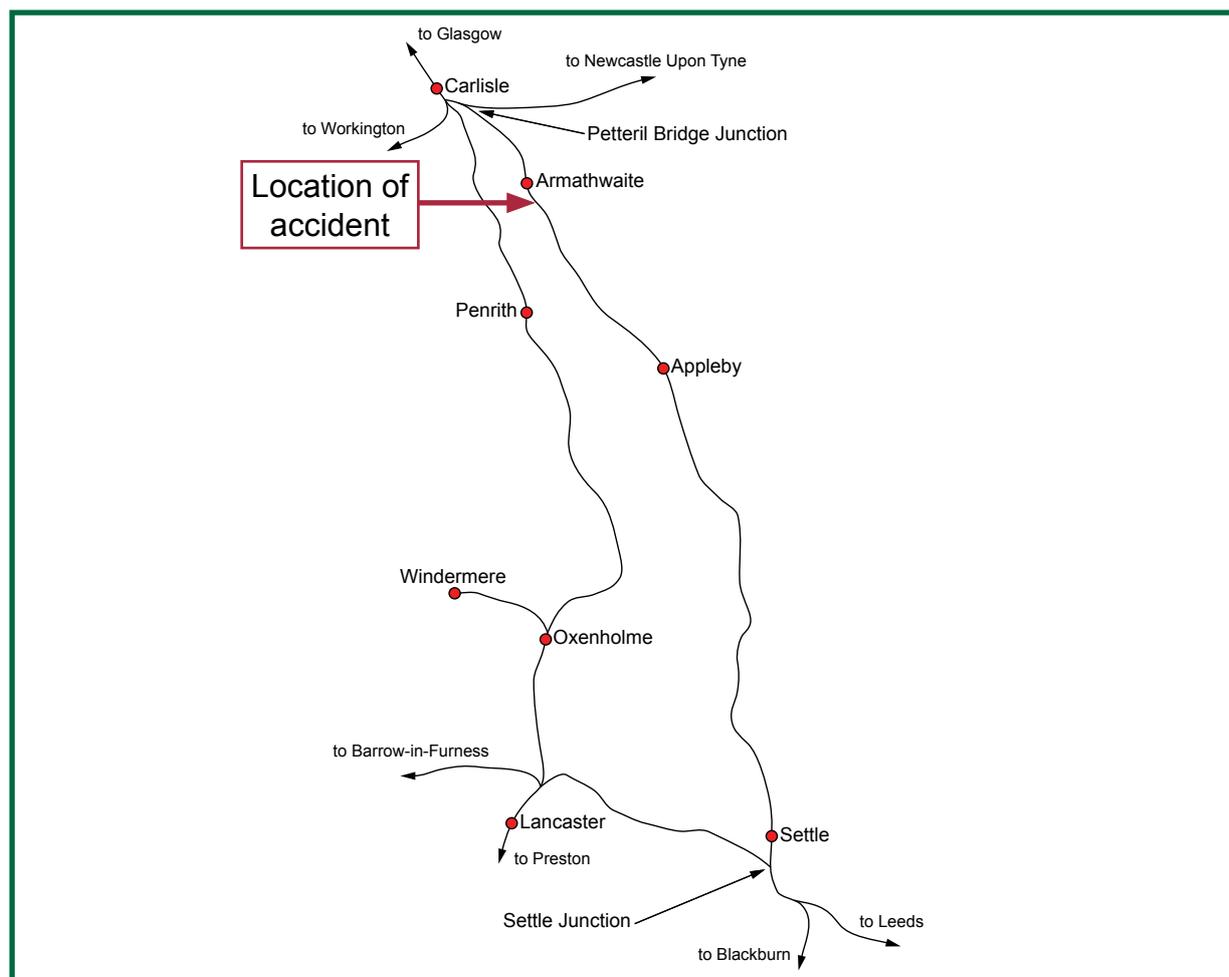
Figure 2: Diagram of the location

- 15 The accident occurred in an *engineer's work site* set up to renew 900 yds (823 metres) of the *up line* just south of Armathwaite station. The work site was in a *possession* of the line from Settle Junction to Petheril Bridge Junction, Carlisle (Figure 2). There were several other work sites within the possession which are not relevant to this accident.

- 21 The collision occurred on the down line at the south end of Armathwaite viaduct at 297 miles 23 *chains*. This was just south of Armathwaite station (298 miles 9 chains) on the line which runs from Settle Junction at 234 miles 44 chains, to Petheril Bridge Junction, Carlisle, at 307 miles 12 chains. Figure 2 shows the location and Figure 3 is a view north from overbridge 319 towards Armathwaite viaduct.
- 22 Going south, the gradient of the line through Armathwaite station is a maximum of 1 in 217 falling, followed by a short section of level track at Armathwaite viaduct, followed by a rising gradient at a maximum of 1 in 155.

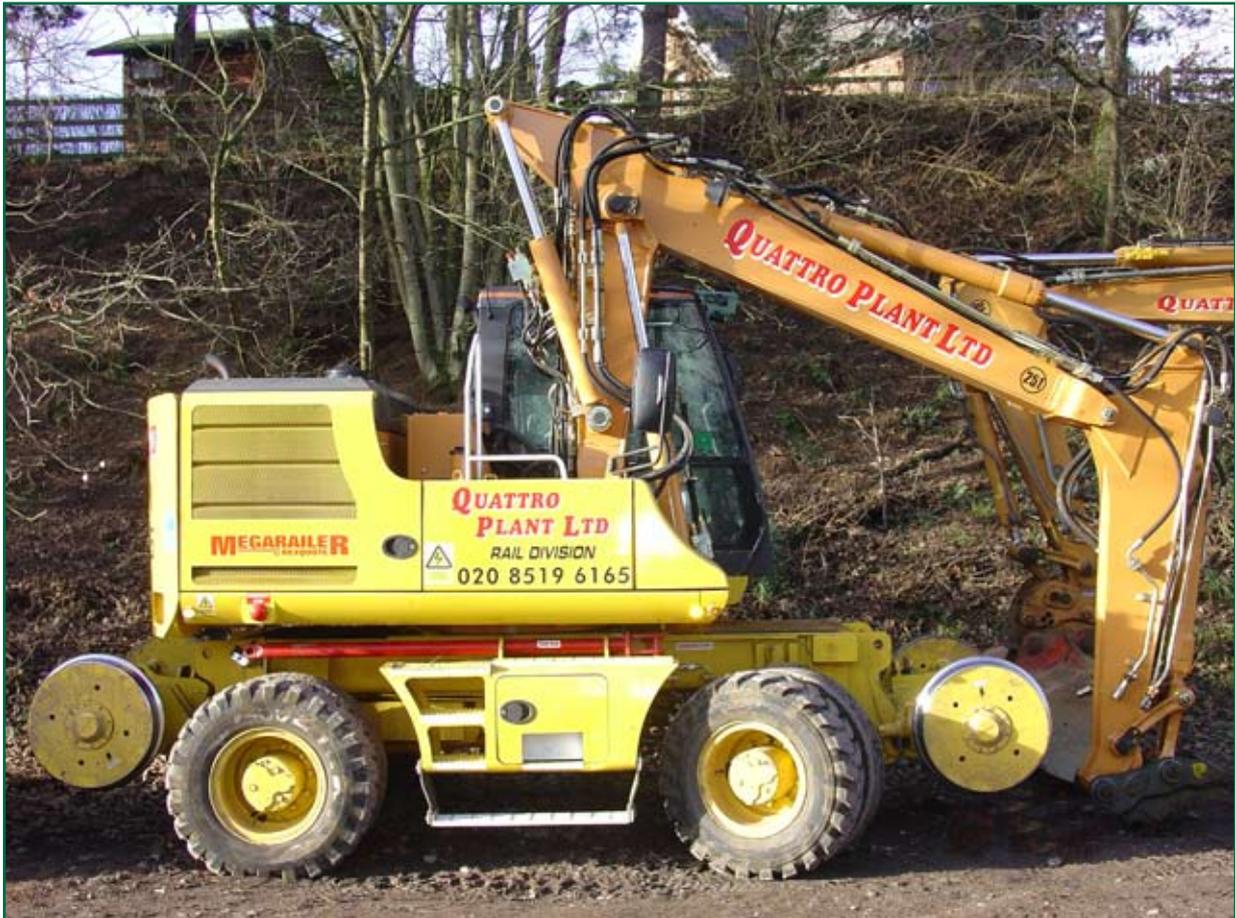
Figure 6: Case 170 RRV number 251

- 31 The RRV involved in the collision was a Case Poclairn WX170 excavator/crane, converted for operation on rail by Rexquote Ltd. It was numbered 251 in the fleet numbering system operated by Quattro Plant Ltd. Figure 6 shows the RRV.

- 49 From both witness evidence and subsequent calculations carried out by the RAIB, the speed at impact is likely to have been around 27 km/h (17 mph).
- 50 The impact caused the leading bogie of the salmon wagon to derail and pushed the RRV back along the railway by about 3 metres (3.28 yds).
- 51 The RRV was only superficially damaged, but the thimble being used to position the new rail was broken. Minor damage was caused to the salmon wagon including a snapped off brake pipe *air cock* and lamp bracket, and bogie springs in the leading derailed bogie that had come out of position. Figure 10 shows the consequences of the collision.
- 52 The RRV operator who had remained in his cab, although not injured, was shaken up as a result of the collision.
