Rail Accident Investigation Branch

# Rail Accident Report

**Passenger door open on a moving train  
near Desborough  
10 June 2006**

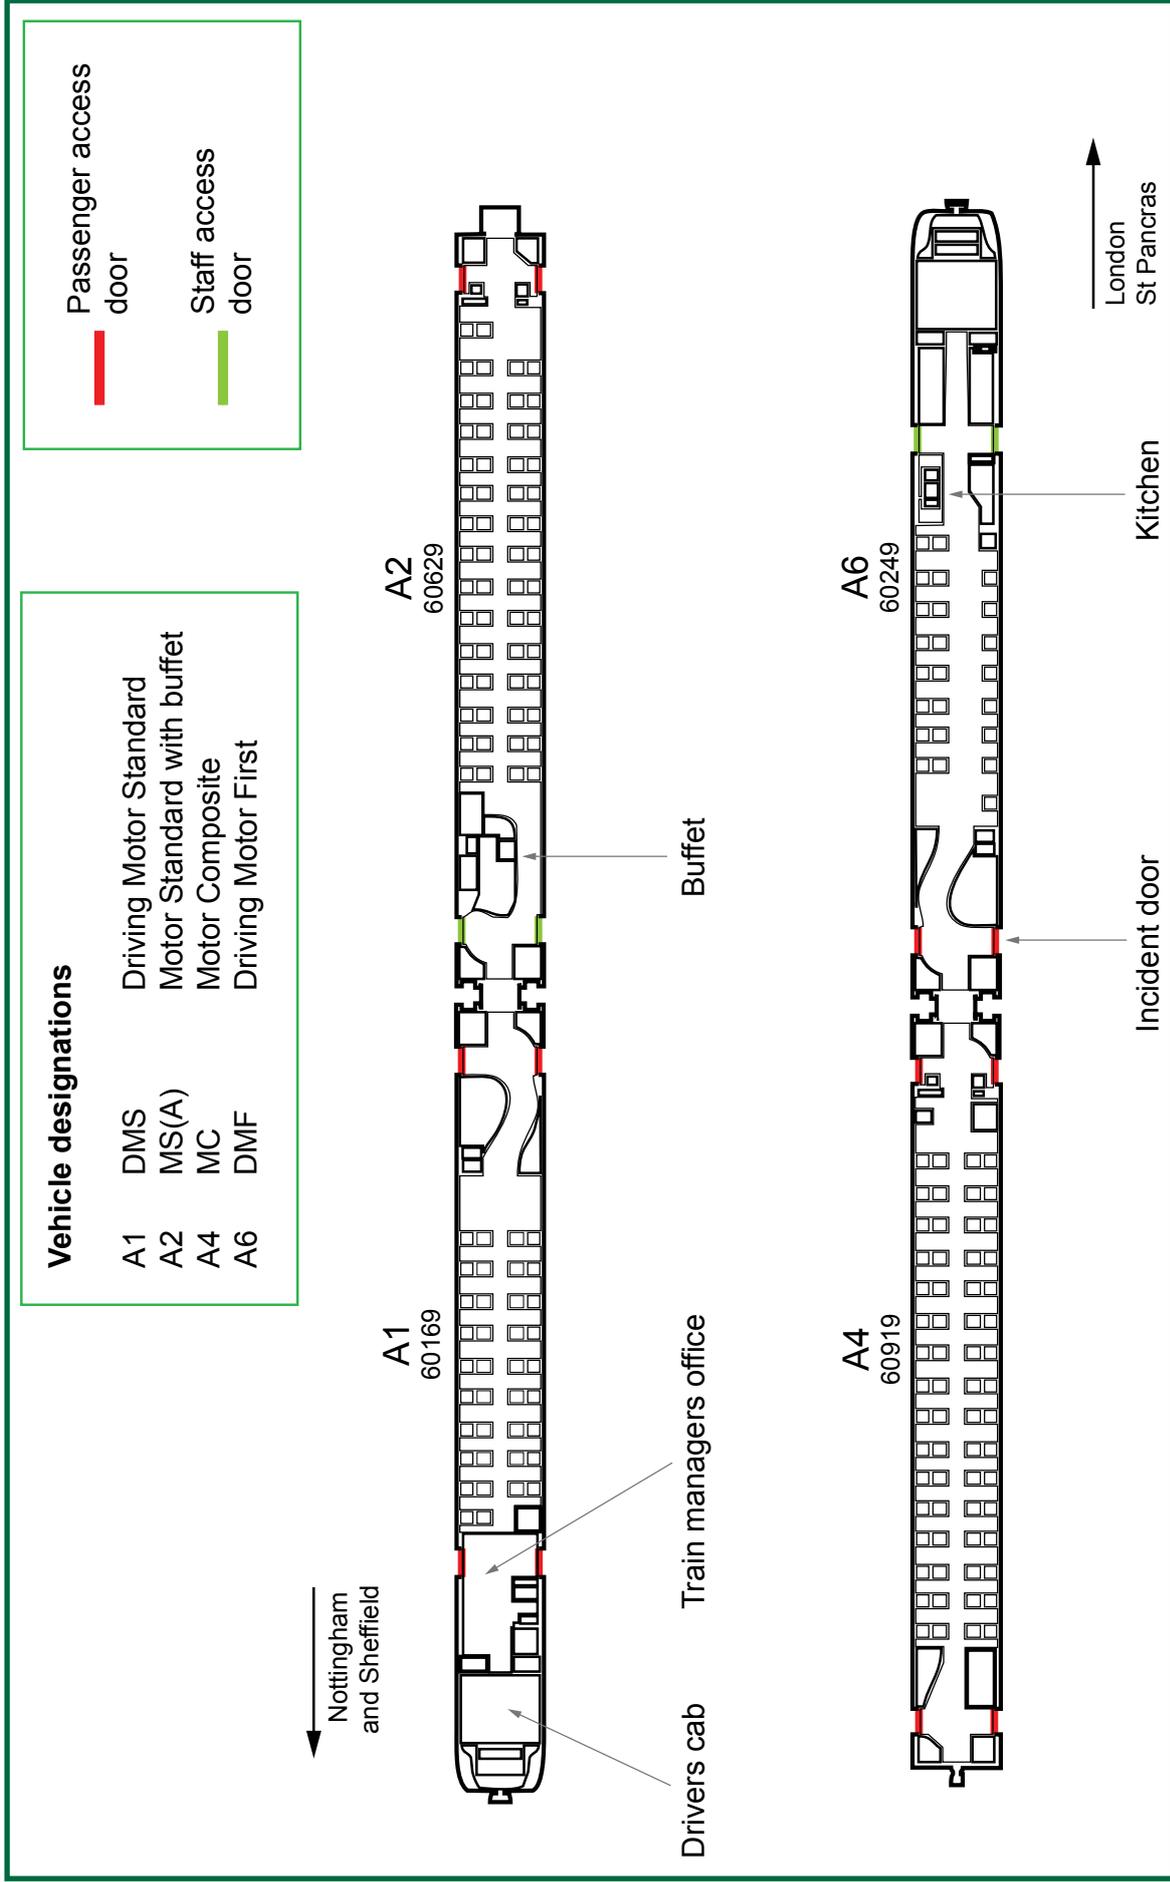
Figure 3: Train formation unit 222 009

- 31 The trains can be marshalled into a variety of car formations. Unit 222 009 is formed of four cars. Figure 3 shows the train formation, vehicle designations, numbers, and pertinent features.

- 32 The trains are fitted with electrically operated exterior doors, two on each vehicle side. On *intermediate vehicles*, they are located in the two *intermediate end vestibules*. On driving vehicles, they are located in the intermediate end vestibule and also toward the cab-end of the passenger area: in the kitchen area on the first class vehicle and next to the train manager's office on the standard class. The doors are a single leaf *slide-and-plug* design. Most of the doors are designated for passenger access use. However, some are for staff use only – these have different controls. The location of each door and type is shown in Figure 3. The door which opened (the incident door) was on the west side of the train; this is also identified on Figure 3.

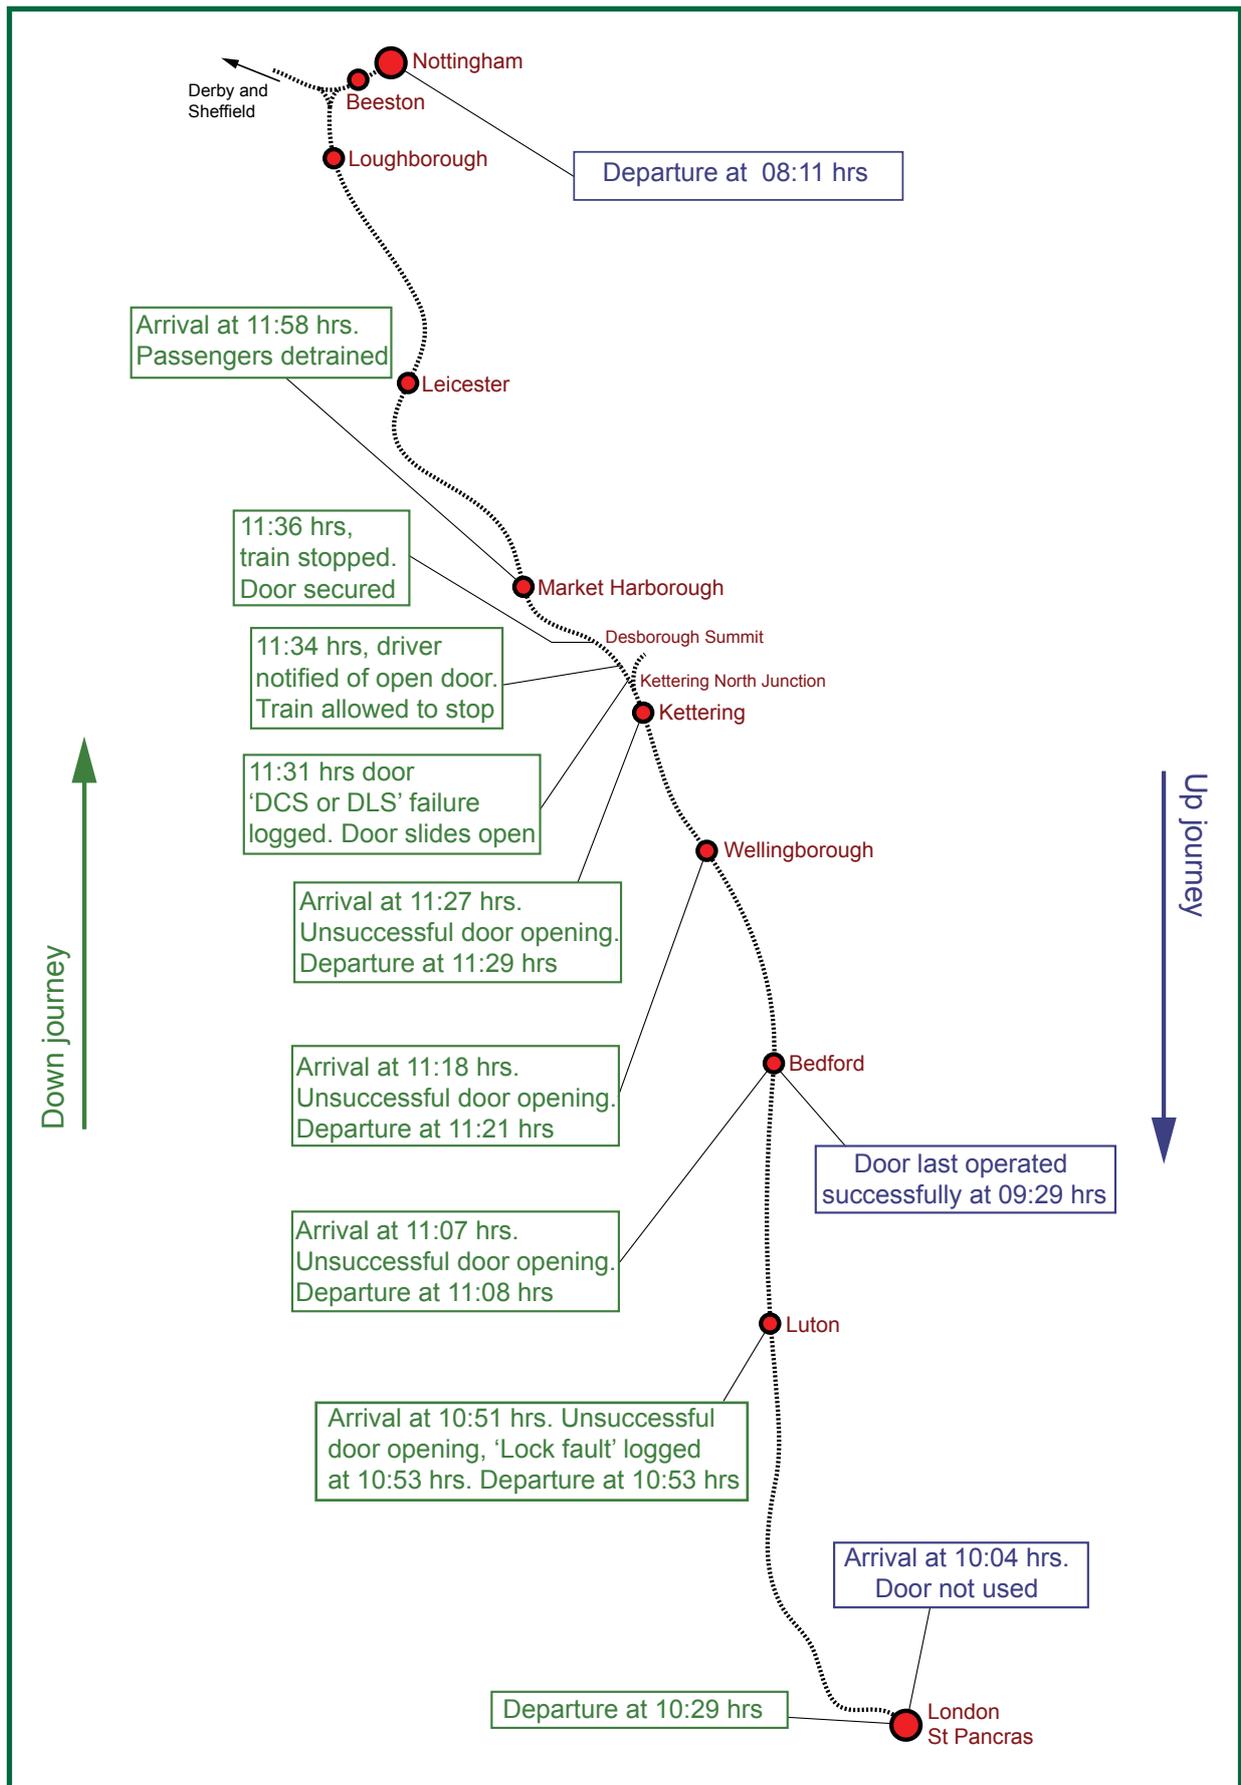
Figure 4: Overview of key events

- 73 Figure 4 shows a diagrammatic overview of the key events associated with the incident and its consequences.
- 74 The full sequence of events identified by the investigation is included in Appendix E.

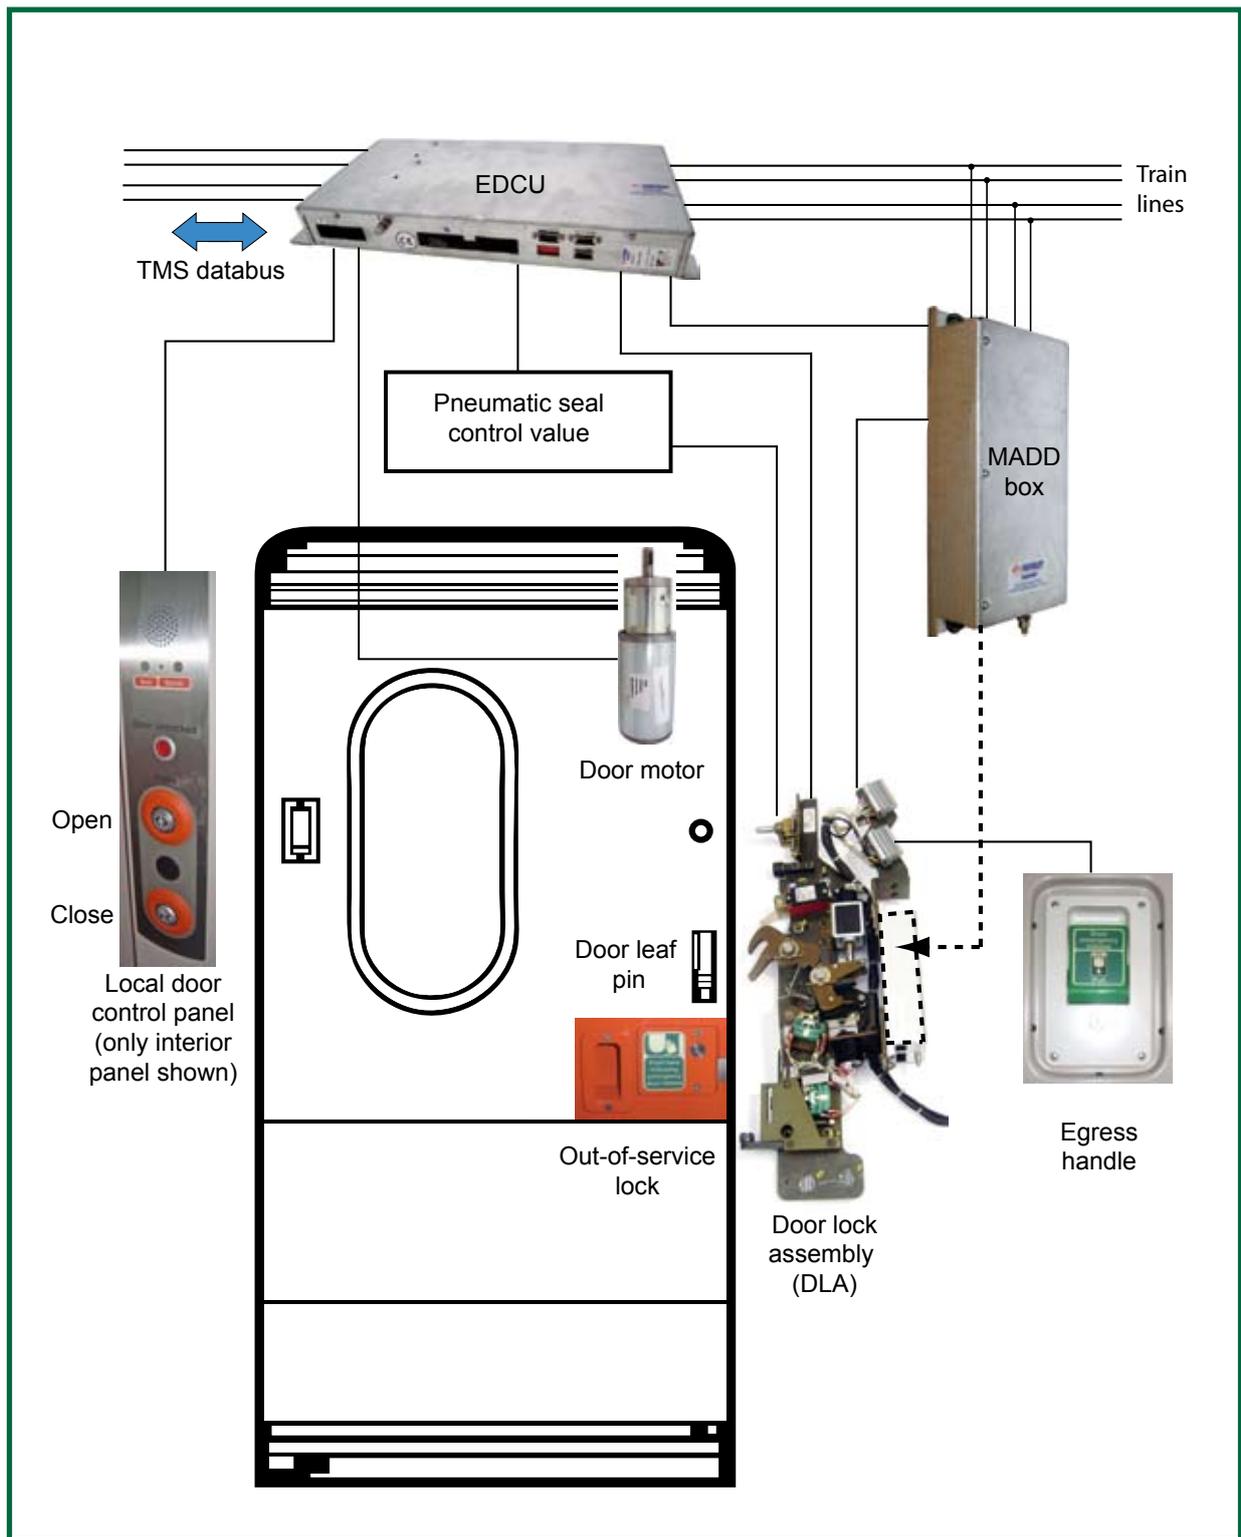
Figure 5: Overview of the door system and its associated connections

- Door leaf and associated parts. This is fitted to the door *portal*; the associated parts include the door motor, a *guidance and stabilisation system*, and a pneumatic door seal. A pin, fitted at mid-height on the door leaf (the *door leaf pin*, see Figure 5), is used as part of the locking arrangement;

- The DLA; see Figures 5 and 6. This is fitted to one of the *vertical door stanchions*; it includes the locking mechanism which engages with the door leaf pin to lock the door (paragraphs 81 and 82). Also mounted are the detection switches used to indicate that the door is closed (*door closed switch* (DCS)) and locked (door lock switch (DLS));

- The EDCU; see Figure 5. Fitted above the door, this contains the processor circuits that control and monitor door operation. Supplementary relay circuits are included for safety critical functions;

- Relay control box (known as the *MADD box*, see Figure 5). Fitted on the DLA, this contains additional door control relay circuits; and
- Local door control panels. Fitted adjacent to the door, these include the passenger ‘open’ and ‘close’ pushbuttons (see Figure 5) and other related equipment (eg microphone, loudspeaker and indication lamps).

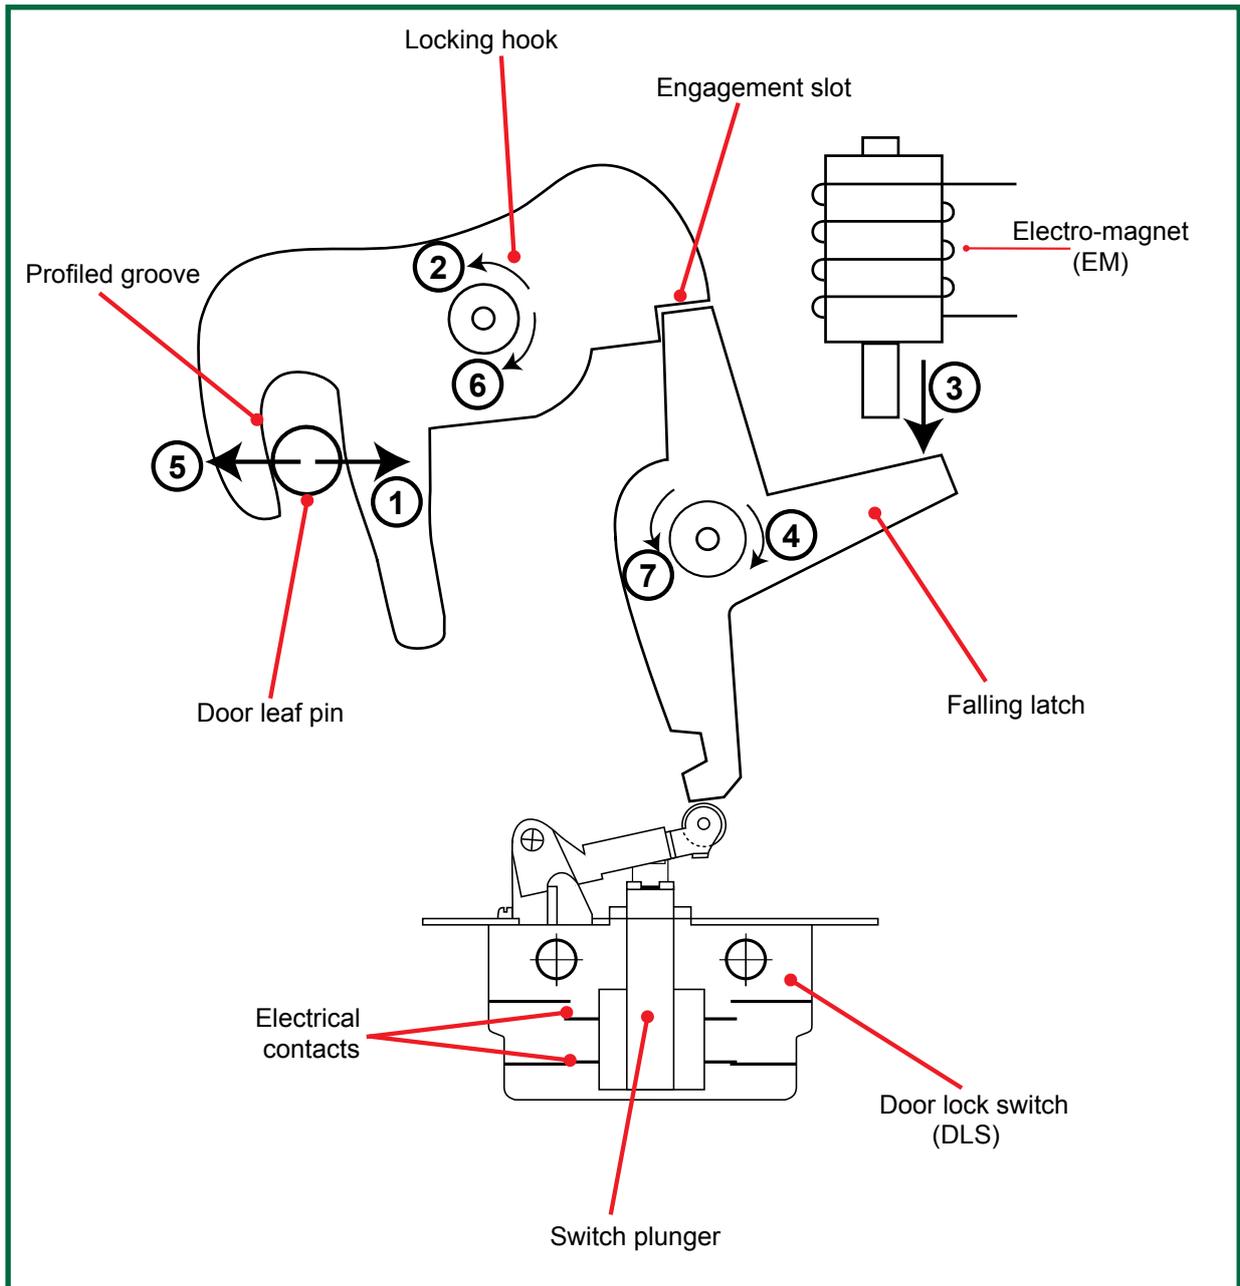
Figure 8: Door locking mechanism (shown in locked state) - annotation on diagram refers to description given in paragraphs 85 - 89

82 The door is in the locked state when the door leaf pin is held in place by the locking hook; see Figure 8. The locking hook can rotate, but when locked, it is held in place by the falling latch locating in the *engagement slot* (engagement). Locking detection is provided by the DLS. When deactivated (natural condition), an unlocked door state is indicated; the *switch plunger* (which opens and closes the electrical contacts) is raised. When the falling latch engages in the locking hook, the switch plunger is depressed and the opposing contacts made. The DLS is activated and a locked state is indicated. The door is unlocked by the *electro-magnet* (EM); when activated, it presses on the falling latch, rotating it out of the engagement slot.

- 85 When the passenger presses the ‘open’ push button, the EDCU initiates a further sequence of control commands. Referring to Figure 8, first a current is applied to the door motor to close the door; this pulls the door leaf pin to the right (1) – toward the portal – rotating the locking hook (2) and relieving any force on the top of the falling latch and the engagement slot. Unlocking is then initiated. The electro-magnet is energised (3), forcing the falling latch to rotate clockwise (4) and disengage from the locking hook; the locking hook is now only held in place by the door leaf pin.

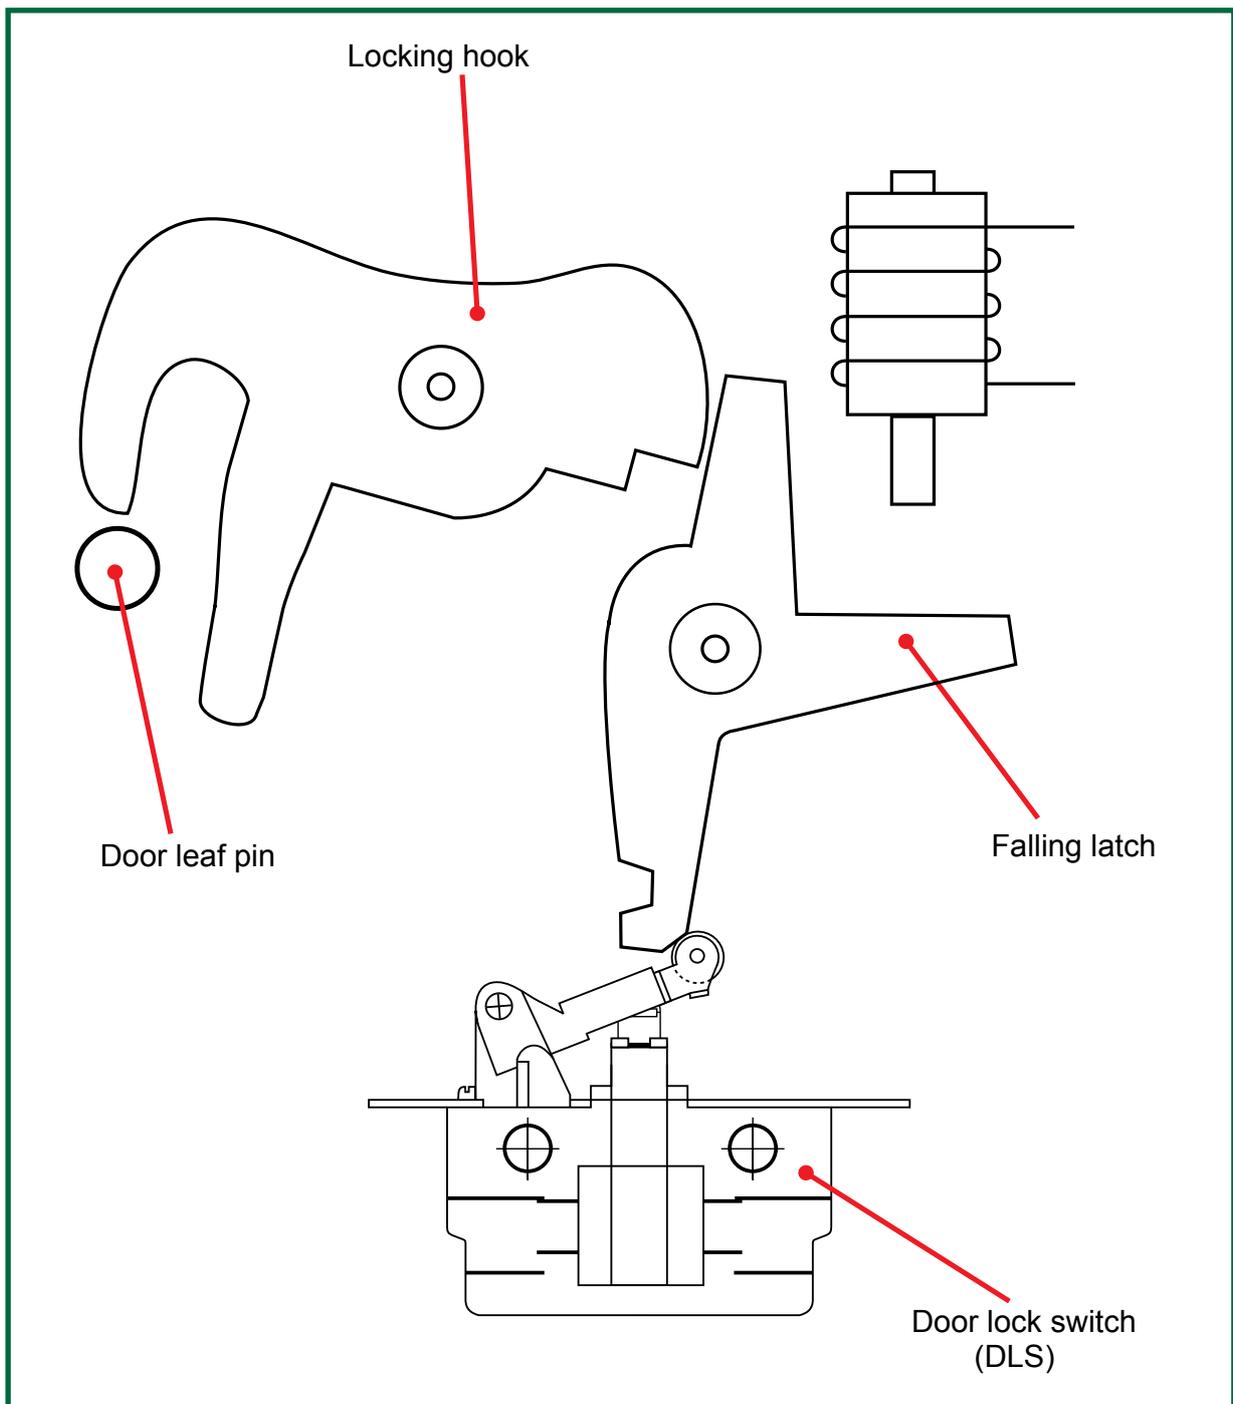
Figure 9: Door locking mechanism in unlocked state

- 87 As the door opens, the DCS (which acts on the door leaf) deactivates. The electro-magnet is de-energised after a fixed time period (configurable in the range 2-5 seconds) and the falling latch is released. This is also spring biased and it rotates anti-clockwise (7) to rest against the locking hook (it cannot enter the engagement slot because of the now clockwise orientated position of the hook). Figure 9 shows the door locking mechanism in this unlocked state with the door leaf pin free of the locking hook.

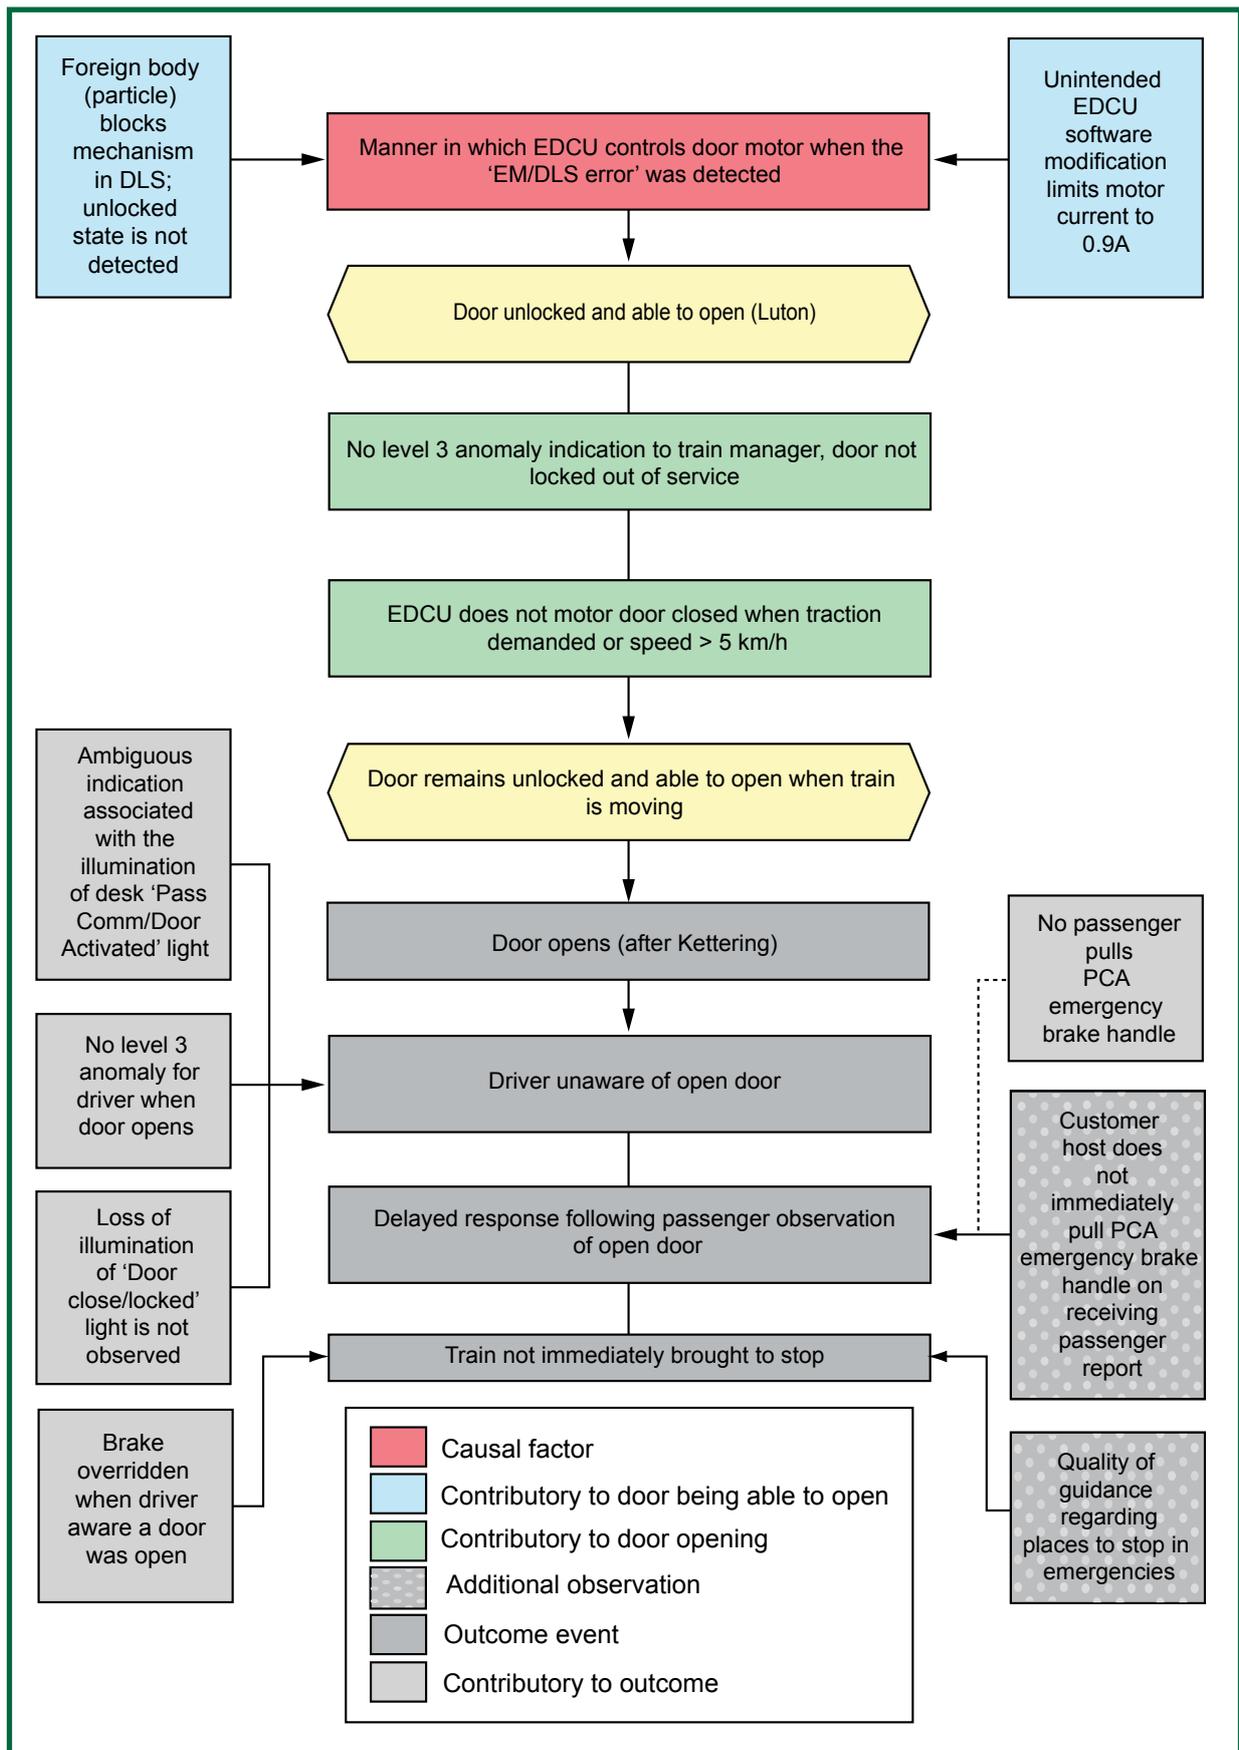
Figure 14: Overview of the identified causal factors

219 Figure 14 is an overview of the most likely identified causal and contributory factors, showing their relationship to the incident and its outcome. It does not show possible causes which have been discounted as part of the investigation (paragraph 159).
