Rail Accident Investigation Branch

Rail Accident Report

**Derailment at Phipps Bridge on Croydon
Tramlink
25 May 2006**

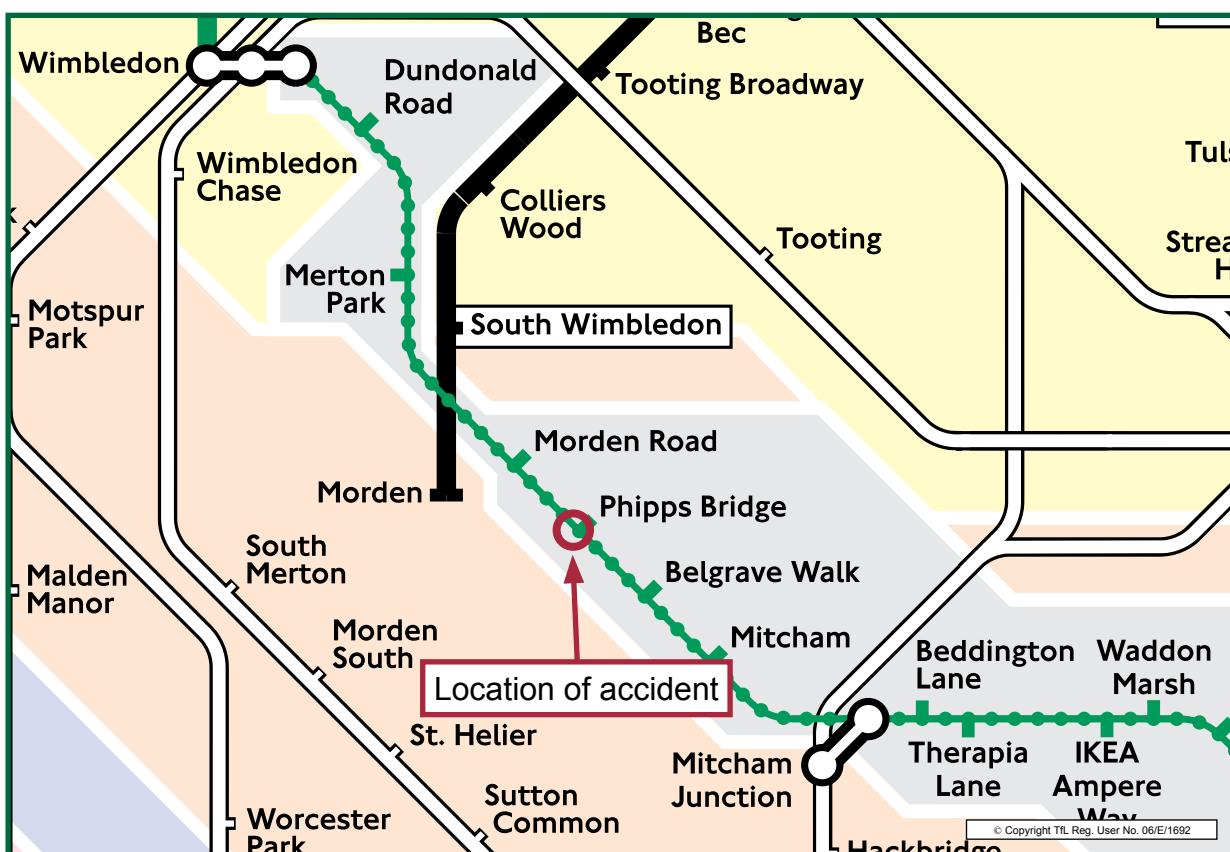
Figure 1: Extract from TfL map showing diagram of Croydon Tramlink system and location of accident

- 5 Tram number 2532, a 3-section articulated unit, travelling eastbound on the single line between Wimbledon and Croydon with approximately 180 passengers on board, became derailed after passing over *facing points* PBR02G at the single to double line junction on the approach to Phipps Bridge tram stop near Merton, Surrey, at 15:57 hrs on Thursday 25 May 2006. As the tram approached the points they were set, incorrectly, in the *reverse* position. After the leading *bogie* of the tram had passed over, the points sprang back to the *normal* position and the centre and rear bogies of the tram took that route. As the paths taken by the front and rear of the tram diverged, the centre bogie became derailed. The tram came to rest about 43 m beyond the points (Figure 2).
