Rail Accident Investigation Branch

Rail Accident Report

**Cutting of rail from a line that was still open to traffic, near Thirsk station, East Coast Main Line.
11 January 2006**

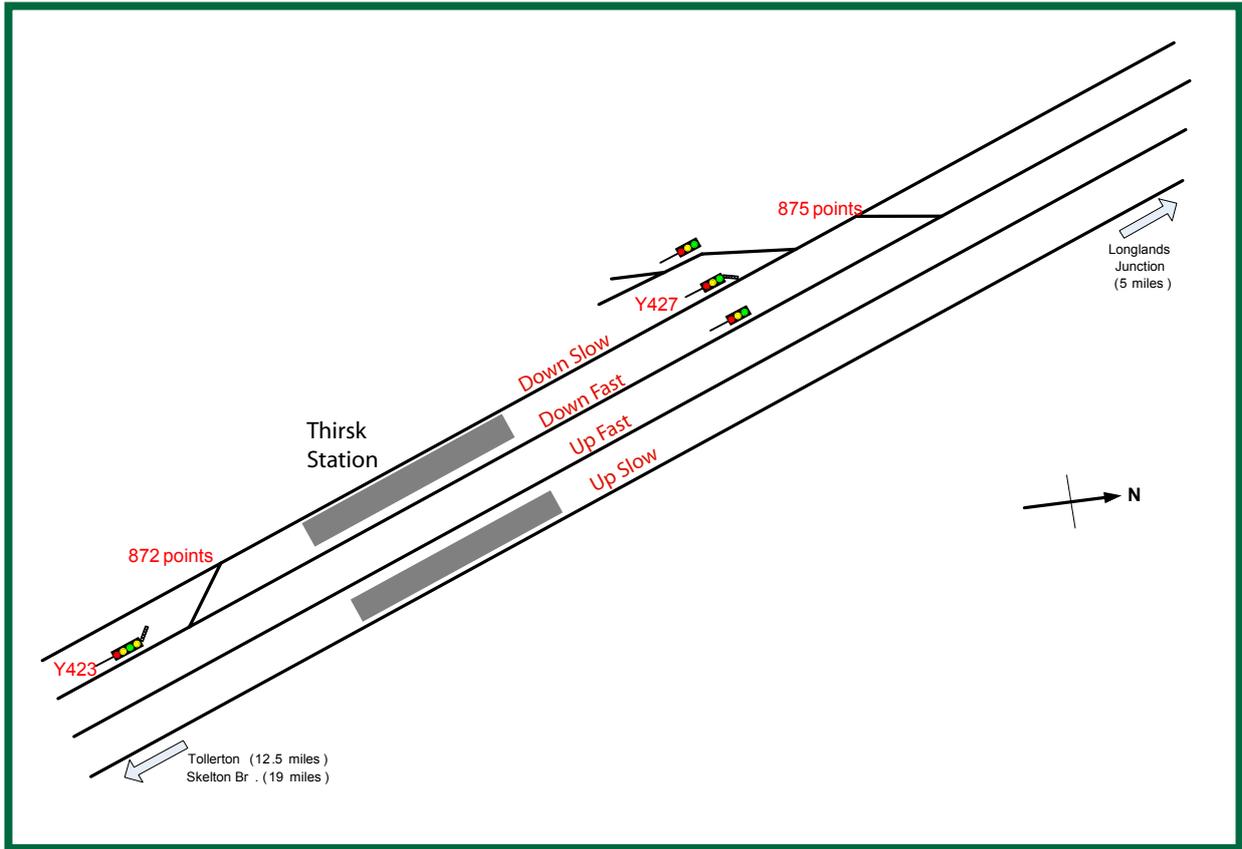
Figure 2: General view of Thirsk and locality

- 11 This incident occurred on a four track section of the East Coast Main Line (ECML), in the vicinity of Thirsk. The designation of the lines in this area is shown in Figure 2.

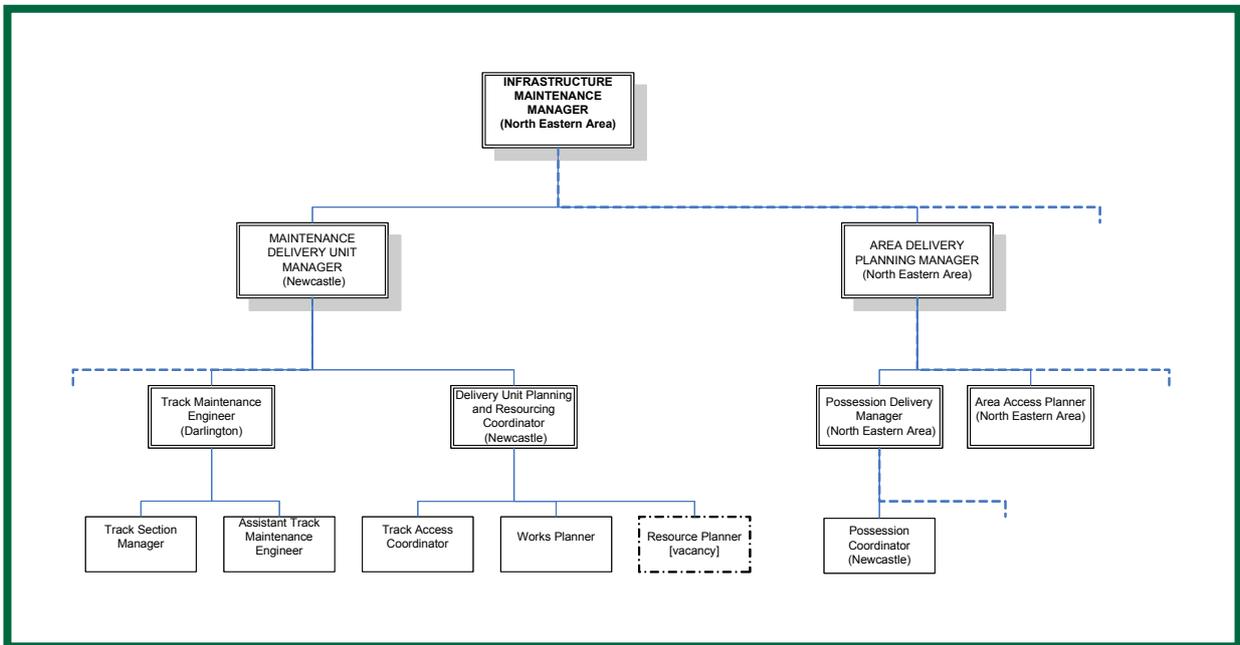
Figure 3: Organisational chart showing the Network Rail management arrangements that are relevant to this investigation

- 19 An organisation chart showing the management arrangements relevant to this investigation is to be found at Figure 3.
- 20 At the time of the incident individuals qualified to act as a Person In Charge Of the Possession (PICOP) were often procured through a labour only contract with Bridgeway Consulting (this was in line with a policy that all possessions arranged for renewals works should be covered by professional PICOPs procured from a commercial provider).

- 76 There is evidence that the various staff and managers involved in this incident were unclear on their roles and responsibilities in the area of possession and works planning (Recommendations 2). This lack of clarity has arisen in part due to the recent major changes in the way track engineering is being managed by Network Rail. Further to this there appears to be some overlap between the roles of the various departments shown at Figure 3. This is exacerbated by the existence of a number of long term vacancies.
