Rail Accident Investigation Branch

# Rail Accident Report

**Freight train derailment at Hatherley, near  
Cheltenham Spa  
18 October 2005**

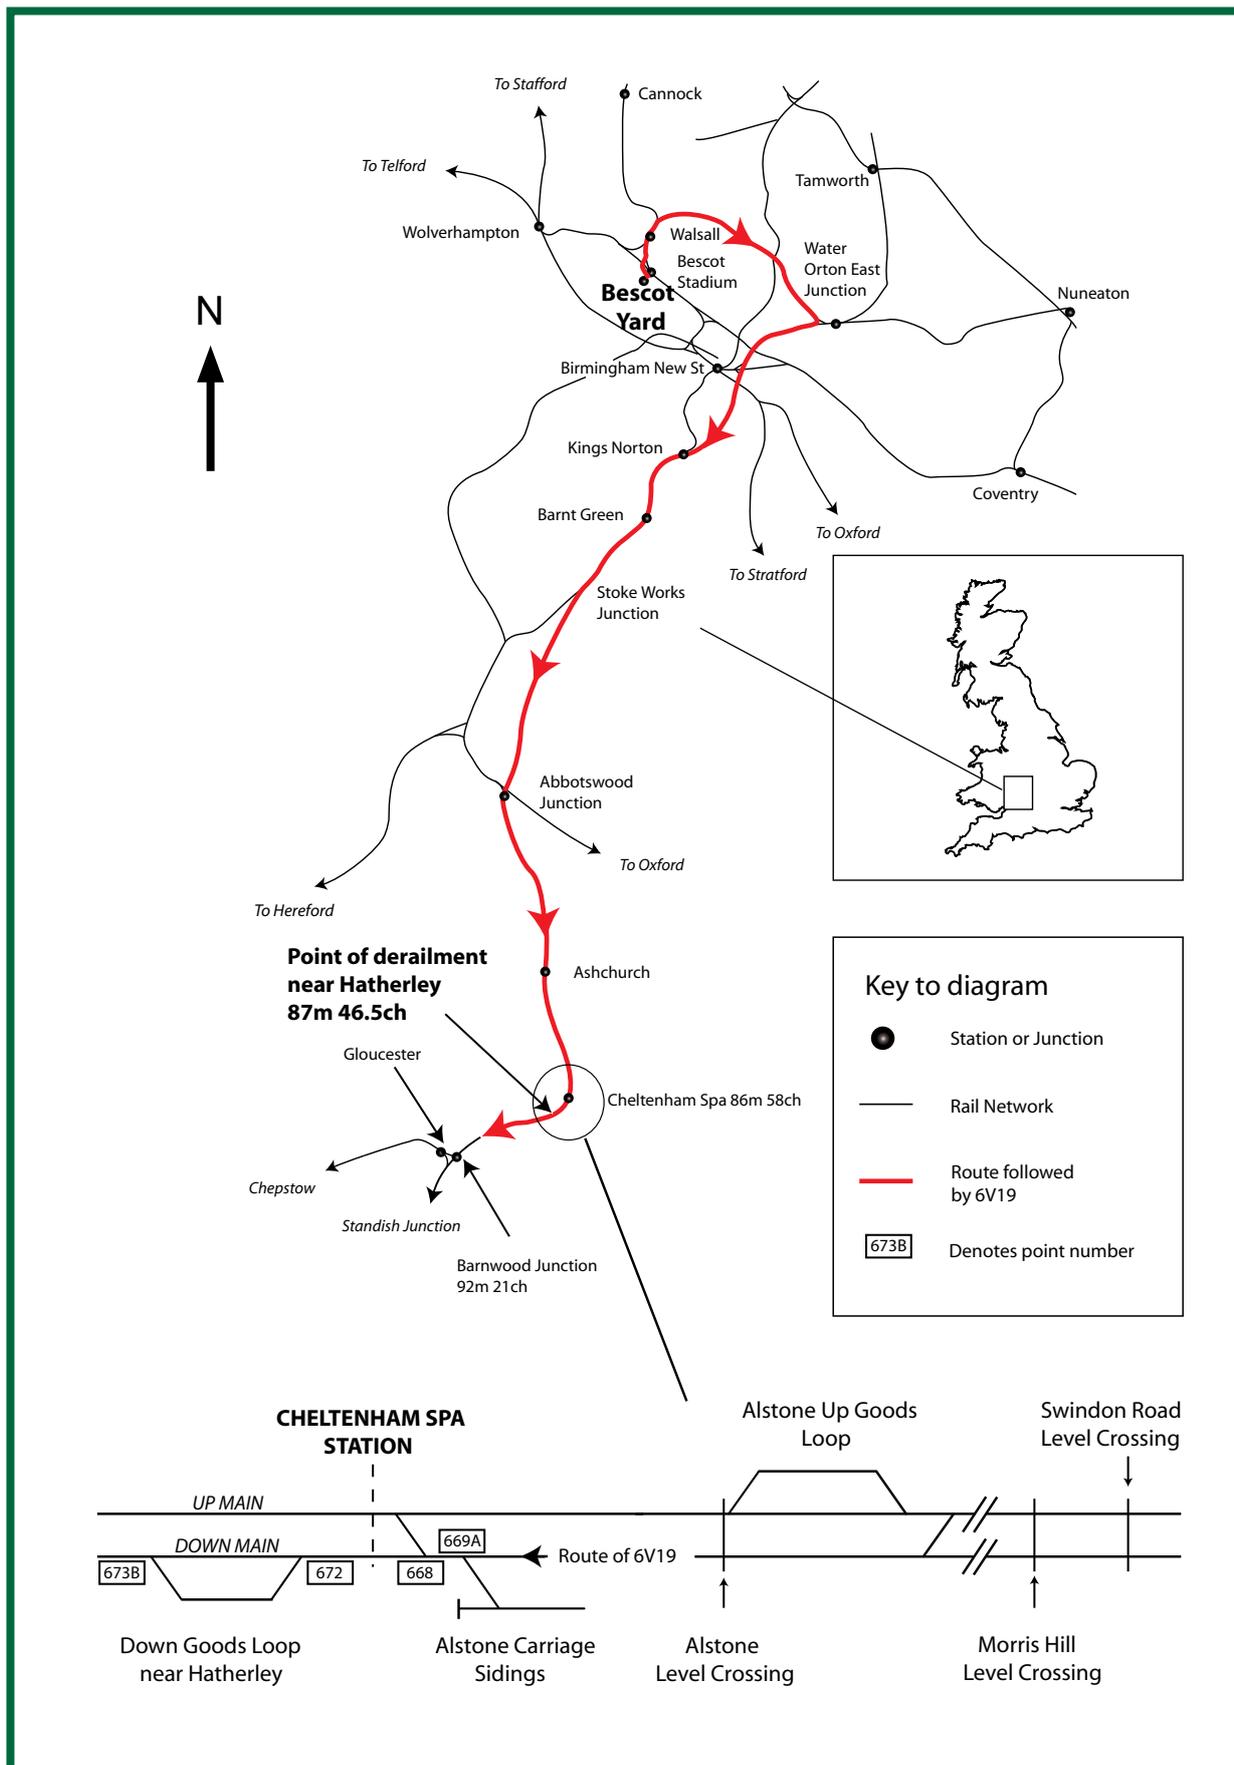
Figure 3: Map of the route taken by train 6V19

- 27 A train travelling southwards over the Down Main line negotiates four sets of points in this area (Figure 3); 669A (*trailing*) and 668 (*facing*) forming the exit to Alstone Carriage sidings and a crossover between the main lines respectively, and 672 (*facing*) and 673B (*trailing*) forming the entrance and exit respectively to the Down Goods Loop near Hatherley.

- 44 There were no fatalities or injuries as a result of this accident.
- 45 Pre-derailment infrastructure damage was caused to 669A points, 672 points and 673B points (Figure 3).

- 58 Evidence from wheel/rail contact marks indicated that wagon SSA 470028 had derailed momentarily whilst traversing 669A points (Figure 3) in the trailing direction. The mechanism of this partial derailment was similar to that observed further down the track at 673B points (paragraph 60). However, the resistance of the rails to overturning at 669A points was sufficient to prevent full derailment, and the leading wheelset rerailed itself as it passed beyond the toes of the points. 669A points comprise flat bottomed rail on concrete bearers.
