**Report on the accident to  
Airbus A-320-231, G-MEDA  
On approach to Addis Abeba Airport,  
Ethiopia  
31 March 2003**

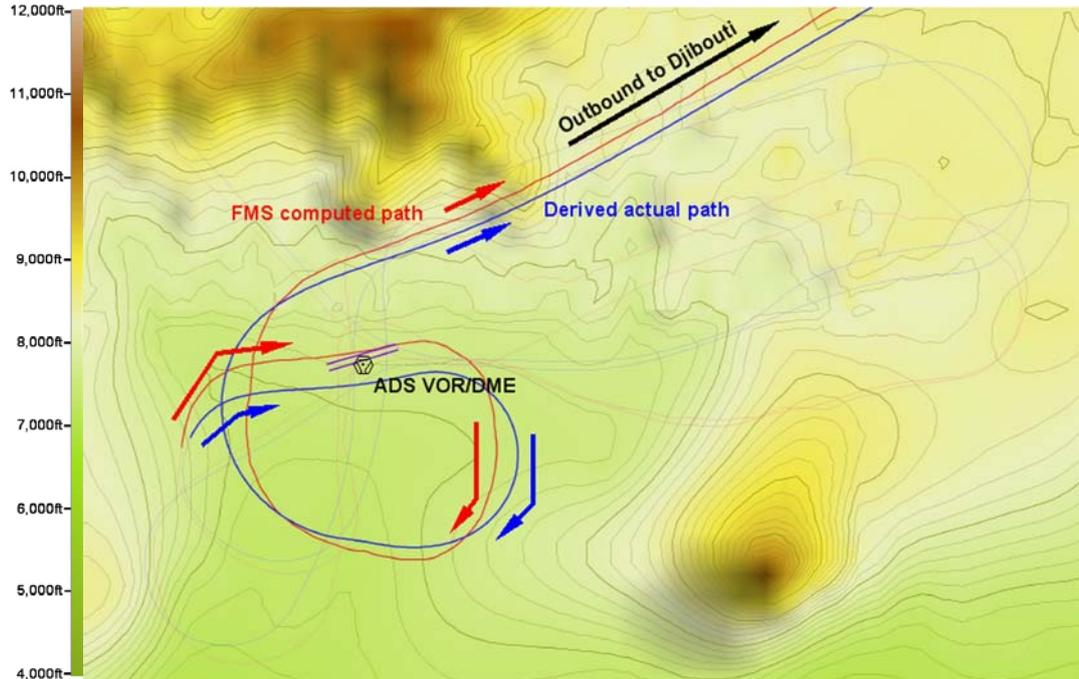
**Figure 17**

Figure 17 shows the subsequent departure from Addis Abeba, approximately 35 minutes after arriving. The aircraft landed at Ambouli airport, Djibouti at 0042 hrs.

FMS computed path v derived actual path - hold and diversion to Djibouti
