Report of the Investigation into the
over-pressurisation of a cargo tank
on the Oil Tanker

MOBIL PETREL

at Fawley Oil Terminal
on 7 November 1989

Marine Accident Investigation Branch
5/7 Brunswick Place
SOUTHAMPTON
Hants SO1 2AN

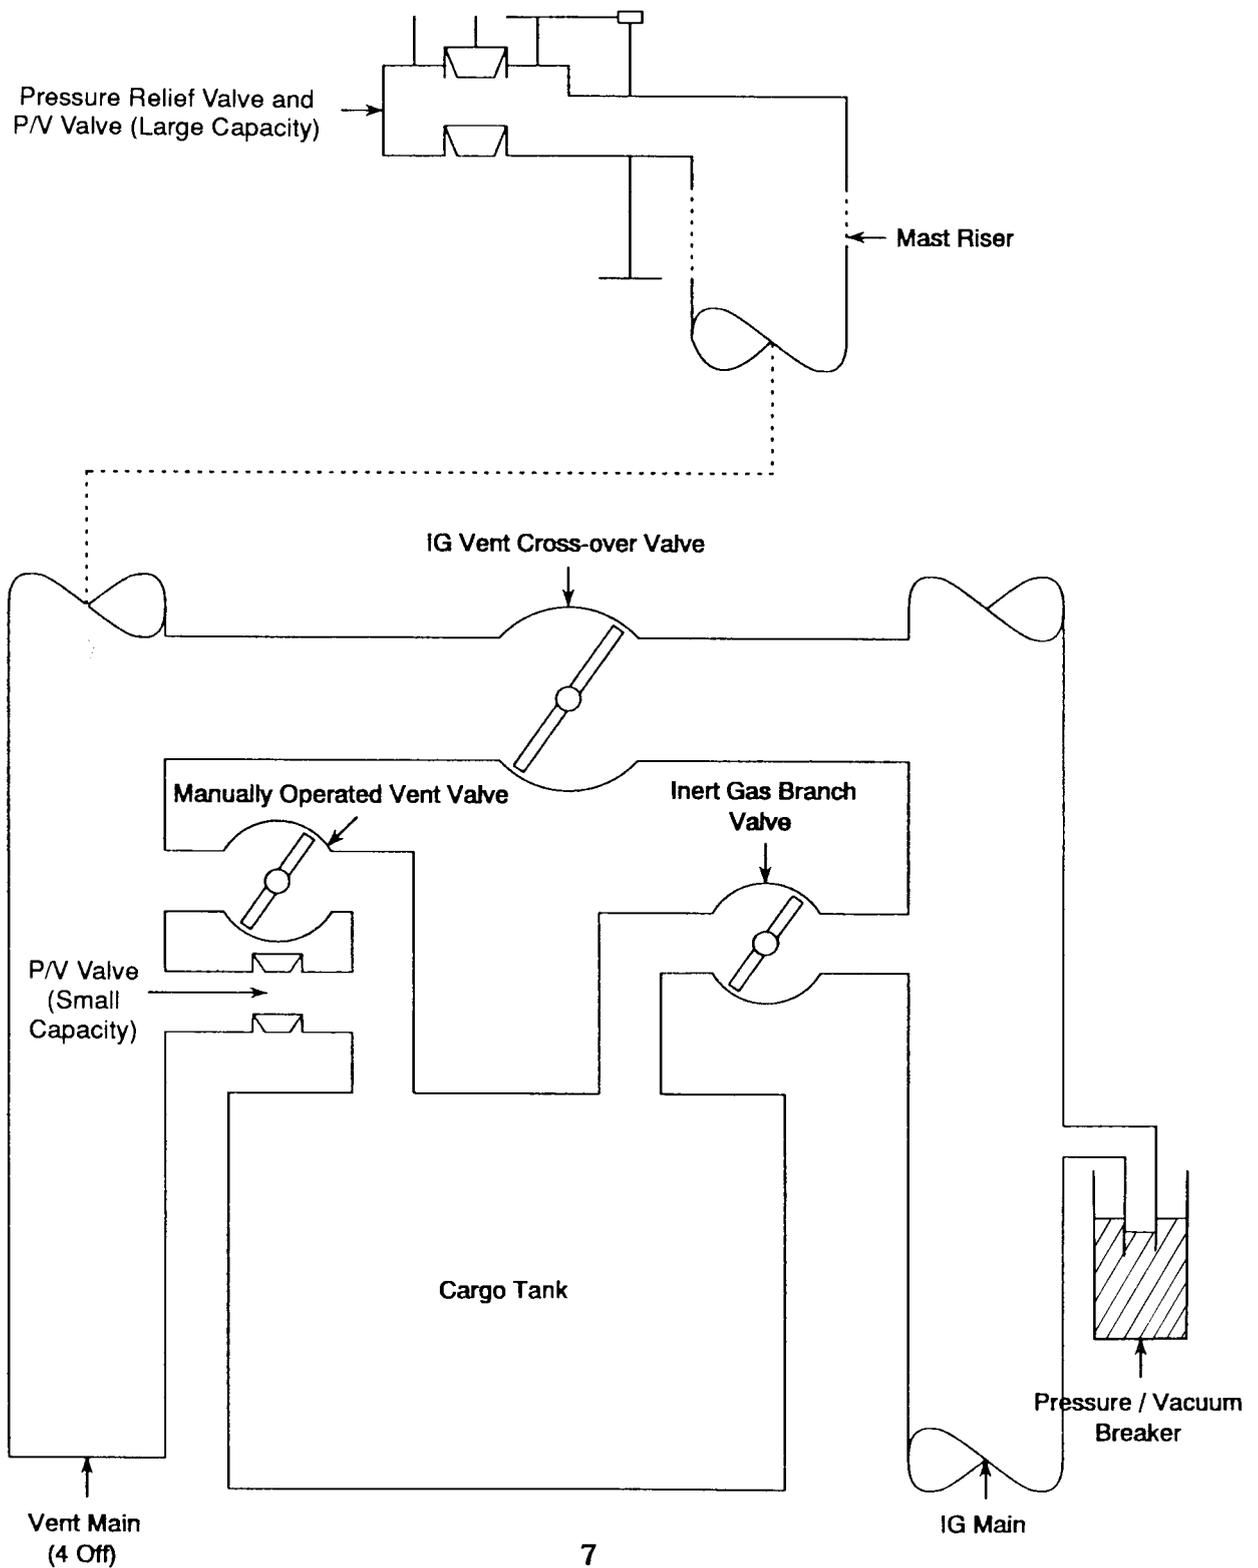
Fig. 2

The gas venting system [Fig 2] consists of four separate common vent mains which run along the length of the main deck. Branch pipes lead from the top of each of the cargo and slop tanks into one of the mains. Each vent line is fitted with a manually operated butterfly valve (vent valve) around which is a smaller bore line fitted with a pressure vacuum valve (p/v valve). The p/v valve is designed to control pressure variation in the tank caused by ambient temperature changes; it can be jacked into an open position or set to operate automatically.

A hydrostatic pressure relief valve is fitted on the vent main lines at the base of each mast riser.
