Marine Accident Report 2/98

Report of the Inspector's Inquiry
into the loss of the Fishing Vessel

“GORAH LASS”

with three lives on 11 March 1997
off Portreath, North Cornwall

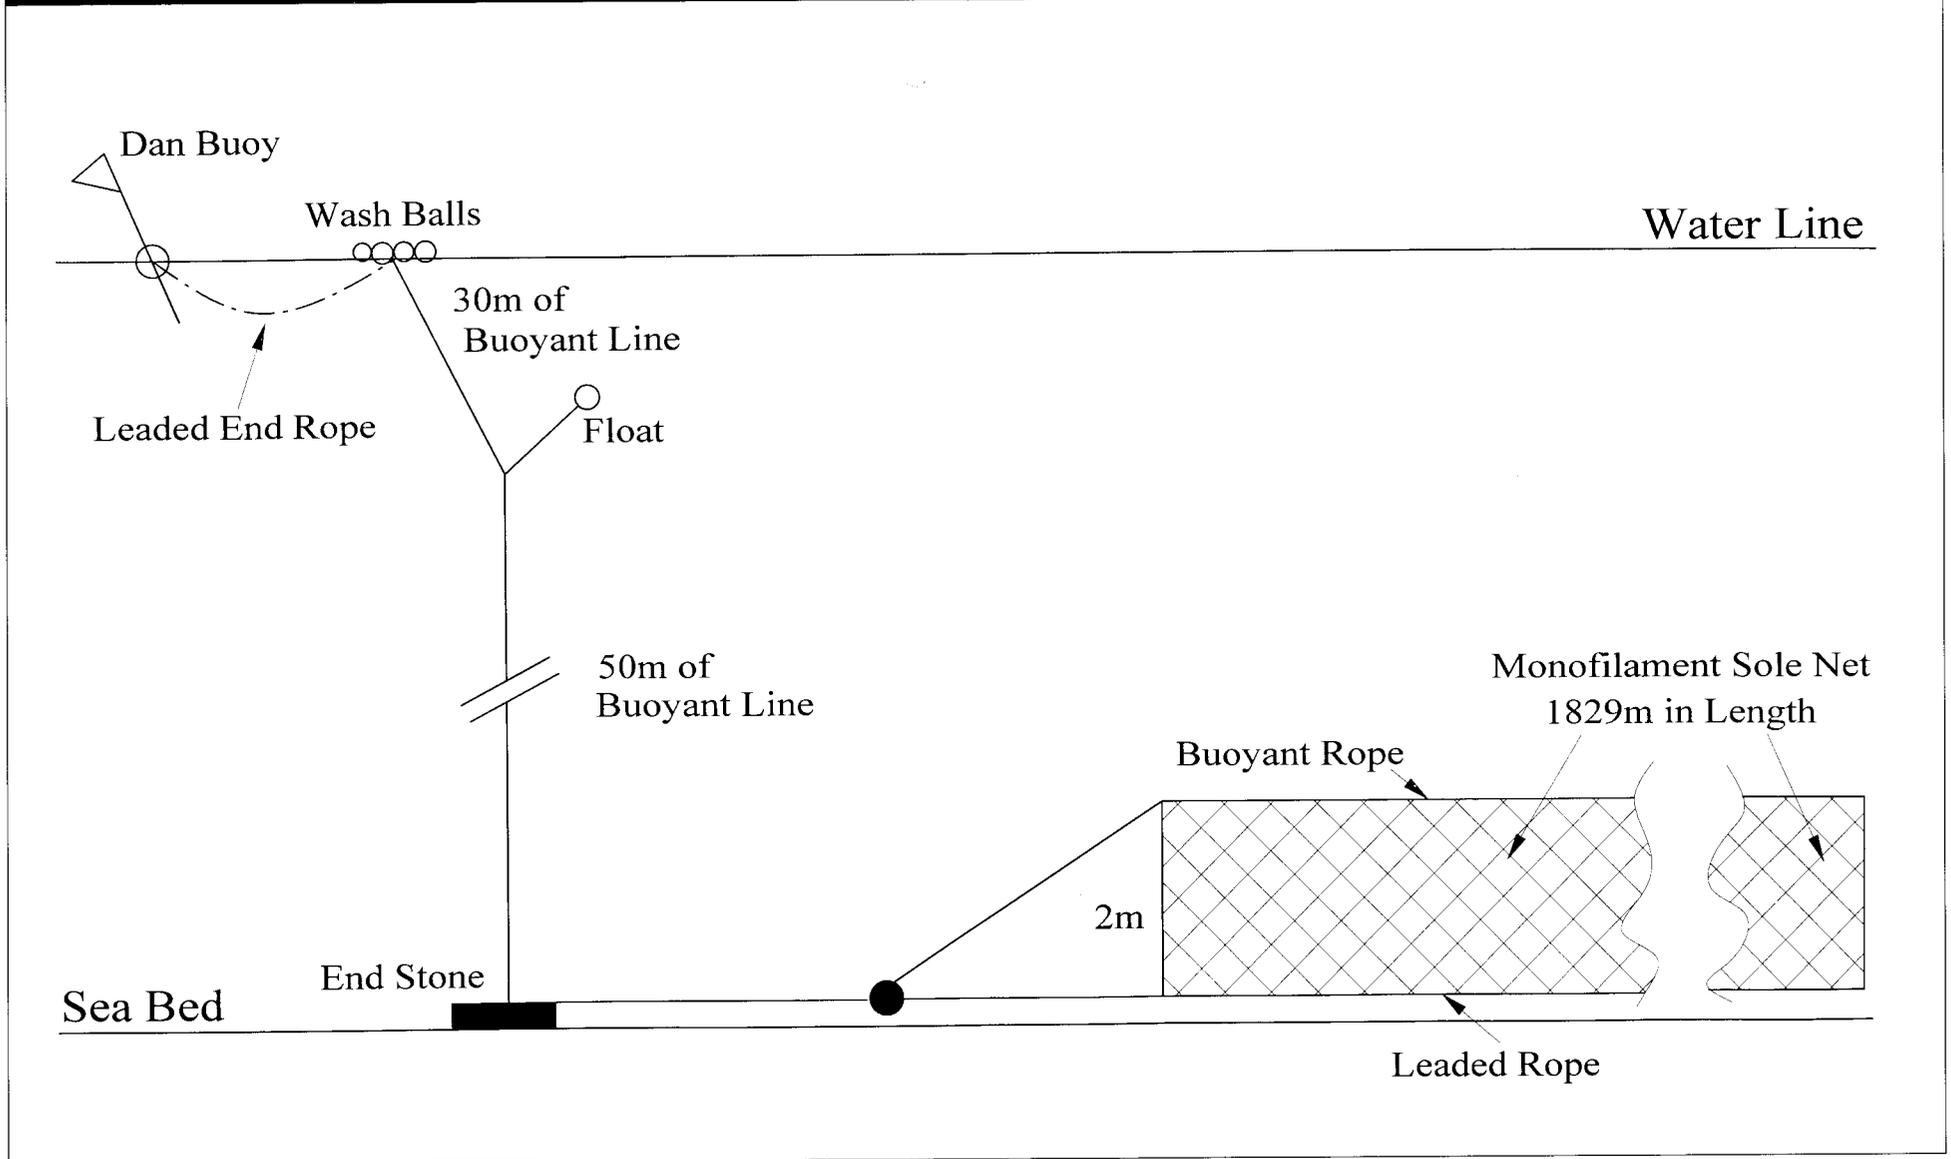
Figure 2 One End of a Typical Sole Net Rig *Not to Scale*

Figure 2 indicates a typical rig for a sole net. It does not necessarily indicate the exact arrangement used by Philip Benney. The “end stones” typically consist of scrap metal, often links of vessel’s anchor cable. Each end stone weighs about 8 kg. On GORAH LASS five tiers (rigged nets) each of 1829m were carried. Each tier was stowed in, and shot from, a plastic net bin. Each full net bin, complete with end stones and net, weighs about 160 kg. In the process of shooting a net the net bin is manhandled to the after end of the deck and, at the chosen location, one dan buoy and end stone are thrown into the water. The net is then streamed out over the transom while the vessel steams slowly ahead in the chosen direction of deployment. As the last end of the net goes over the stern the final dan buoy, and end stone, are dropped into the sea.

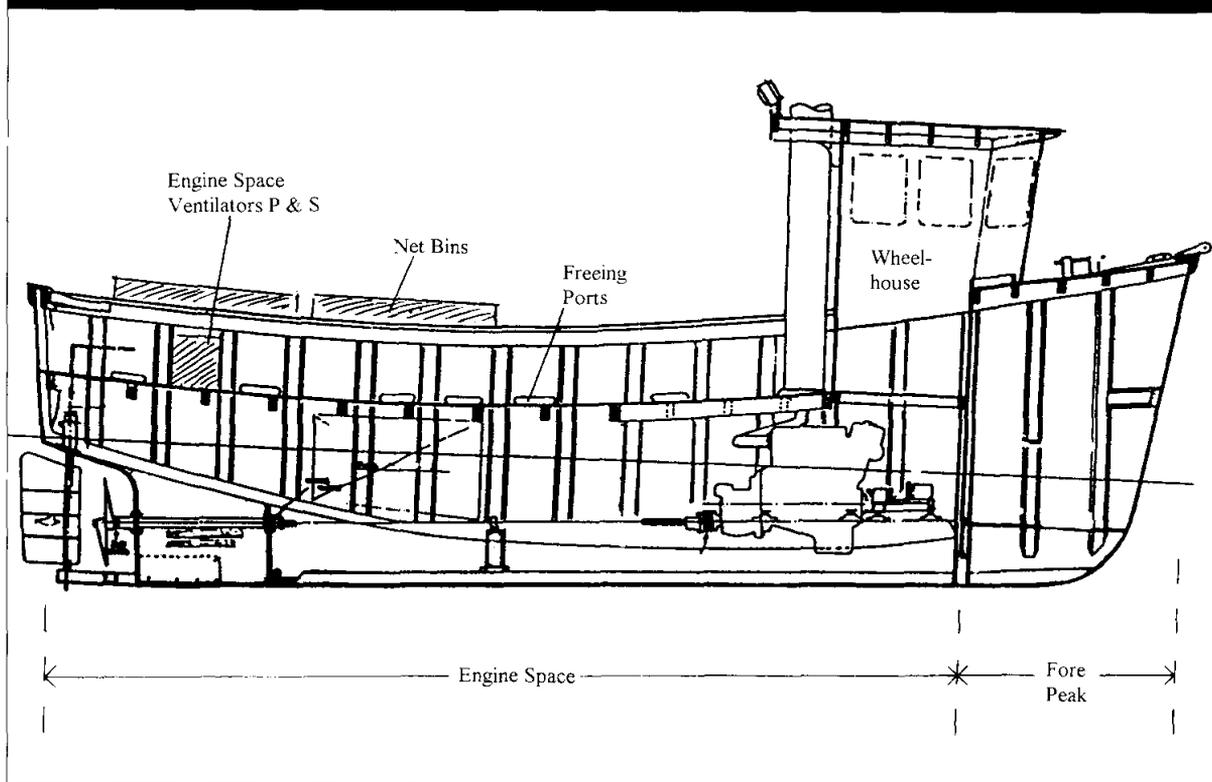
Figure 4 "Gorah Lass" Profile Drawing *Not to Scale*

There are bulwarks of 0.58m height around the after deck and on the port, non-working, side a single square section tubular railing of stainless steel is fitted above the bulwark for the whole length of the afterdeck. Two open topped rectangular section air vents which serve the engine compartment are tucked-in under the bulwarks towards the after end of the working deck, one on the port and the other on the starboard side. There are fourteen freeing ports fitted at deck level through the bulwarks, seven on each side of the after deck. Each freeing port has a maximum freeing area of 0.0125 m². An after "A" frame of stainless steel supports a stainless steel after mast which is rigged to deploy a mizzen steadying sail. The hydraulic net hauler is mounted on the forward starboard side of the after deck.

The wheelhouse is entered from the after deck by a narrow sliding door situated on the port side. Within the wheelhouse there is just space for three or four men to stand shoulder-to-shoulder. The steering position is sited on the starboard side with an instrument console immediately in front of it comprising switch panel, compass and engine monitoring instruments and controls. The engines can be controlled, by interlinked "Morse" controls, from the steering position and from the after deck adjacent to the net hauler, one lever for gear selection and one for throttle. The VHF radio is mounted on the deckhead above the steering position. The radar is mounted on the console to the left of the steering position with the main GPS on the deckhead above it.
