## Marine Accident Report 1/98

Report of the Inspector's Inquiry  
into the sinking of the Fishing Vessel

**PESCADO PH409**

with the loss of life of all six of the crew  
in February 1991

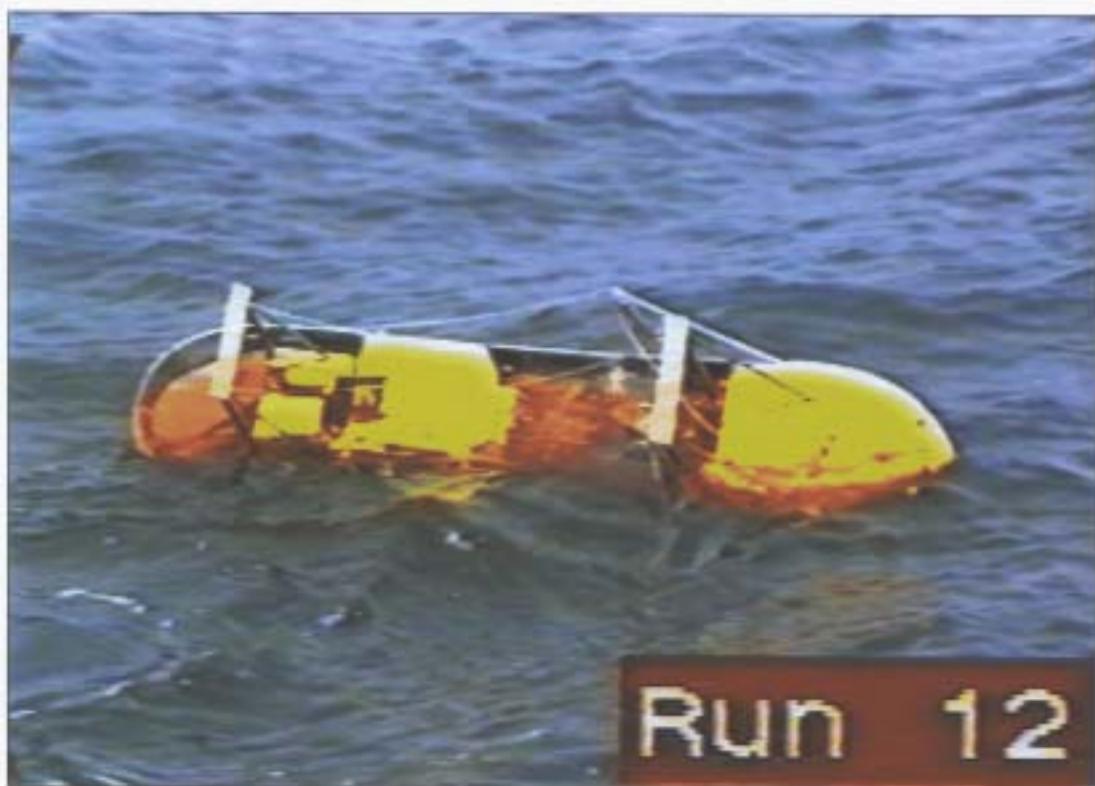
As modelled, the vessel would have lain over on her beam ends, or partially submerged on her side at about 90°, with the port bulwark near the surface. Down flooding would have continued through all openings, but mainly through the deckhouse openings and into the engine room. The model tests suggest that this stage of the sinking would have taken a few minutes (see Figures 14 and 15). Flooding of the hull would have continued until sufficient buoyancy had been lost to cause the vessel to sink deeper (see Figures 16 and 17). The vessel would most likely have sunk by the stern because of a greater number of flooding openings aft.

Figure 14: Model heeled heavily to starboard with weather deck awash and wheelhouse flooded

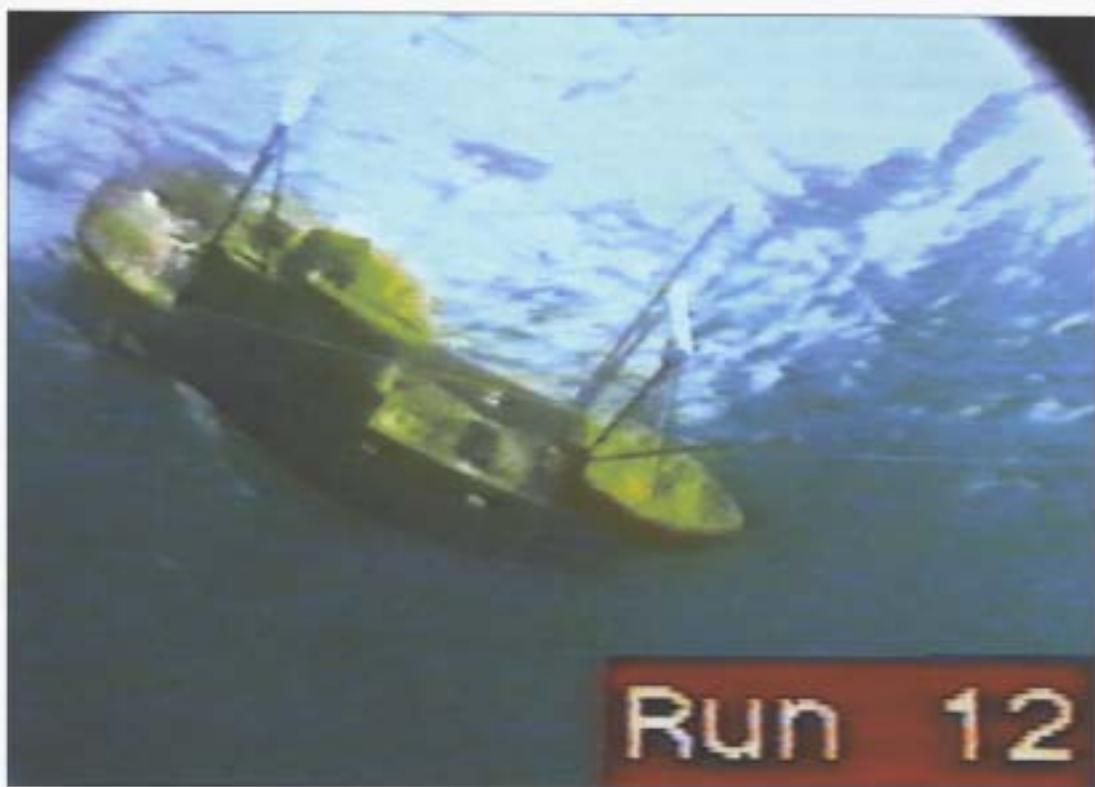
With the brake off and the clutch disengaged, the starboard trawl wire would, if tarred and greased, come off the drum easily whilst under load. The initial load would have been exerted by the vessel sinking to the bottom. However, when the wreck was surveyed in June 1991 there was no wire on this drum. The remaining wire on the drum was most likely pulled off it by fishing vessels which were known to have unintentionally trawled into the wreck.

Figure 15: As seen underwater just below the surface tethered by the starboard trawl wire

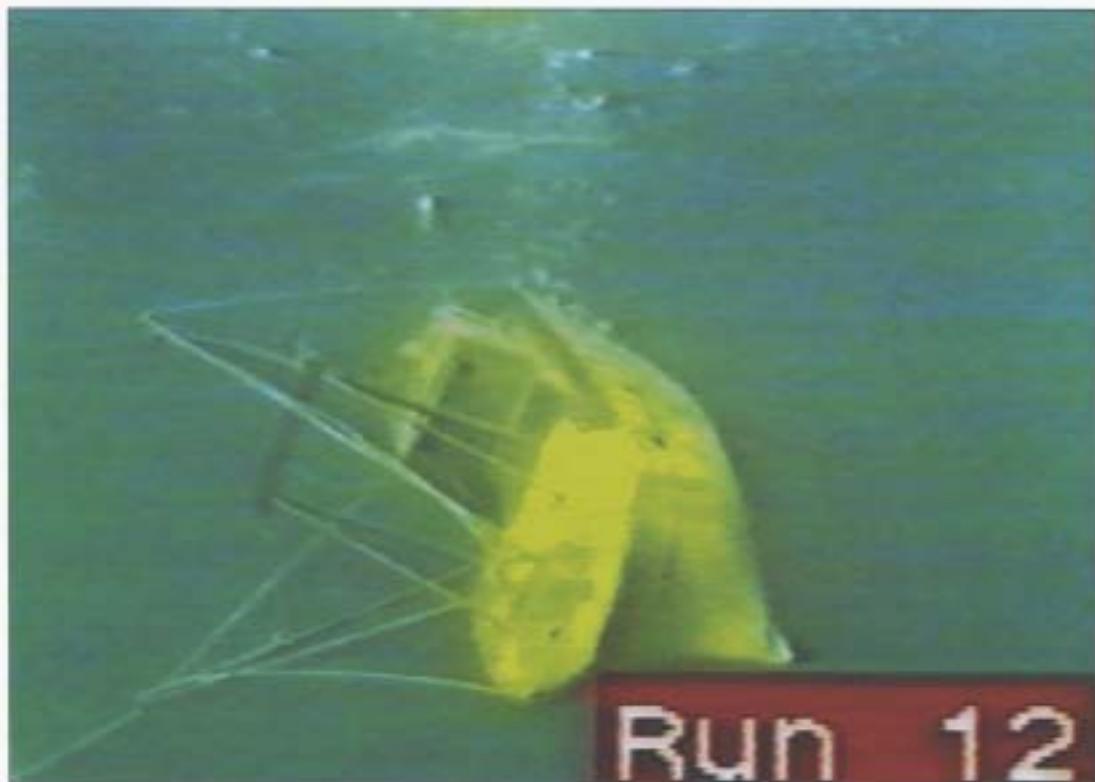
Figure 16: Model leaving the surface, descending in an arc (the port derrick could swing inboard)

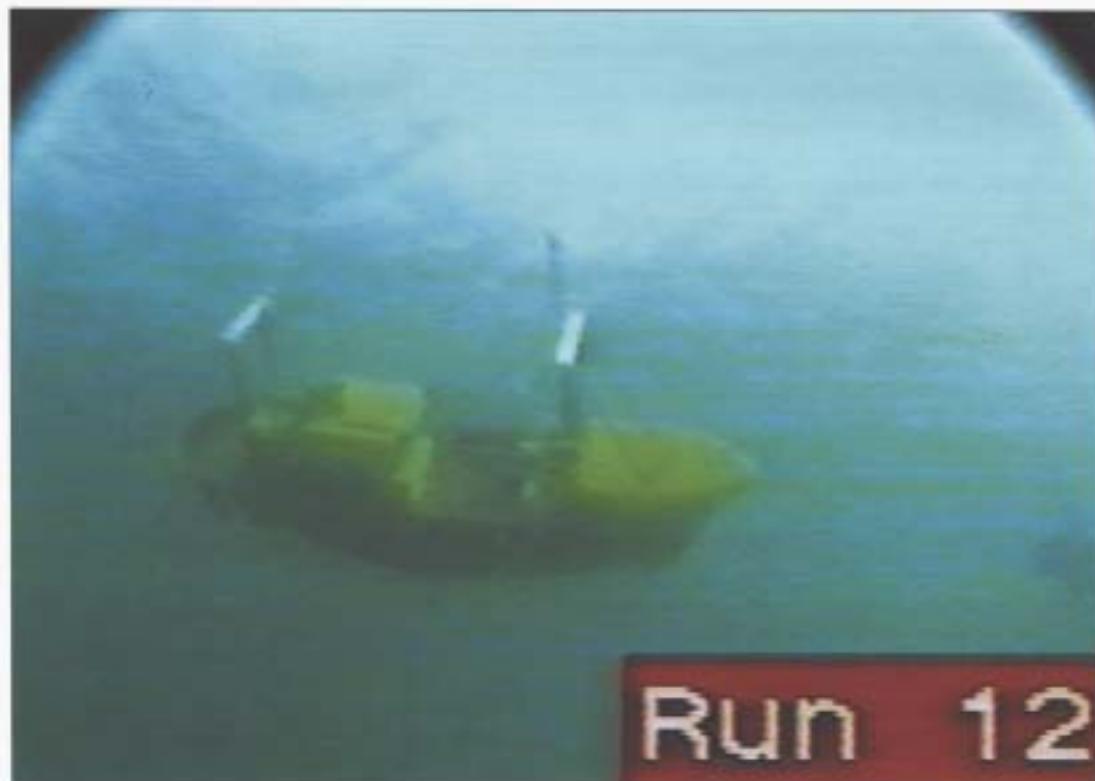
Figure 17: Model observed during descent from starboard side

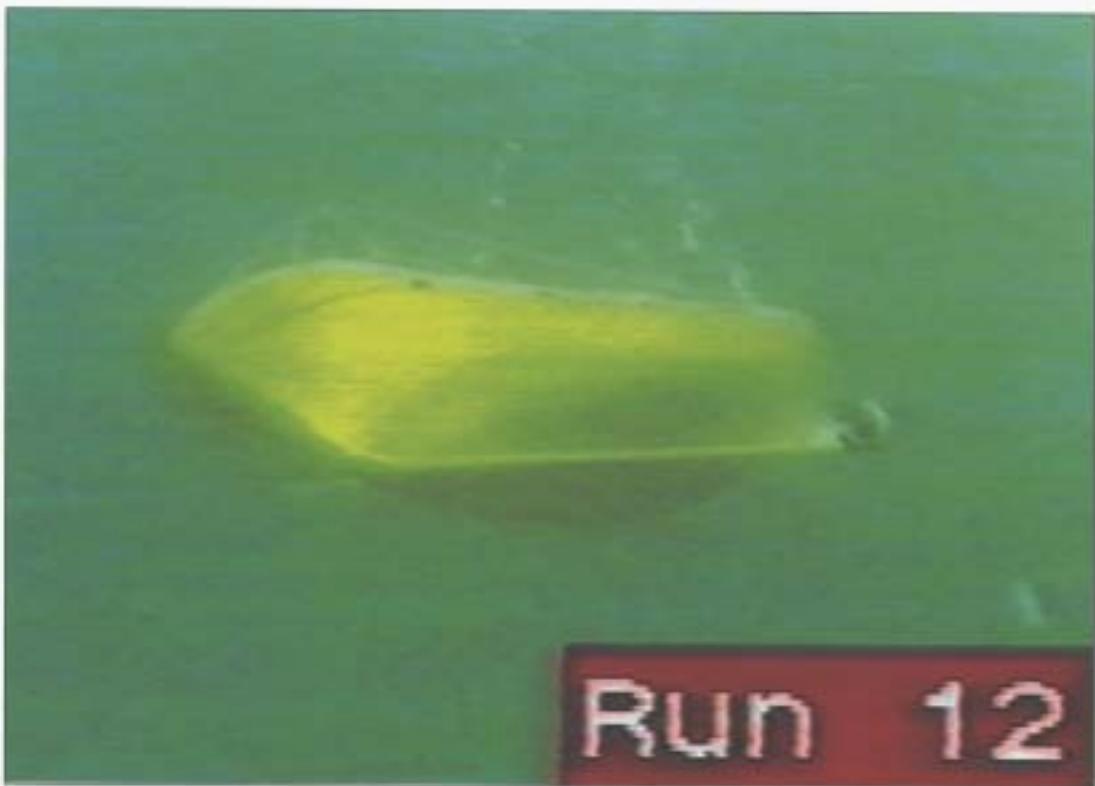
Figure 18: Model heeling heavily to starboard, descending and close to sea bed

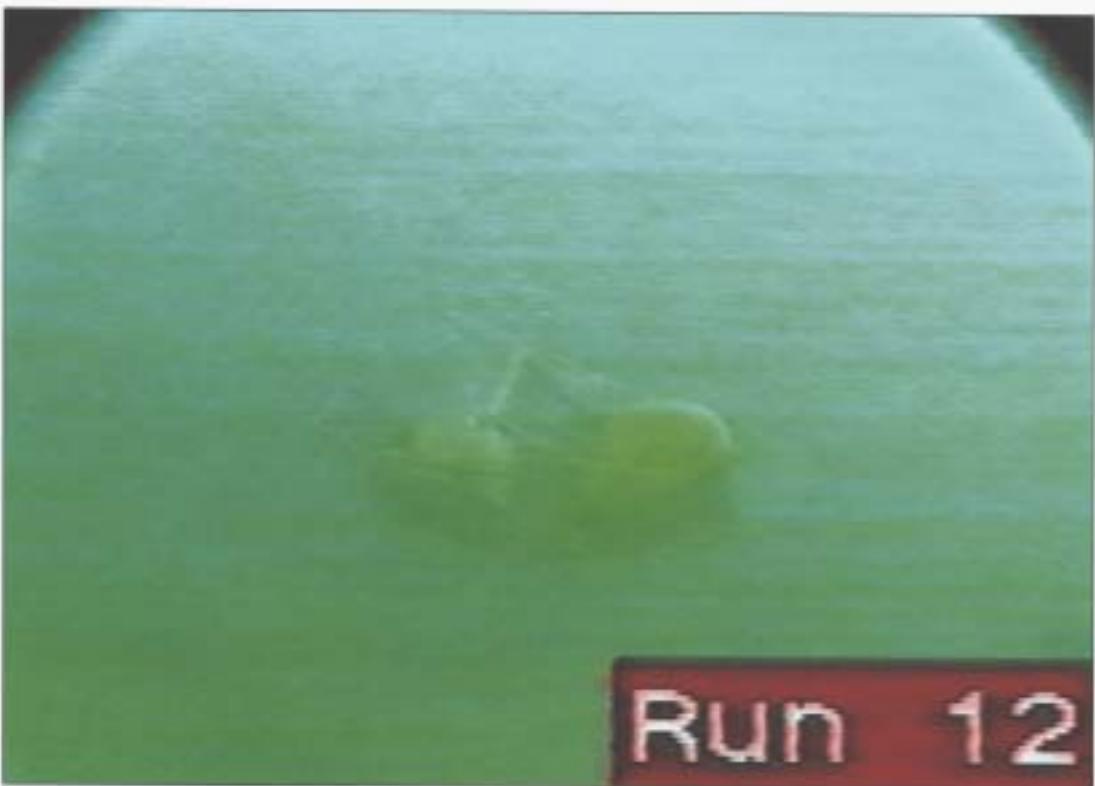
Figure 19: Model seen descending from port side, air escaping first point of impact will be starboard turn of bilge

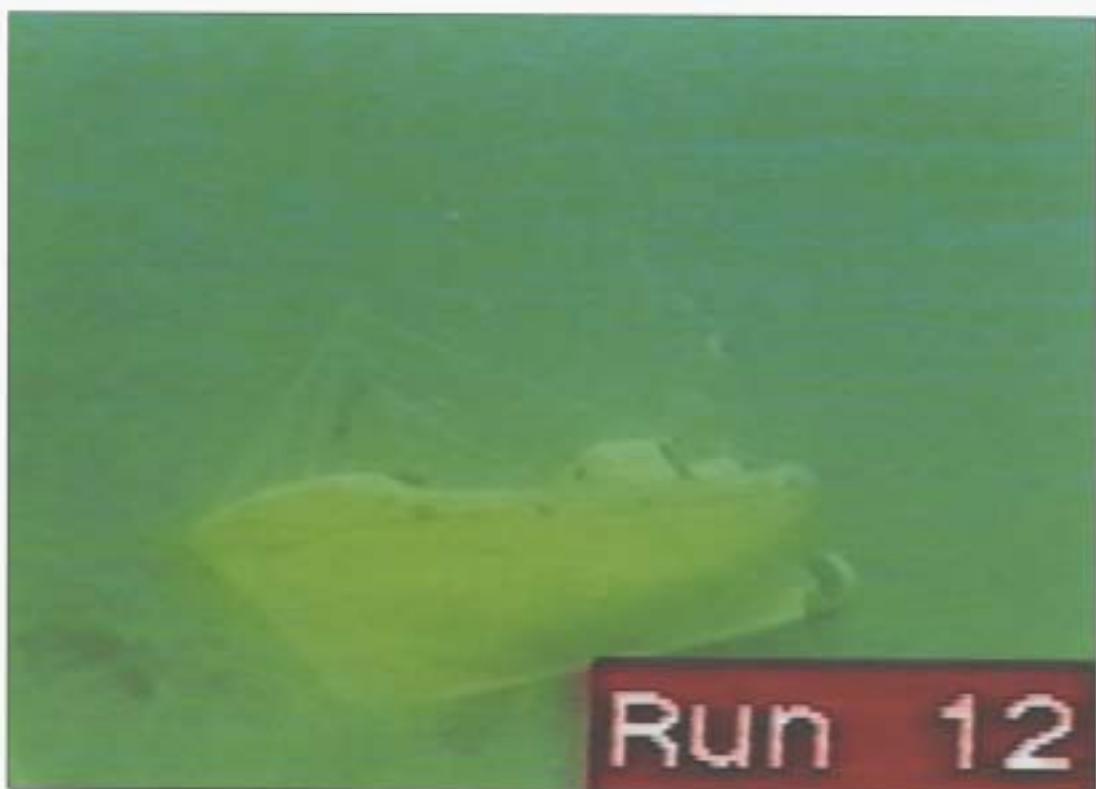
Figure 20: Model making impact on starboard side with the sea bed.

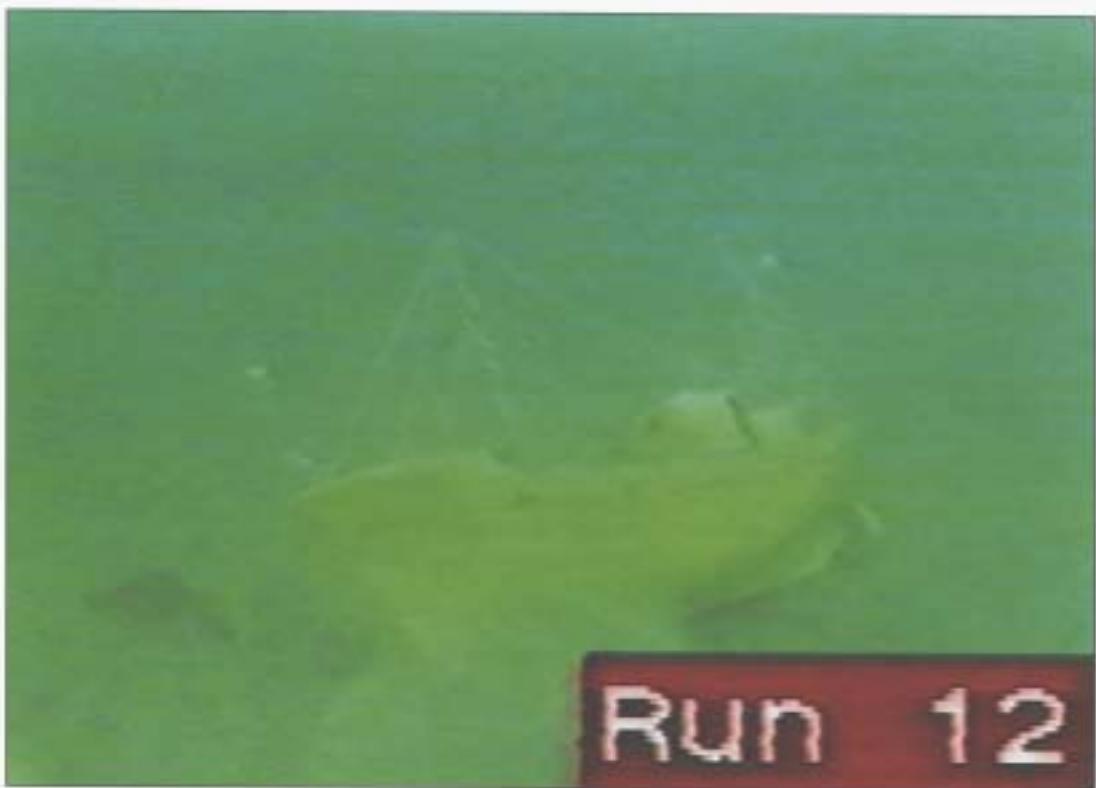
The hydrostatic pressure damage to the deck in way of the net store, confirms that the forward net store initially remained watertight and buoyant, supporting the fore end of the vessel at the early stage of sinking. Once the vessel had left the surface, she would have descended quite rapidly. With air being expelled, flooding would have continued, the hull sinking to the sea bed still tethered to the starboard trawl by the trawl wire. During descent the hull would have swung in an arc on a fairly even keel, developing an angle of heel of about 45°, which brought the starboard derrick in line with the submerged trawl wire (see Figures 16, 17 and 18). At this angle the starboard bilge keel would be the first point of impact with the sea bed, (see Figures 19 and 20) causing damage to the turn of the bilge. Sufficient kinetic energy remained in the hull to cause her to roll to port and take up a nearly upright position on the sea bed. (See Figures 21 and 22). Figure 23 shows a graphical representation on how the vessel sank to the sea bed.

Figure 21: Model impacted on sea bed as observed from port side

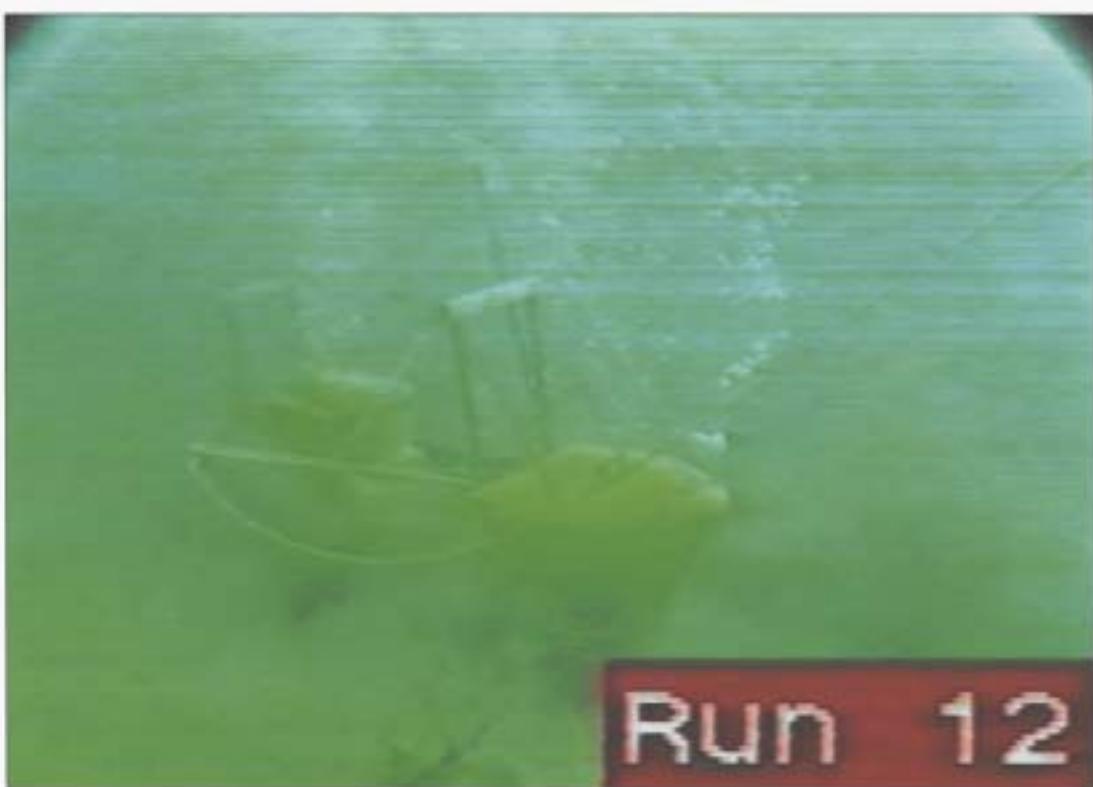
Figure 22: Vessel at rest on the sea bed in a nearly upright position

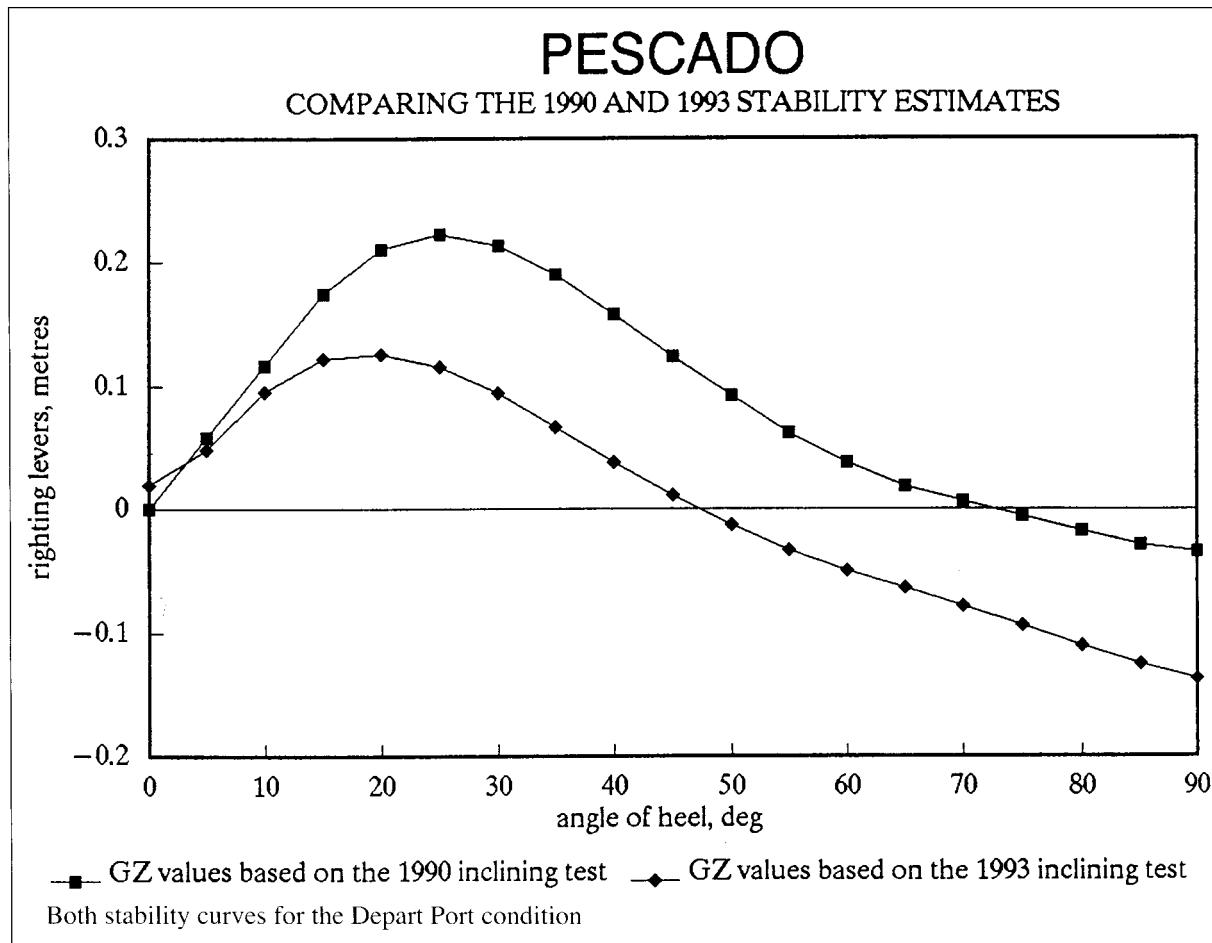
It was found that there was a marked difference between the results of the two inclining tests. Consequently, there was a considerable variation in the estimated stability for the vessel, depending upon which set of results was used to derive the lightship condition. This is clearly illustrated in Figure 25, which shows the righting lever (GZ) curves for the Depart Port condition. It can be seen that the maximum righting lever determined using the “1990” inclining test is some 80% greater than those determined using the “post salvage, 1993” inclining test; while the metacentric heights (GM) differ by about 26%. There was an equally remarkable difference in the lightship weight estimates: the “1990” lightship weight estimate was 101.2 tonne whilst that derived from the “1993” inclining test was 122.2 tonne, a difference of over 20%.

The data presented in Table 1 and Figure 25 indicates that at angles of heel below about 25° the vessel had good stability. This would have been characterised by a quick roll which would perhaps have made her uncomfortable in a seaway. However, at angles of heel greater than 25°, and in the deeper loading conditions, her stability fell short of that which was required by the regulations. This indicates that the vessel lacked freeboard when heavily loaded, suggesting that she would have readily shipped water onto her working deck. In her deepest condition (departing port full of fuel) the maximum righting lever was about 80% of that required by the regulations.

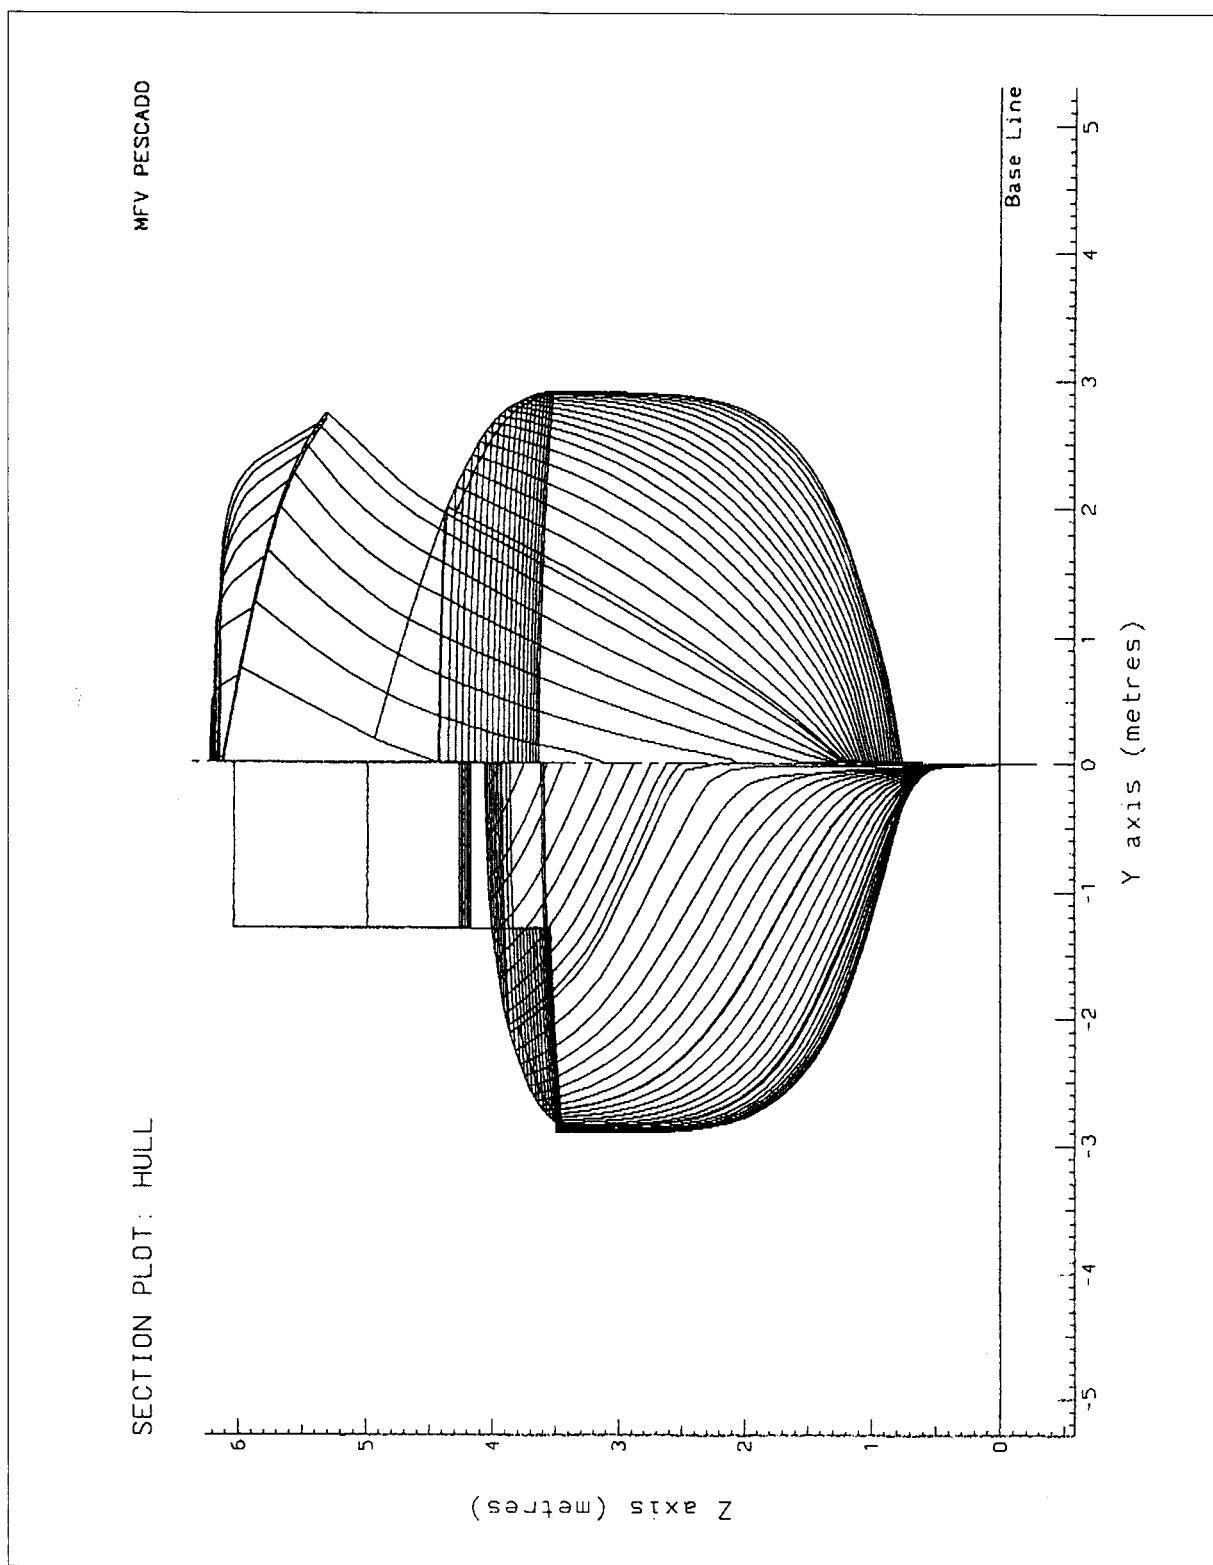
Figure 26

Using, as a basis, the results of the MAIB's inclining test and the hull form derived from the measurements of DML but refined by consultants Marine Data International (See Figure 26) an estimate was made of the likely stability characteristics of the vessel. Her stability was found to be generally below the standard required for a beam trawler which is set out in the Fishing Vessel (Safety Provisions) Rules 1975. This is illustrated in Table 1, which compares the results of a set of standard calculations with the requirements of the regulations. In essence this outcome agreed with the findings of Mr Wilford in 1990. It can be seen that the vessel does in fact meet the criteria in the lightest seagoing conditions.

starboard side decking. Immersion of the engine room door sill occurs between about  $33^\circ$  and  $39^\circ$ , depending upon the loading of the vessel. The engine room door has been taken as a non-weathertight closure because inspection of the vessel showed that it had been rigged with a counterweight so that it would pull to (but not lock) after use. Consequently, if the vessel was heeled substantially to starboard it would swing open and allow water into the engine room. Unrestricted flooding of the engine room would cause the vessel to founder.

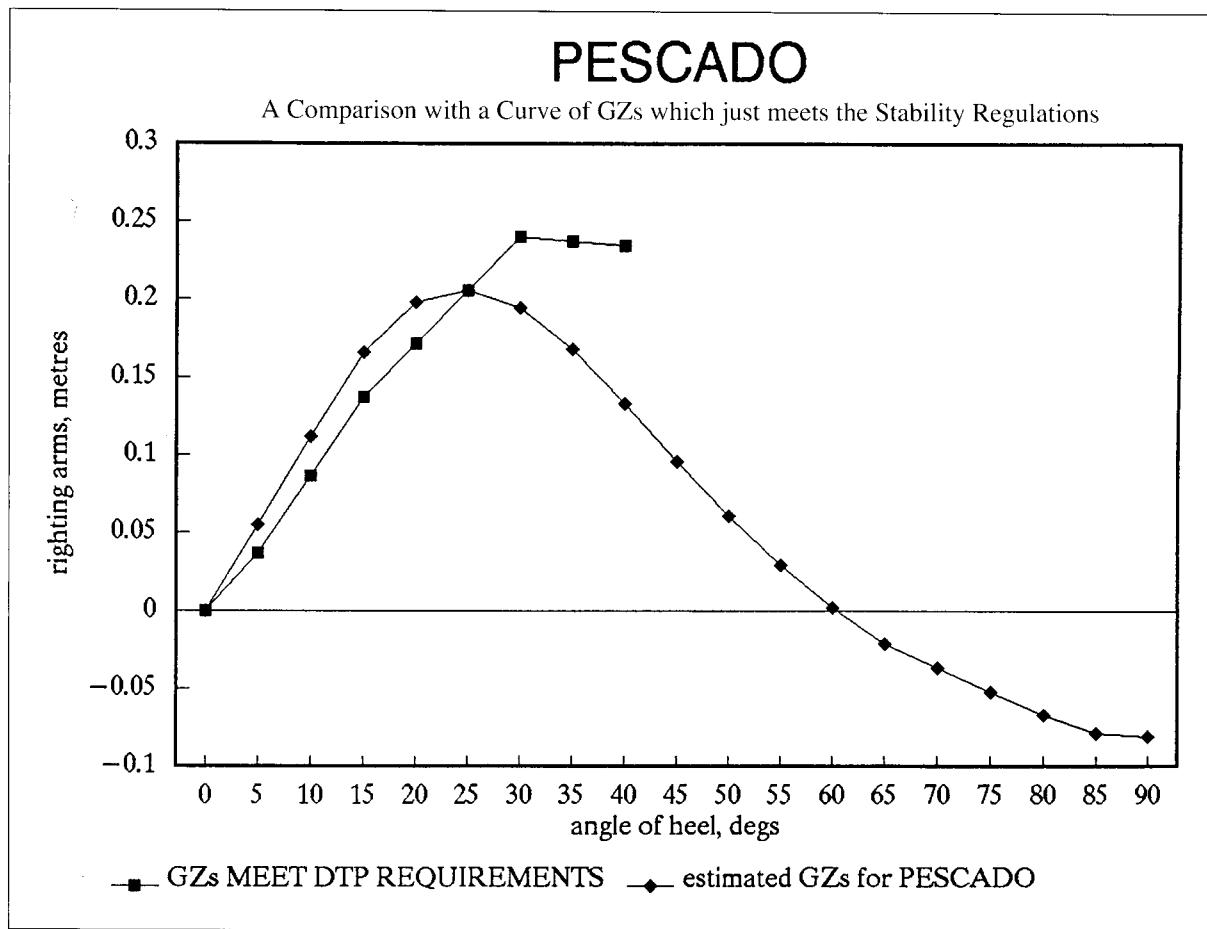
An attempt has also been made to estimate the stability of the vessel at the time of her loss. The stability curve is shown in Figure 27 where it is compared with a notional curve which just meets the stability regulations. The deadweight table describing the corresponding vessel's condition is shown in Table 2. It is estimated that the engine room door sill would be immersed at about 38° angle of heel to starboard in this condition.

The stability determined for PESCADO, whilst unsatisfactory, is sufficiently close to the prescribed level to suggest that this was not the decisive factor which caused the loss of the vessel. It is almost certain that even if she had met the stability criteria in full she would still have been lost in the particular set of circumstances which it is believed overwhelmed PESCADO.
