Marine Accident Report 4/98

Report of the Inspector's Inquiry
into the loss of the Fishing Vessel

WESTHAVEN AH 190

with four lives on 10 March 1997
in the North Sea

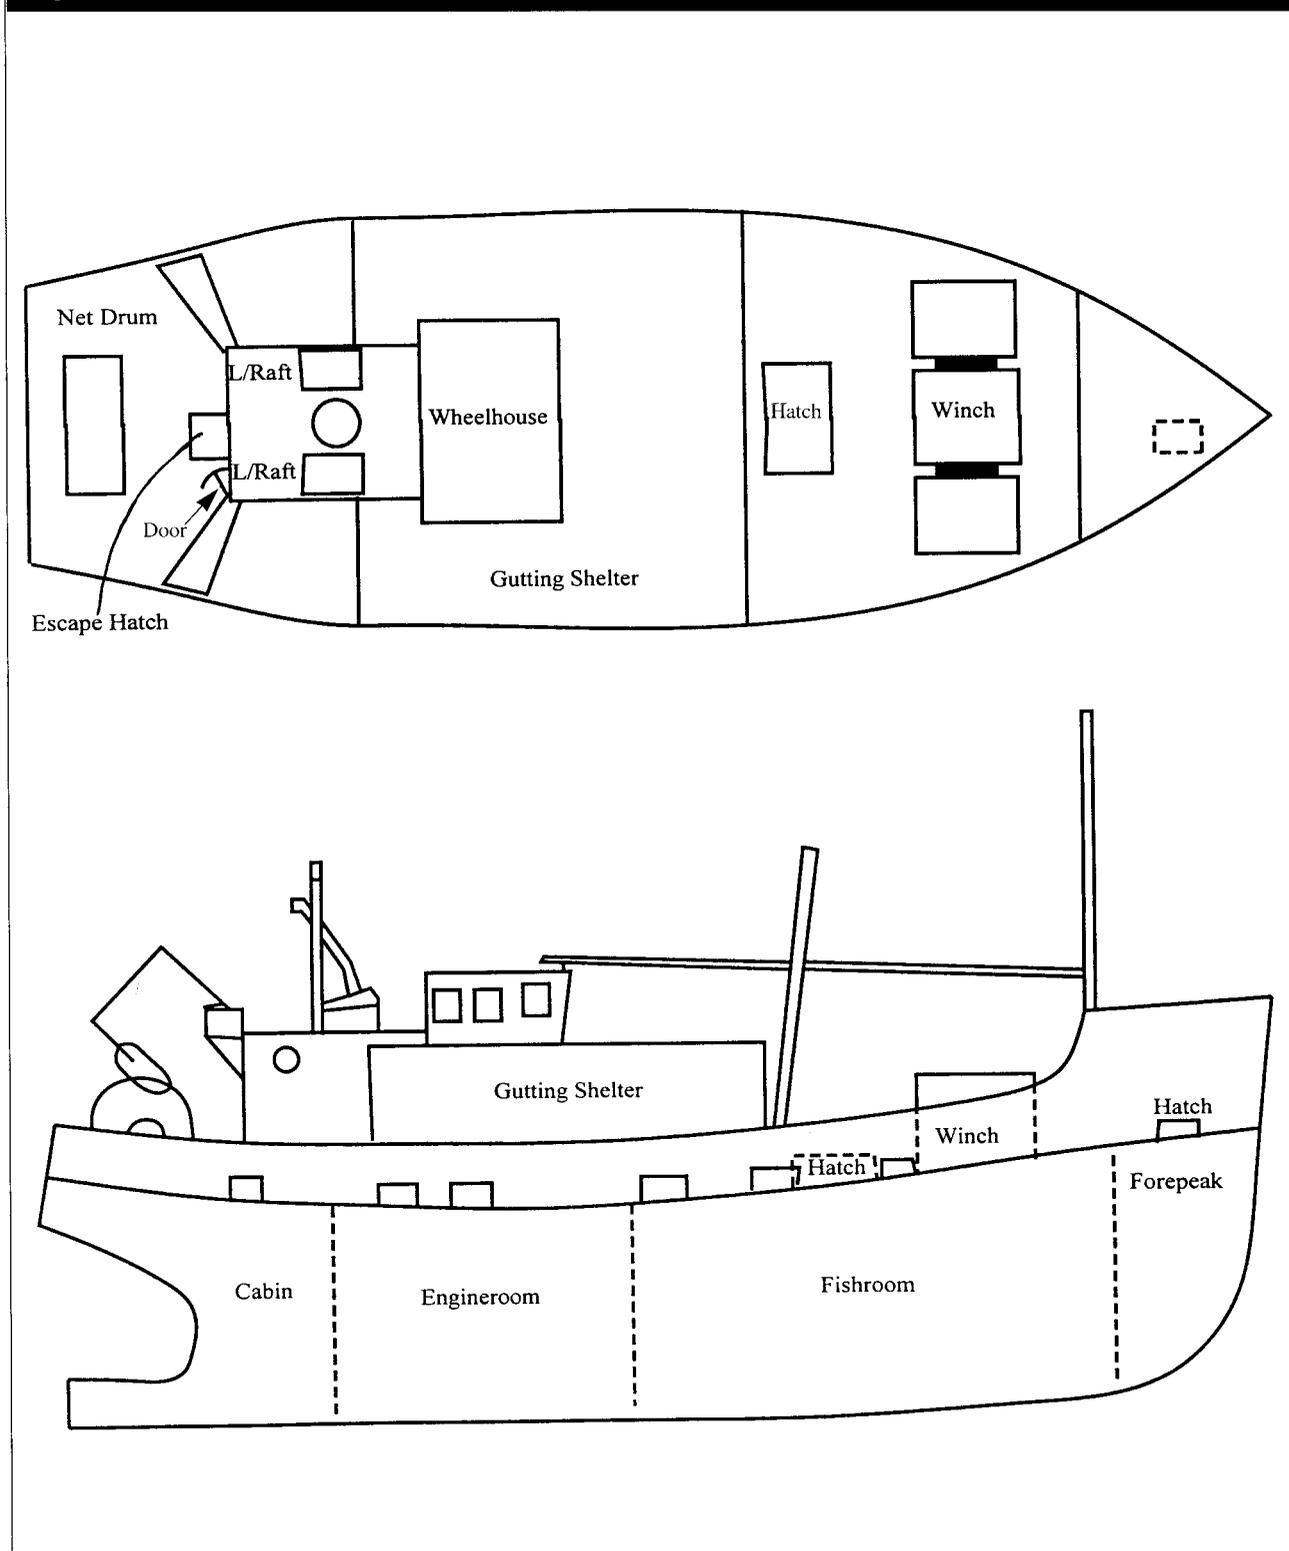
Figure 3: General layout: plan and profile

A sketch of her general layout is shown in FIGURE 3.

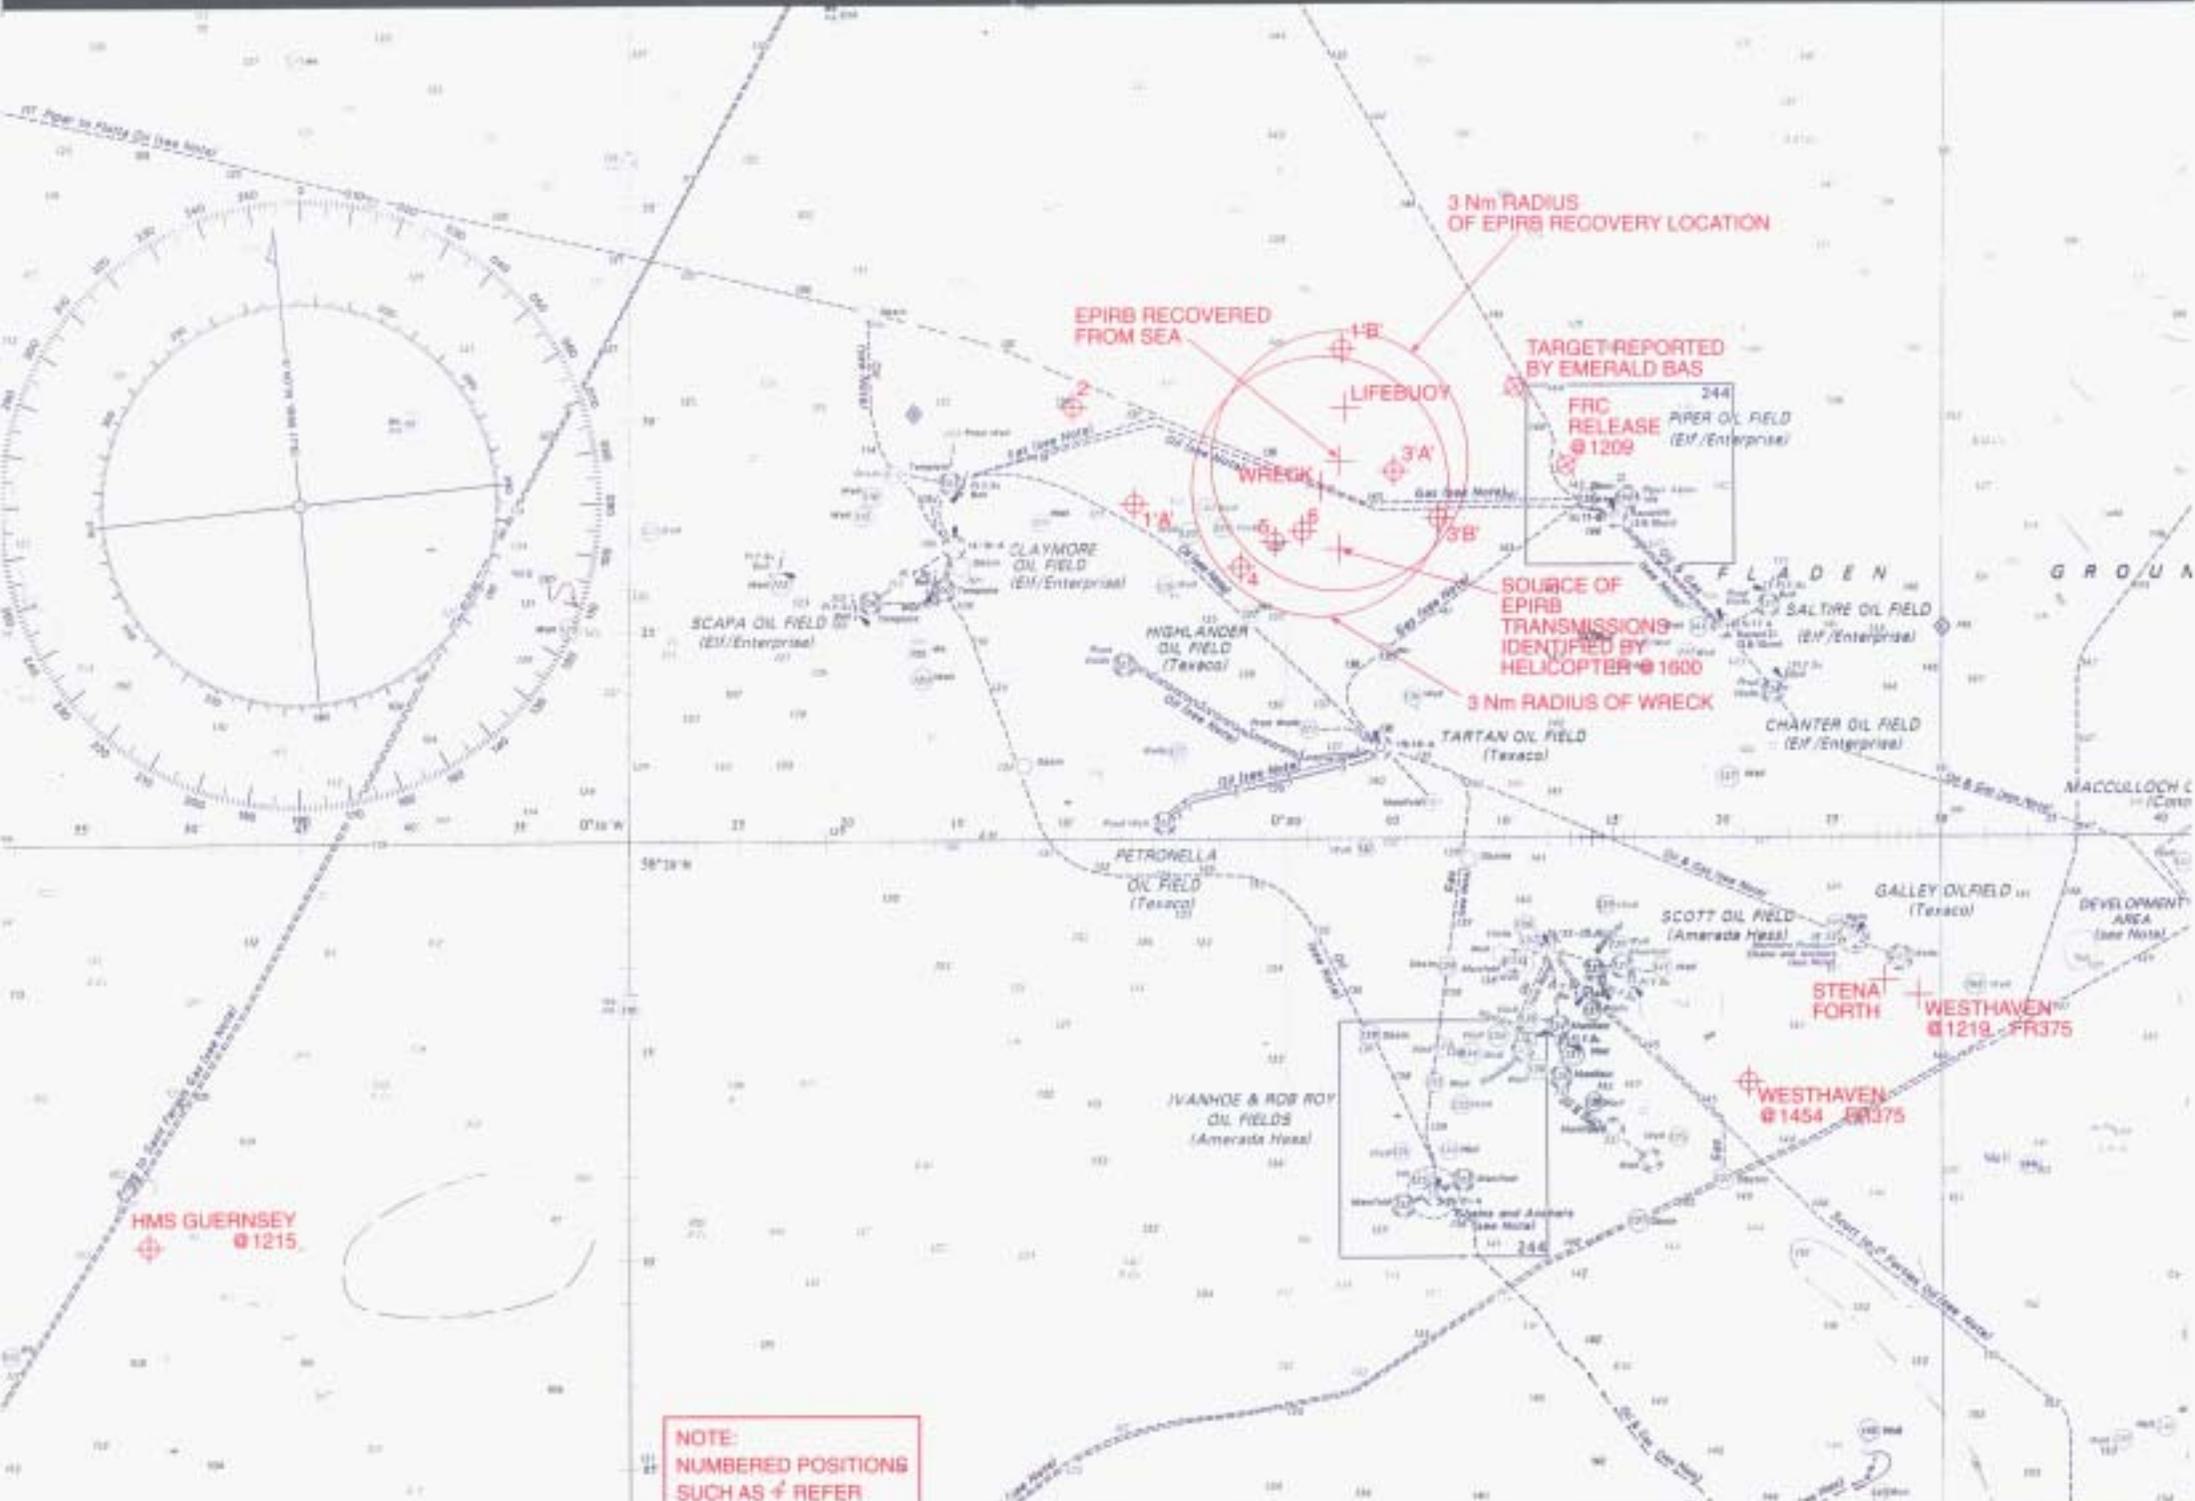
Part of the area in which WESTHAVEN AH 190 was lost (including location of early EPIRB hits)

An extract from the Admiralty chart covering the area of interest is shown in FIGURE 4. Also plotted on this chart are the positions of the Emergency Position-Indicating Radio Beacon (EPIRB) hits received by the MRCC Aberdeen between 1124 and 1551 (when the MAYDAY was re-initiated) on 10 March, and the positions of significant vessels.

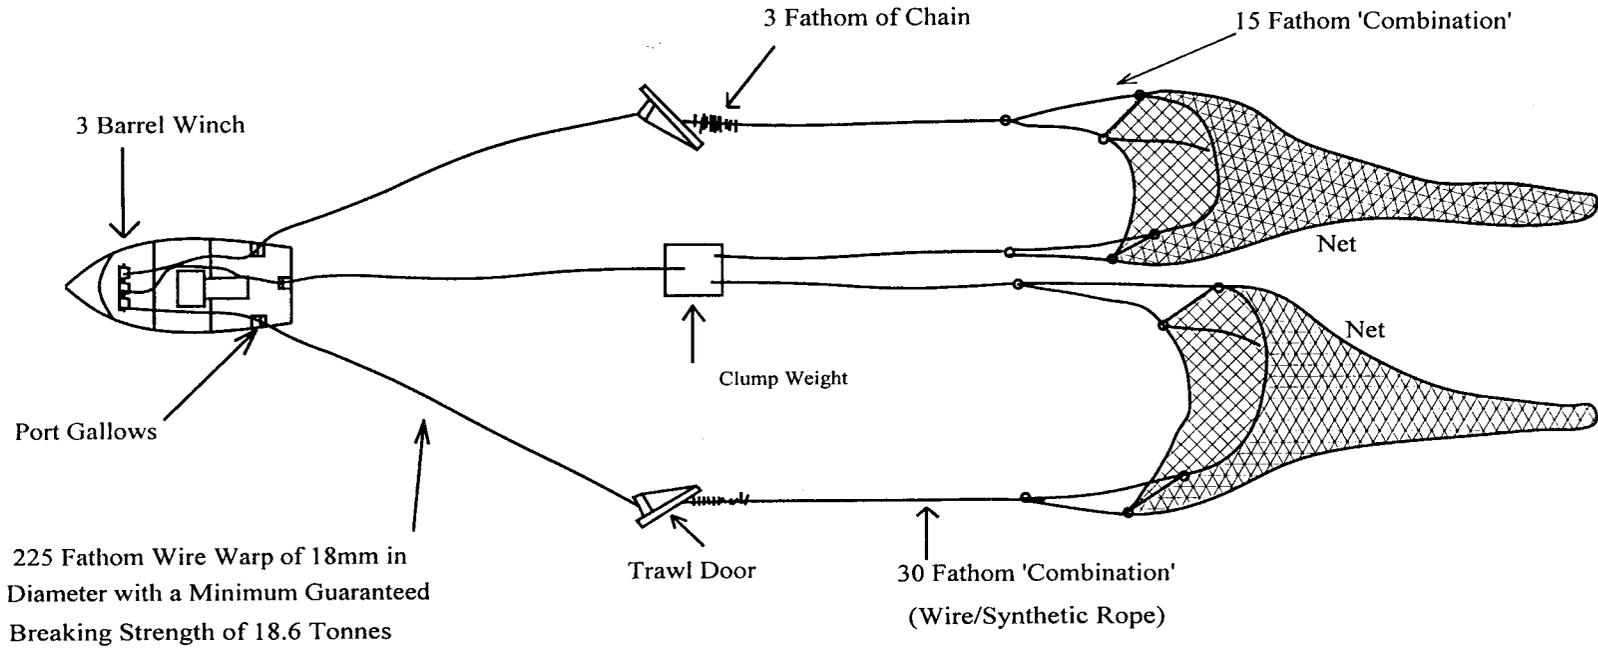
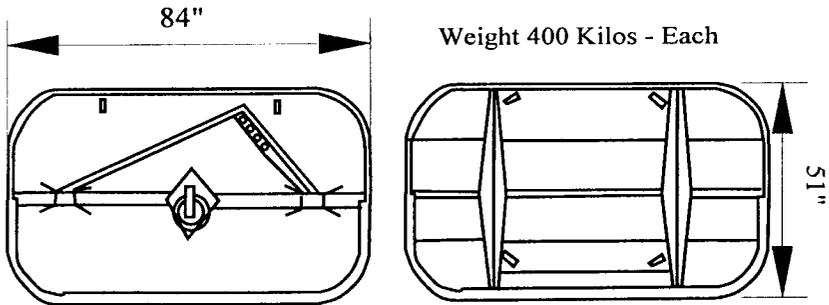
Figure 5: A Diagram of the Fishing Gear Layout

The mode of fishing being pursued by WESTHAVEN is commonly known as twin rig trawling. As the name implies, the vessel would be towing two trawl nets when fishing. A diagram of the arrangement of the trawl gear on WESTHAVEN is shown in FIGURE 5, together with an inset giving the dimensions of one of the trawl doors.

The twin rig gear in use by WESTHAVEN was connected to the vessel by three warps: one each running through the port and starboard gallows and the third through a centre block (see Figure 5). The underwater video shows that the clump weight between the two nets, which was connected to the central warp, had been recovered and was hanging off the aft deck, between the transom and the net drums. It is believed the starboard trawl door had also been recovered and was hanging at the starboard gallows. This last assumption could not be confirmed as the gallows was buried in silt and hidden from the underwater camera.

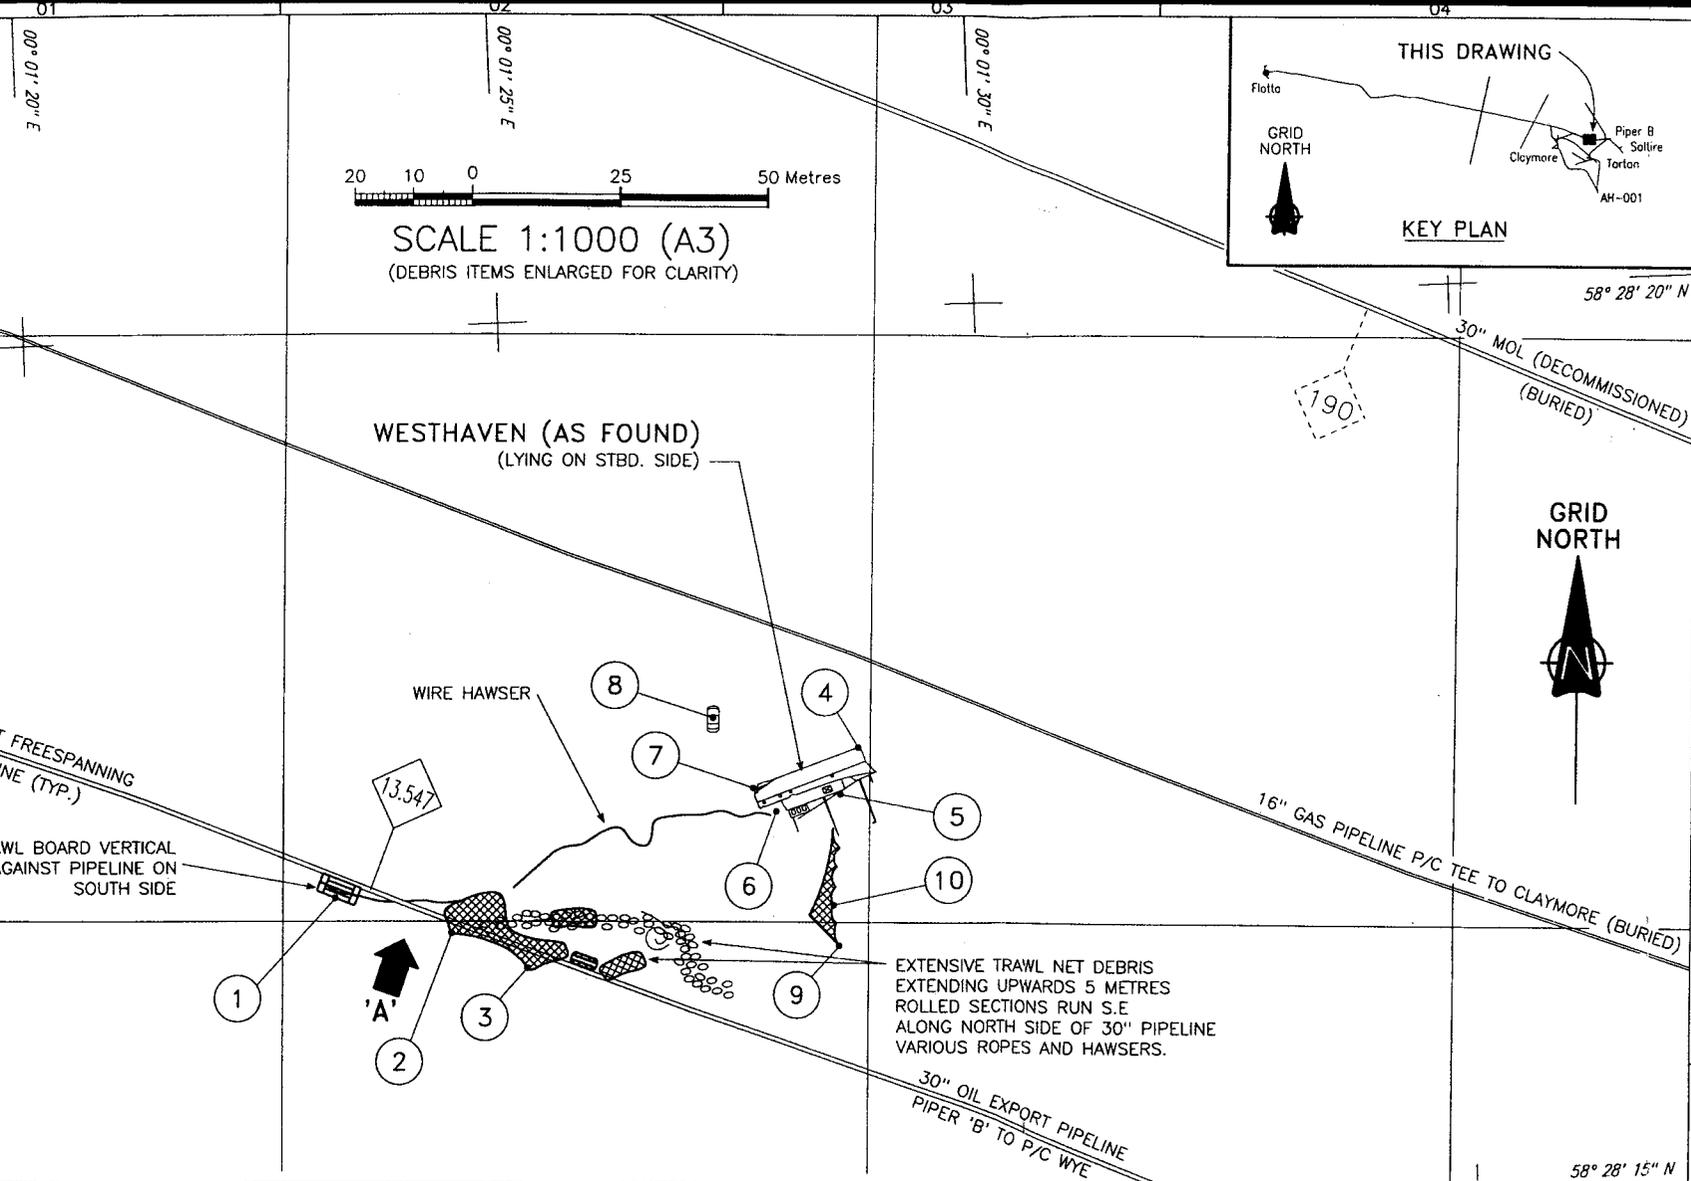
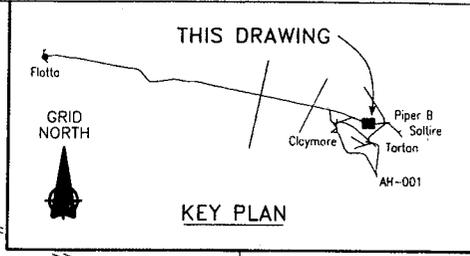
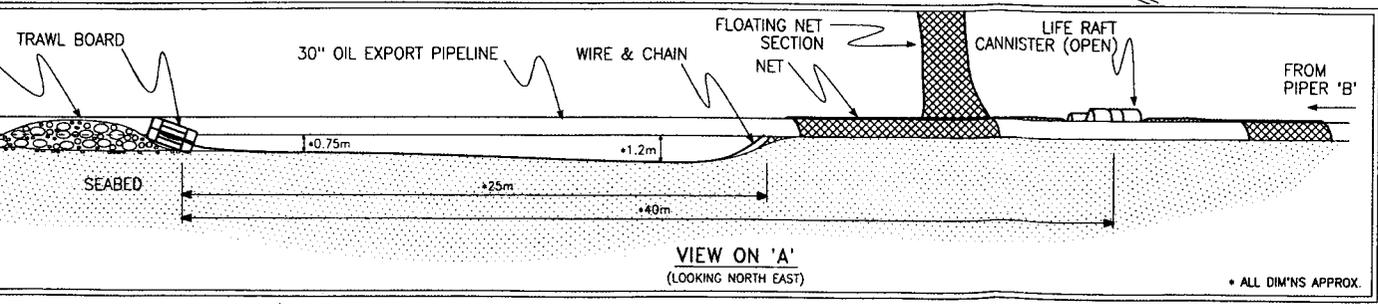
Large scale chart of the area around the wreck of WESTHAVEN

A large scale chart of the area around the wreck of WESTHAVEN is shown in FIGURE 6. This was produced on behalf of Elf Exploration UK PLC and is reproduced here with Elf's kind permission.

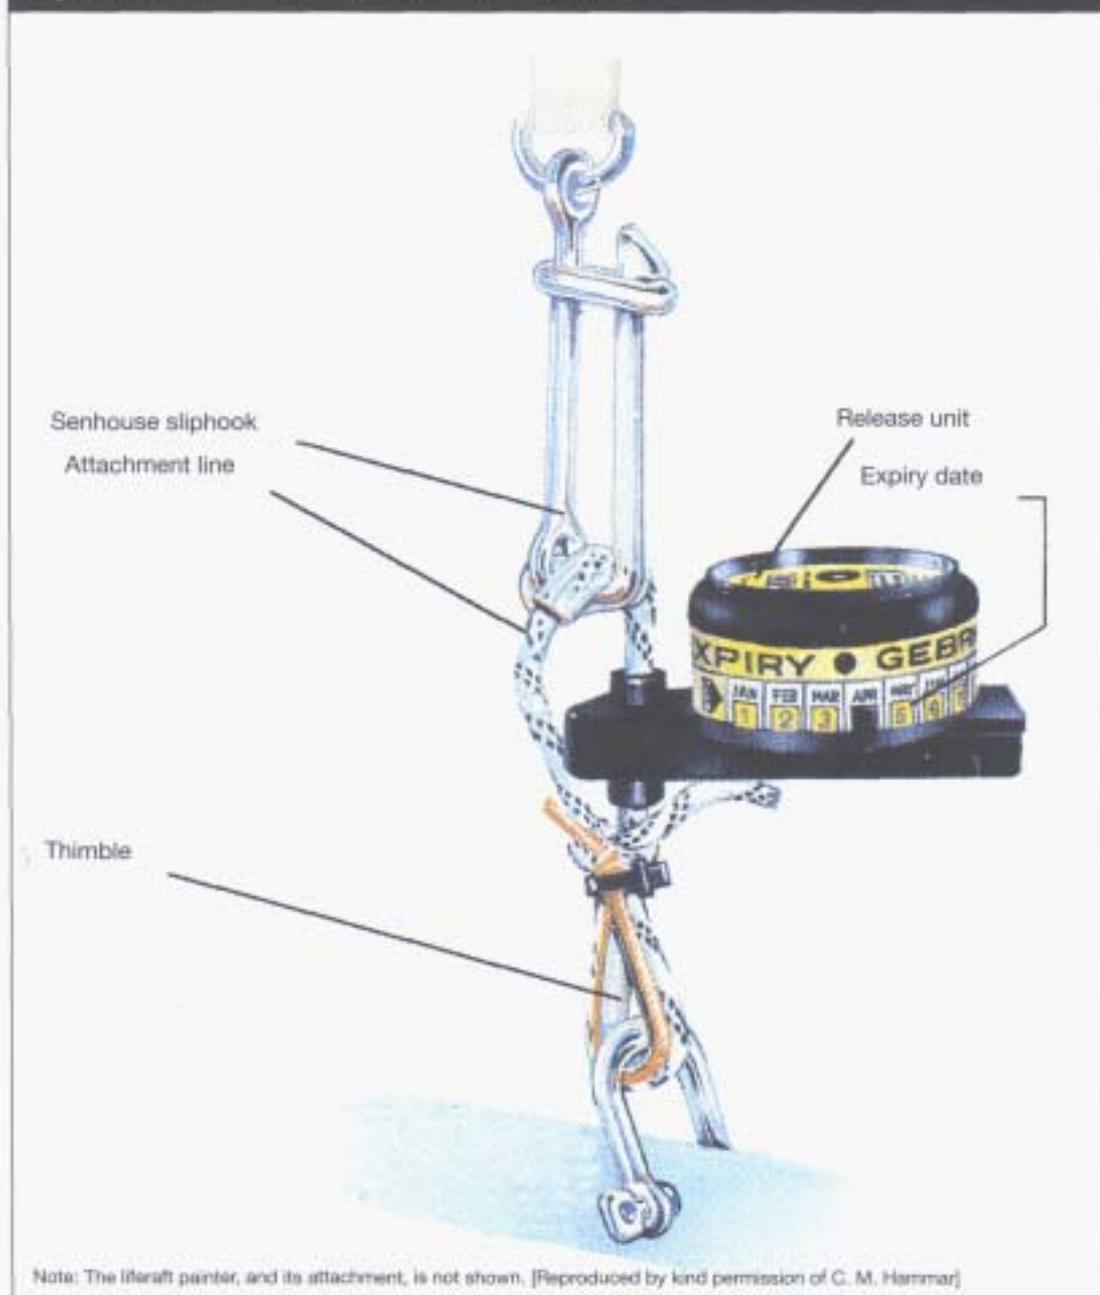
Figure 13: Hammar H20 hydrostatic release unit

WESTHAVEN's liferaft containers were secured to their cradles in the manner shown in FIGURE 13. They could have been released in one of two ways; manually by the opening of

the senhouse slip, or automatically by the operation of the HAMMAR H20 hydrostatic release unit (HRU) at a depth of between 1.5 and 4.0m.

Due to the suddenness with which WESTHAVEN capsized there would have been insufficient time to release the containers manually. Following their automatic release as the vessel sank, the buoyant containers should have risen rapidly to the surface. Since the ends of each liferaft's painter were attached to the vessel, they would have been drawn out of their containers as they rose through the water. Eventually the full length of the painters would have been reached and come taut to trigger the inflation mechanisms of the liferafts. As the liferafts expanded under the pressure of the inflation gases the containers would burst open and drop away. Once the liferafts had inflated fully, the weak links by which the painters should have been connected to the vessel are designed to part. The sequence of events described in this paragraph is well illustrated in the manufacturer's advertising literature, a copy of which is shown in FIGURE 14.

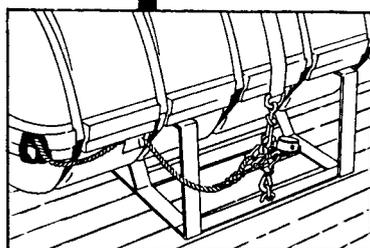
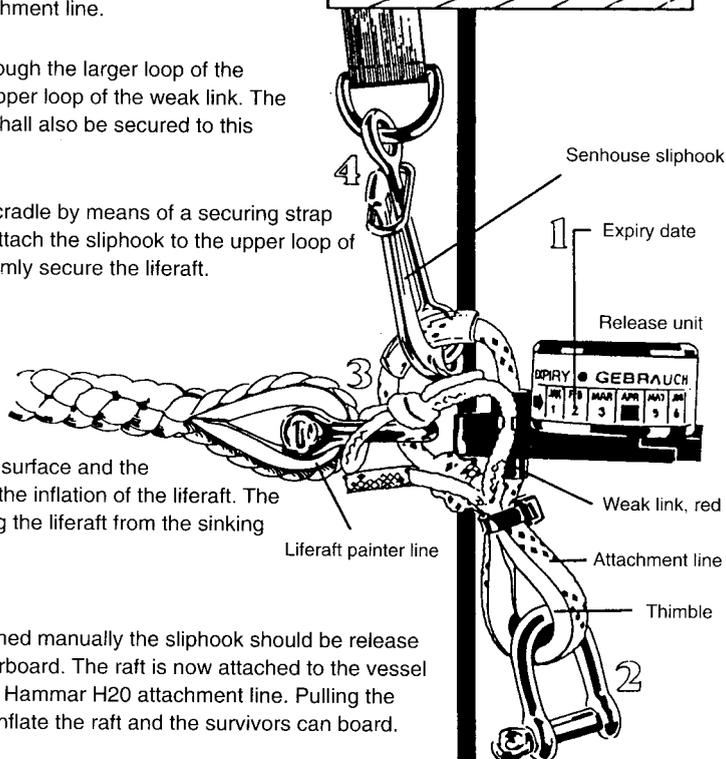
Figure 16: Hammar H20 Notice

The literature supplied with a new HAMMAR H20 HRU is accurate, clear and sufficient to enable any literate adult to install it correctly. The instructions are reproduced in FIGURE 16. Such instructions are normally readily to hand when the liferafts are first installed but are less likely to be available when the painter has to be re-connected at some later date. It is then that errors are likely to occur. A competition run by the MSA at the Fishing Exhibition in Aberdeen in 1997 revealed that only about 20% of contestants were able to rig the unit correctly.

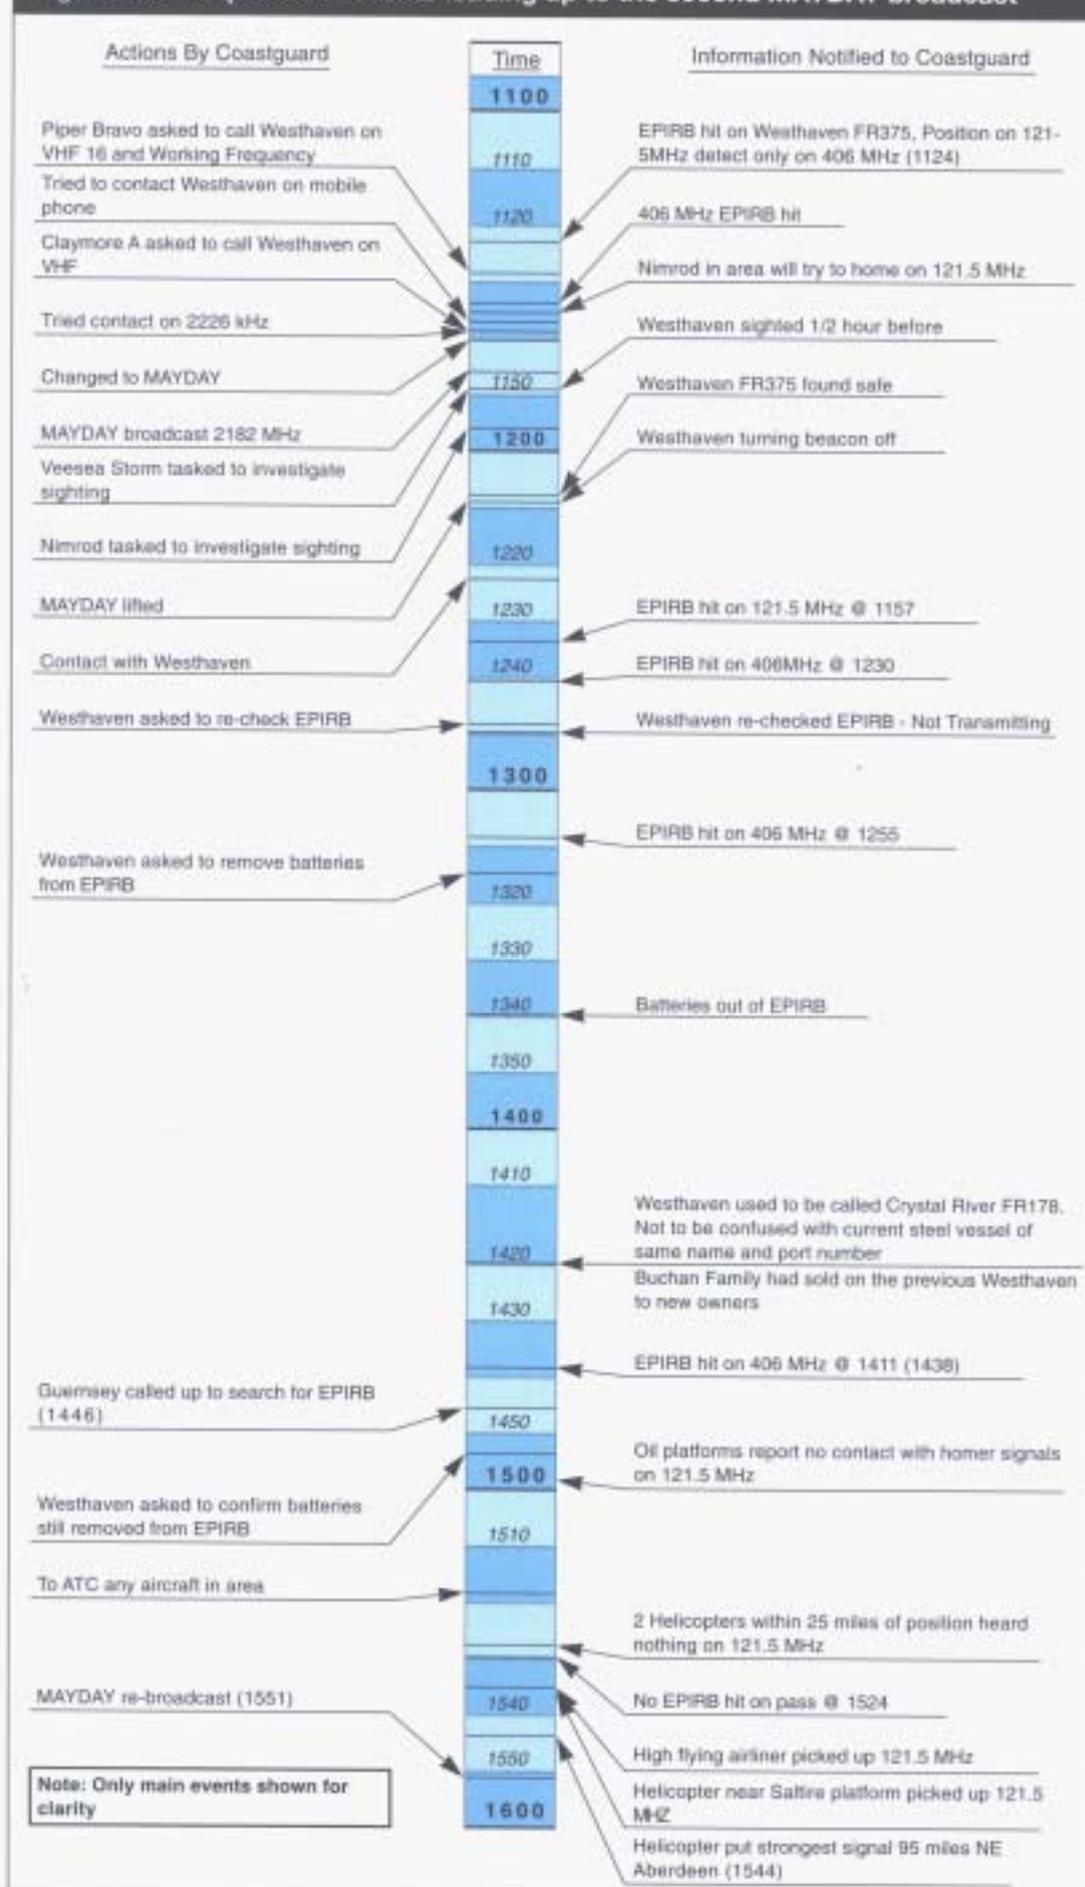
Figure 18a: Sequence of events leading up to the second MAYDAY broadcast

At 1551 the MAYDAY was re-broadcast, following a re-appraisal by MRCC that they were, after all, dealing with a true emergency. A high flying air liner, and a helicopter near the SALTIRE platform, both reporting that 121.5 MHz signals had been picked up, probably influenced this decision. The history of events leading up to the transmission of the second MAYDAY is summarised in FIGURE 18A.

No attempt is made to speculate on how quickly the MRCC might have registered they were handling a real emergency and not a false alarm. The watch officers at MRCC Aberdeen had been given erroneous information on the EPIRB registration. About two hours elapsed before they seriously questioned its validity, and a further one hour elapsed before they decided to re-broadcast the MAYDAY. The circumstances in this case were so unusual and of such a remote possibility that it could not reasonably have been anticipated. The investigation is satisfied that the senior watch officers on duty during this emergency acted to the best of their ability.

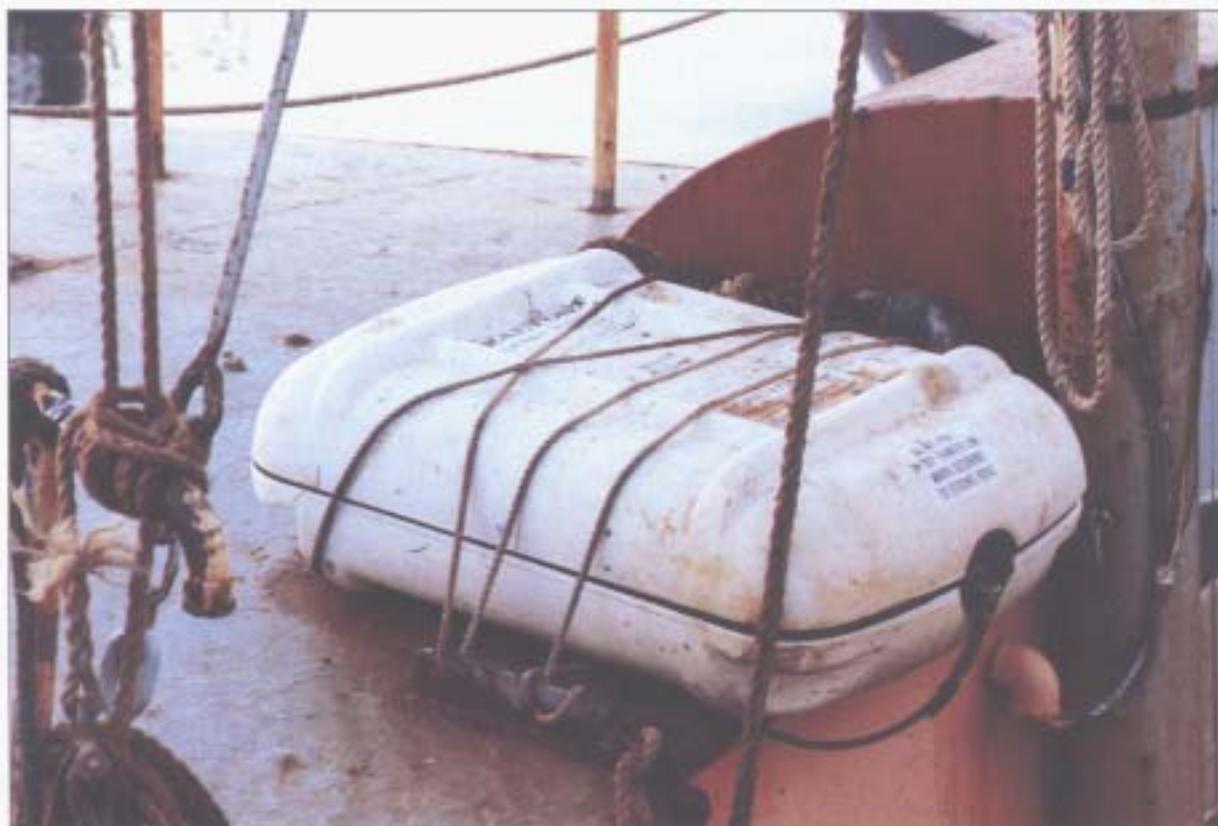
Figure 3

4. Advice on the stowage of liferafts is contained in Merchant Shipping Notice No M.1400.
5. An independent sighting of 23 inflatable liferaft containers, on various types of small vessels, revealed that only two containers were correctly installed. Some of the more common errors of installation are shown in Figures 3, 4, 5 and 6.
