Report on the investigation of the fatality
of a rescue boat crewman on board

Tombarra

at Berth 3, Royal Portbury Docks,

Part A - The failure of the fall wire

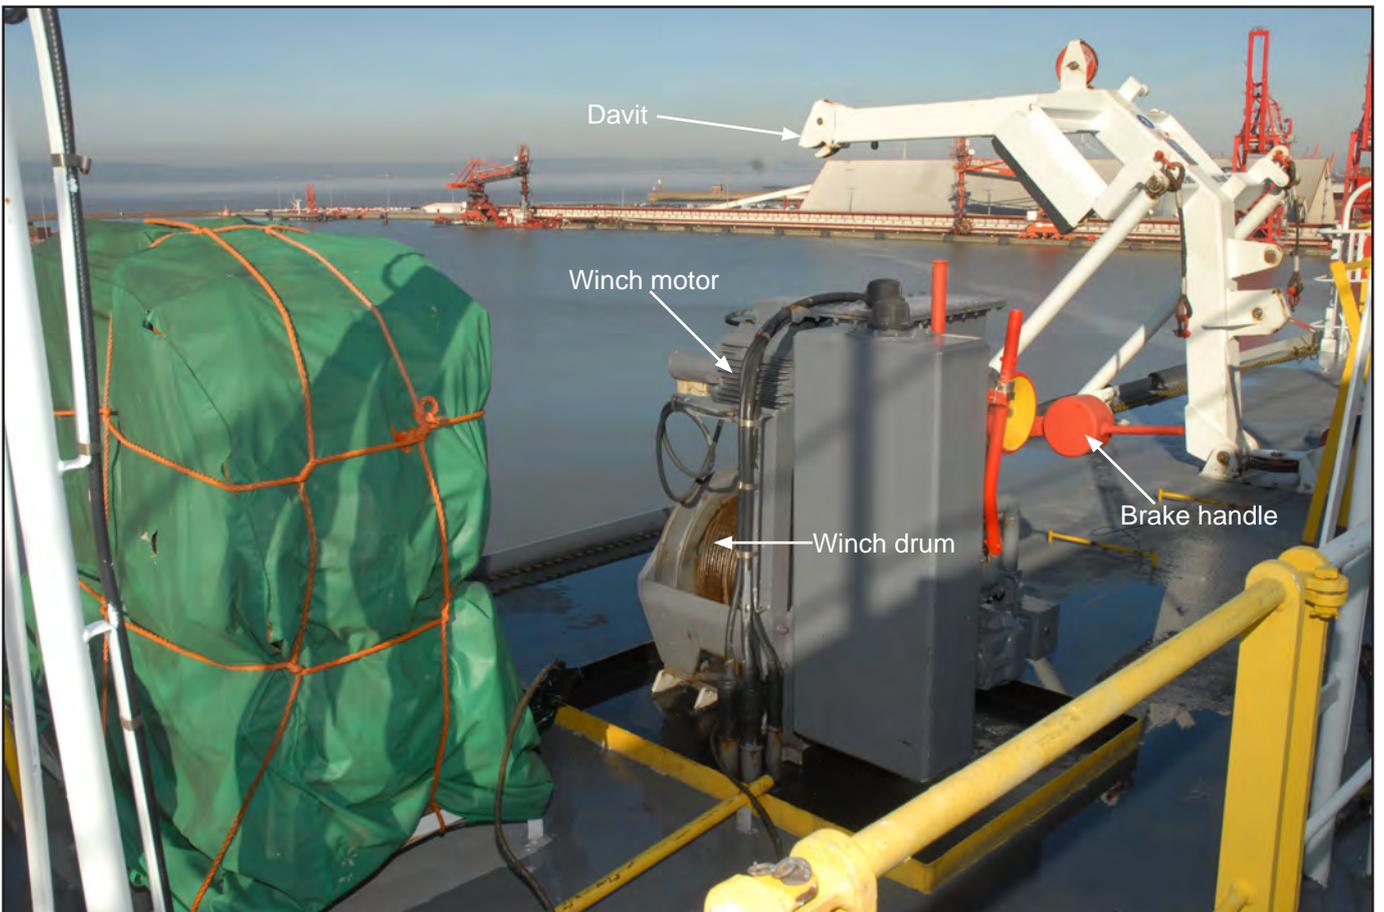
Figure 3: Davit winch arrangement

The winch was sited aft of the davit and comprised: a drum and integrated gearbox, a lowering brake system, a secondary gearbox, a stopping/holding brake, a two-speed electric motor and a hydraulic brake release system (**Figure 3**). A proximity switch was installed on the winch adjacent to the manual winch handle to prevent the motor from operating and causing injury to the crew once the winch handle was fitted.

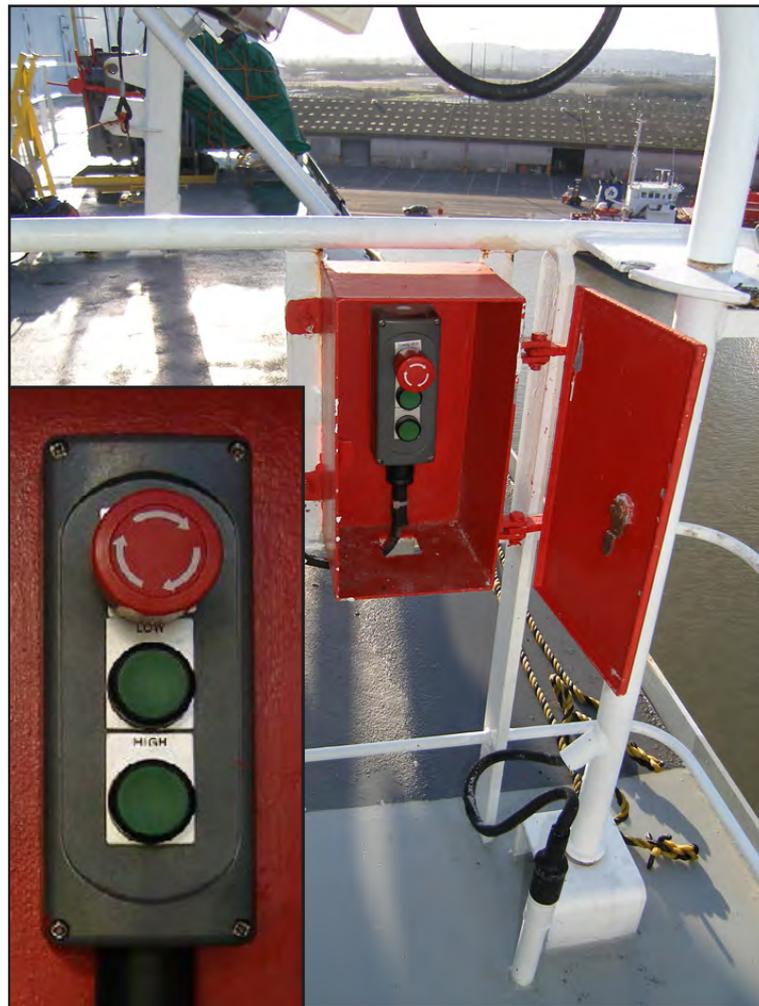
Figure 4: Winch control box

The electric motor was operated by high and low speed buttons located in a control box at the deck edge forward of the davit to allow the operator to monitor the hoisting operation. An emergency stop button was also sited in the control box (**Figure 4**).

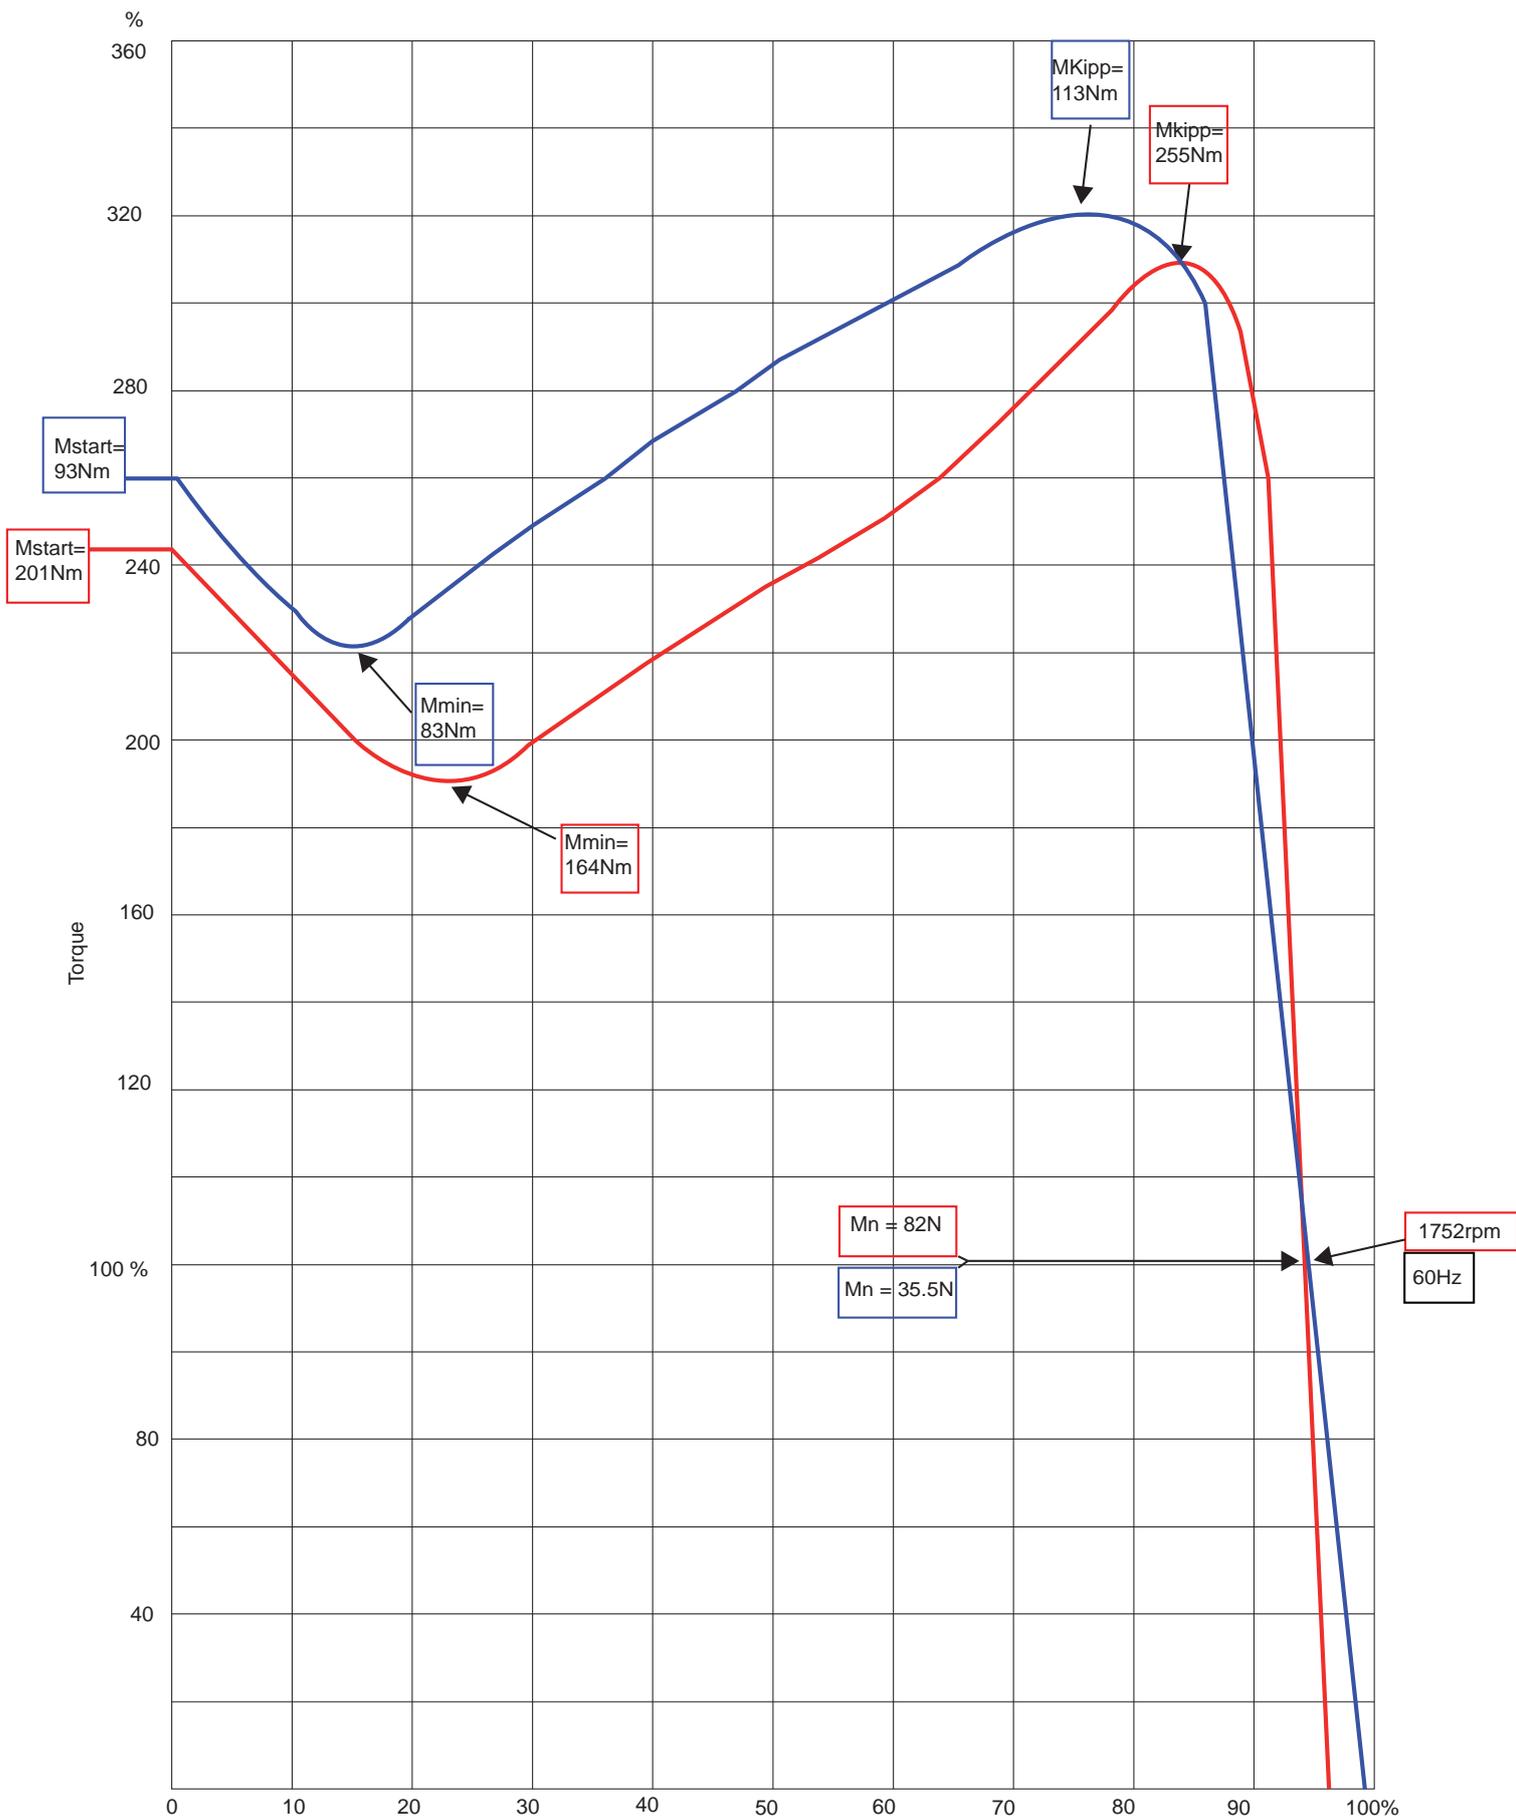
Figure 11: Motor type 7BA 160L 21 and Motor Type 7BA 132M21 speed/torque curves

The speed torque curves for the 7BA160L21 (15/20kW) and the 7BA132M21 (6.5/11kW) motors are shown in **Figure 11**. The performance of the two motors when operating at low speed (high torque) is shown in **Table 2**.

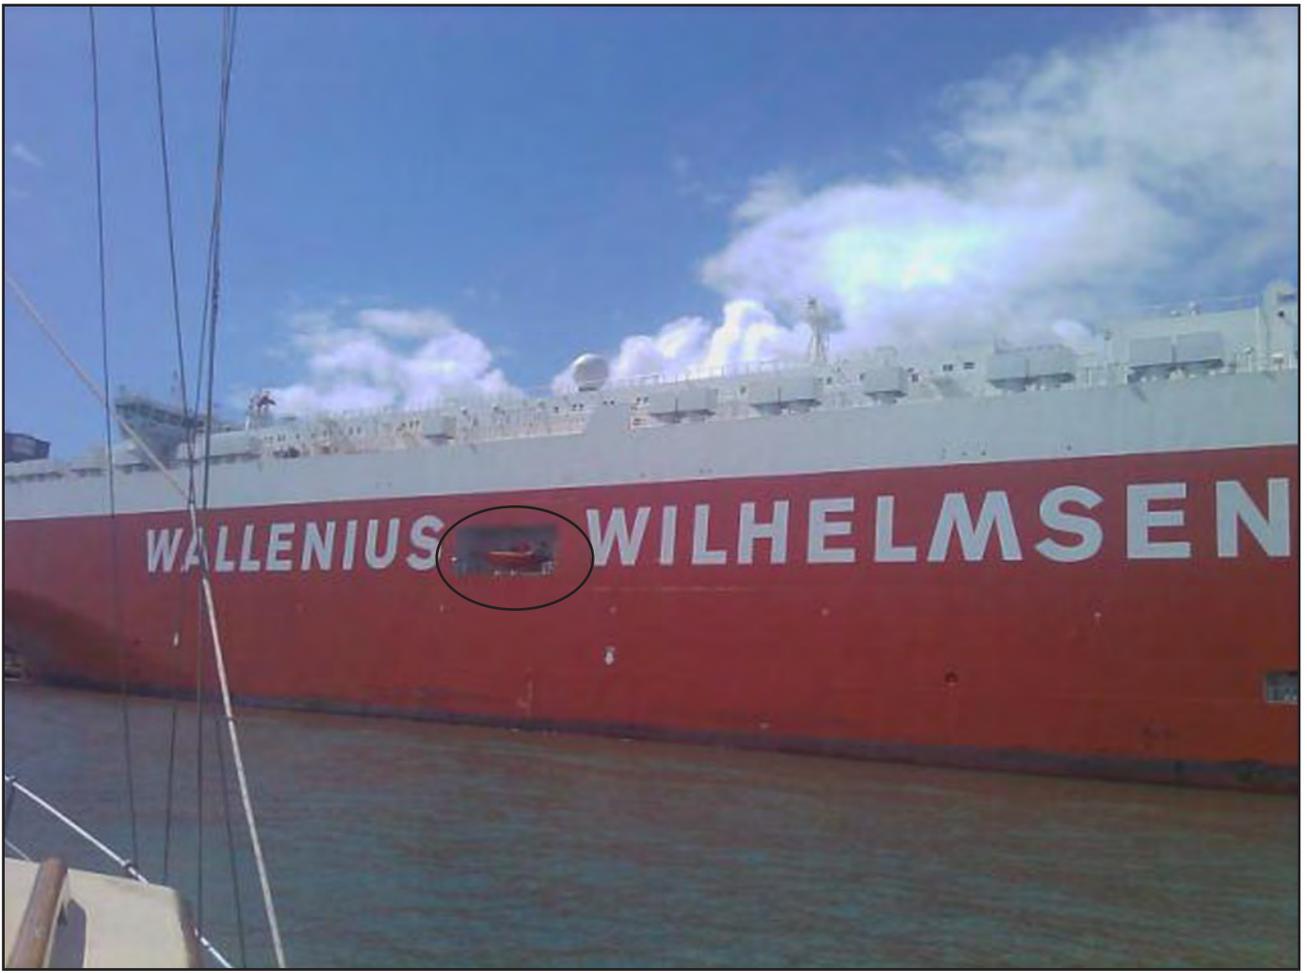
Figure 14: Rescue boat located below the upper deck on a different series of car carrier also operated by Wilhelmsen

The retrofitting of rescue boats to all vessels prior to 2000 was in some cases constrained by vessel design to site the craft on high weather decks. However, there are few practical reasons why the design of new high freeboard vessels cannot be modified in order to position the stowage of rescue boats and survival craft closer to the waterline (**Figure 14**).

Although the positioning of rescue boats and survival craft on vessels with a high freeboard, such as car carriers, adversely affects their cargo capacity to some degree, the cost is relatively insignificant compared to the obvious safety benefits to be gained. However, as long as the height of a davit head is left to the discretion of ship owners, many are unlikely to fully heed the IMO's advice, particularly when this advice is only directed towards passenger vessels. It is only when a maximum height of a davit head is mandated for all vessel types that the disadvantages and dangers of operating rescue boats and survival craft from high-sided vessels will be significantly reduced.
