Disappearance and rescue of the small fishing boat

Water-rail

in the North Sea

20 - 22 May 2014

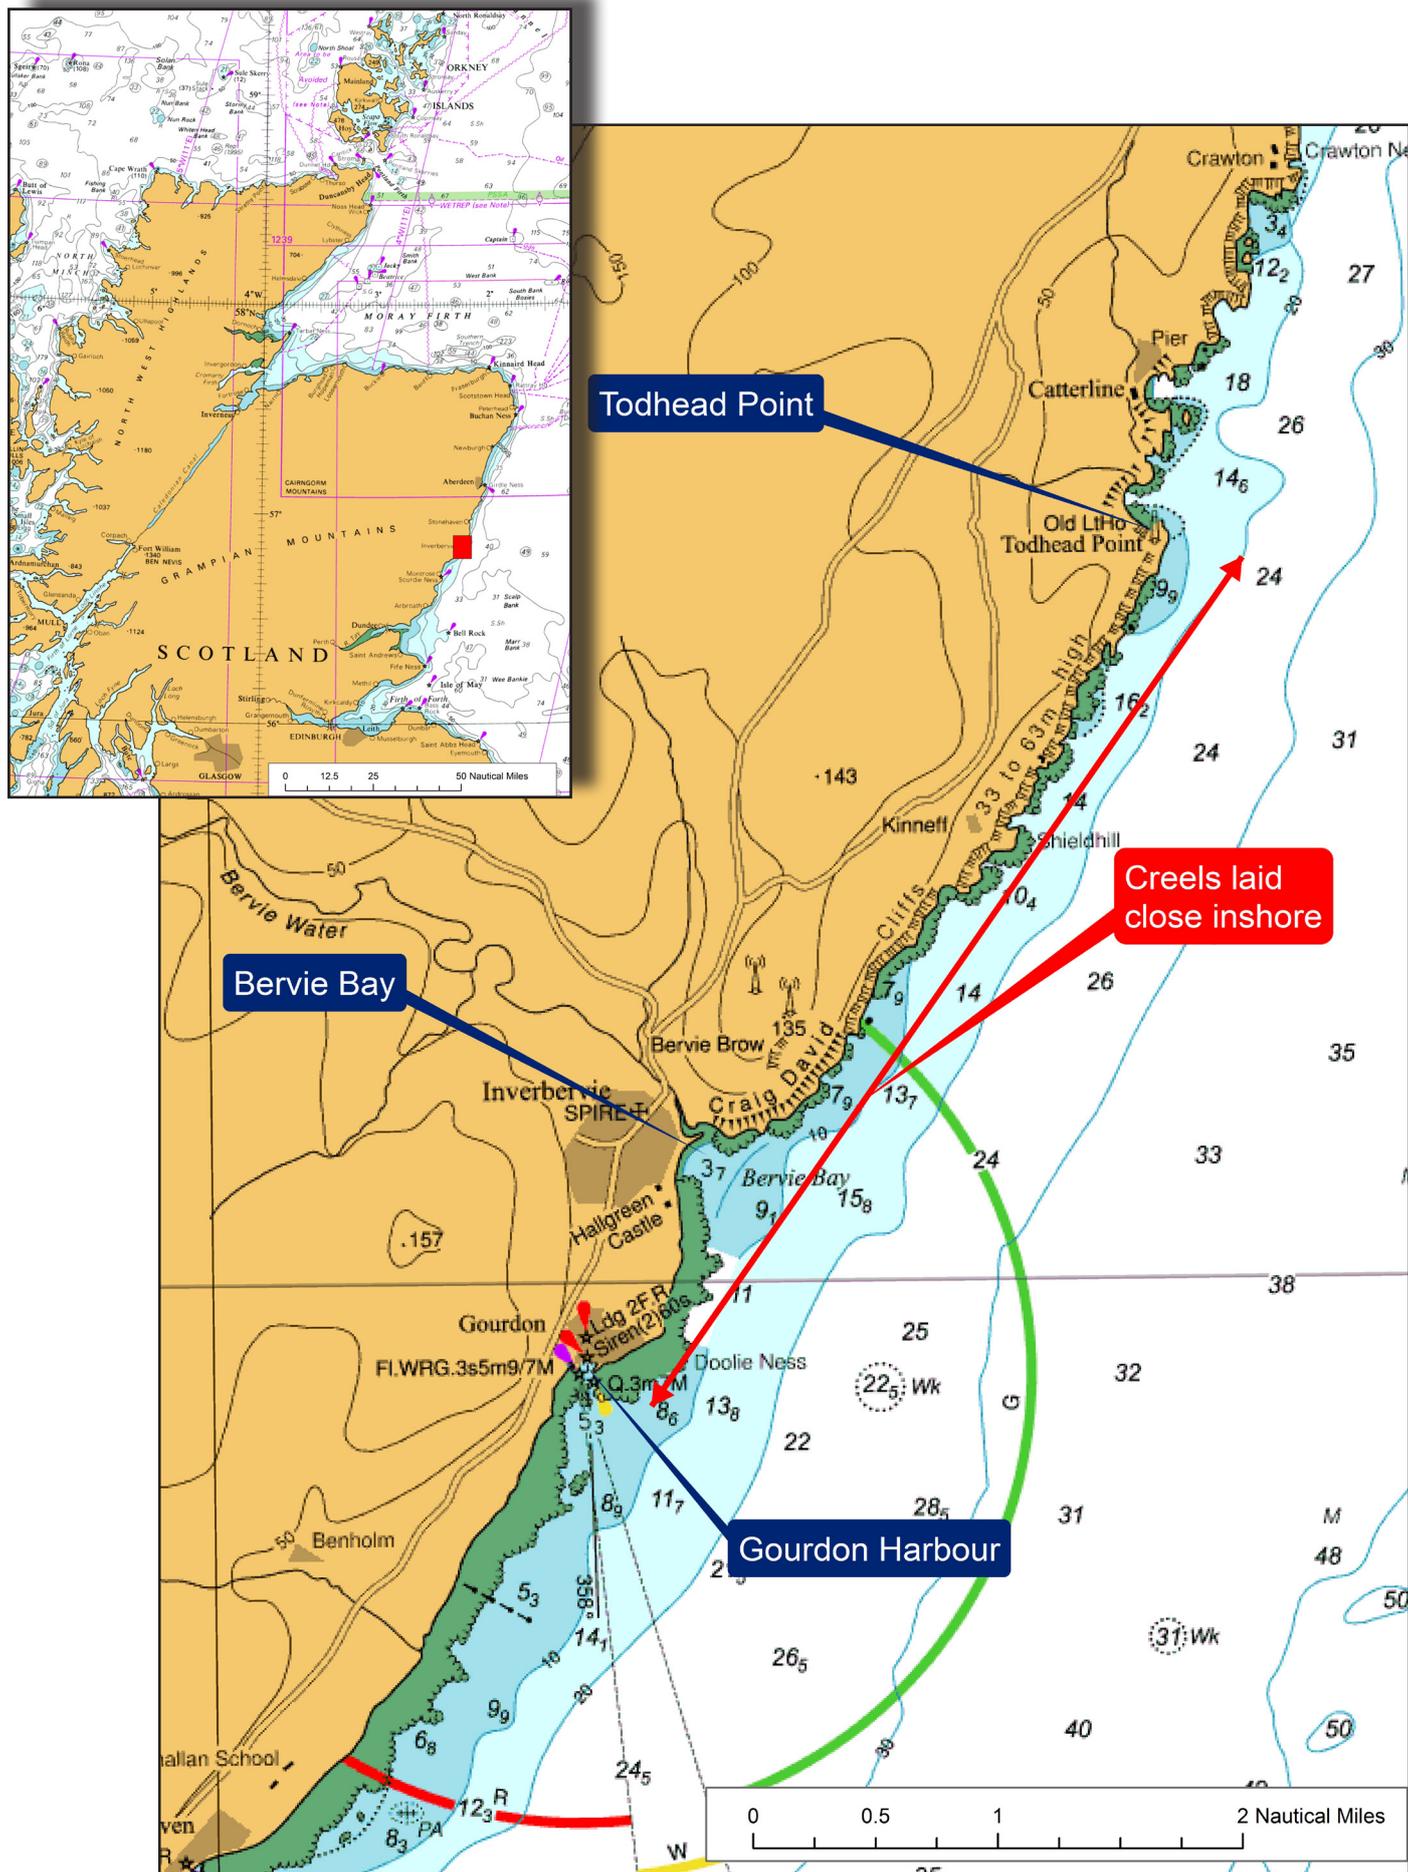
Figure 1: Gourdon Harbour to Todhead Point

Water-rail was a small open fishing boat which had been rigged to operate as a side-hauling creeler. The boat had been owned and operated by its skipper for over 10 years. The skipper tended his creels most days and took his grandson with him to help. They usually departed Gourdon Harbour at first light and returned about 1030. The skipper laid his creels on single lines along the coastline between Gourdon Harbour and Todhead Point, typically within 0.25 nautical miles (nm) of the shore (**Figure 1**).

Almost immediately, sight of land was lost. Unconcerned, the skipper continued out to sea with the intention of using his compass to cross Bervie Bay (**Figure 1**). Initially, he attempted to head north-west where he expected to sight land again within an hour. After 3 hours underway, the skipper became concerned about the situation as sight of land had not been regained. He then attempted to head west in order to find the shoreline, but after a further 4 hours underway, he felt completely disorientated. He had then lost faith in his compass and started to head in different directions in the hope of finding land.
