**Report of the Inspector's Inquiry
into Three Fatalities and Injuries
to Six Crew Members on board
fv ATLANTIC PRINCESS
on 25 July 1996
off the Coast of Mauritania, West Africa**

I have the honour to submit the report of Mr J Stuart Withington, a Principal Inspector of Marine Accidents, on the circumstances which led to the loss of three lives and injuries to six people on board the UK registered trawler ATLANTIC PRINCESS while fishing off the Mauritanian coast on 25 July 1996.

fv ATLANTIC PRINCESS

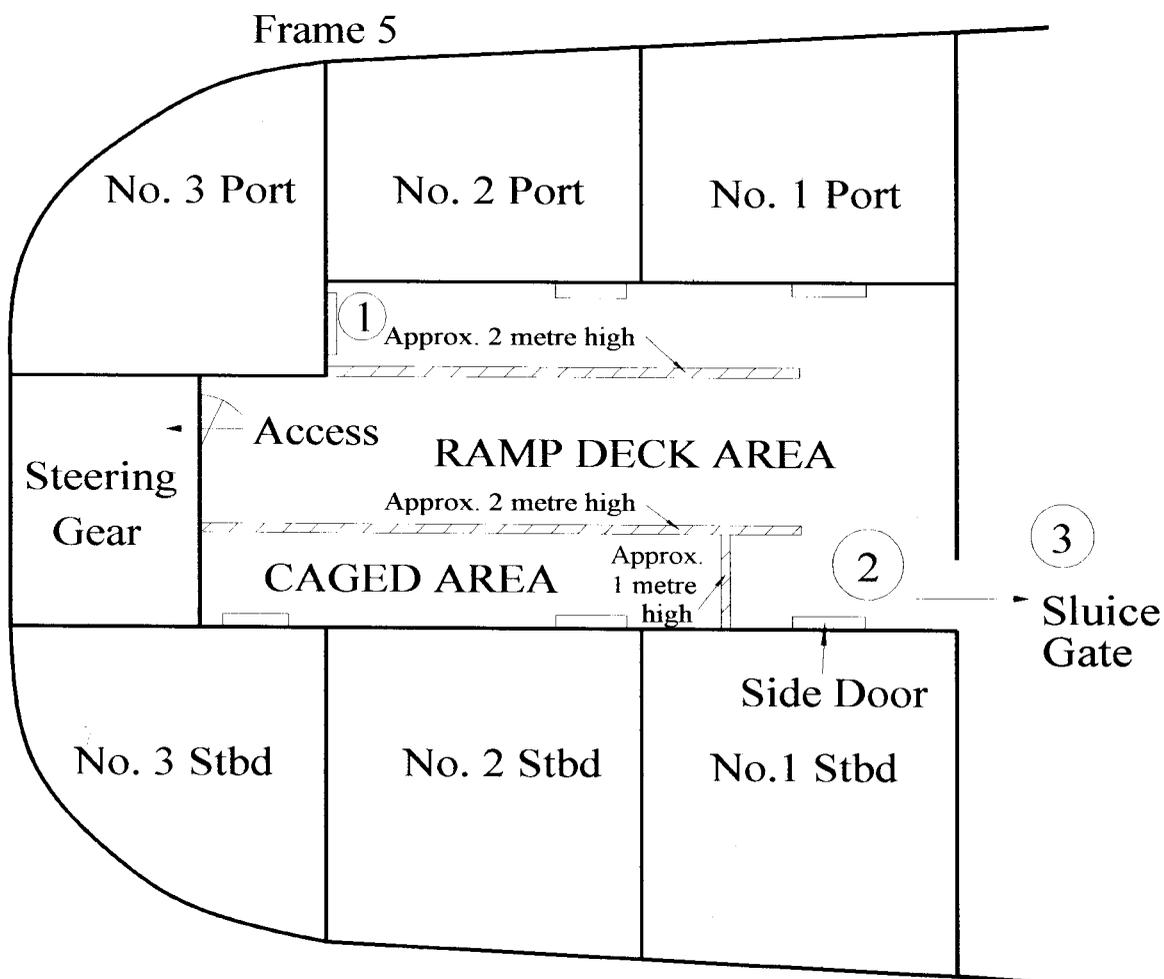
RAMP DECK AREA AND RSW TANKS
Not to Scale

The Third Engineer on the 1800 to 2400 watch, Mr Bruin, took over the pumping operation which was expected to take about 20 to 25 minutes. He left the engine room and proceeded to the upper deck before going down to the ramp deck. He climbed over the low side of the pound boards and into the caged area (Figure 4) where he opened the door to No 3 starboard RSW tank (Figure 5) to release what was described later as grey/black water.

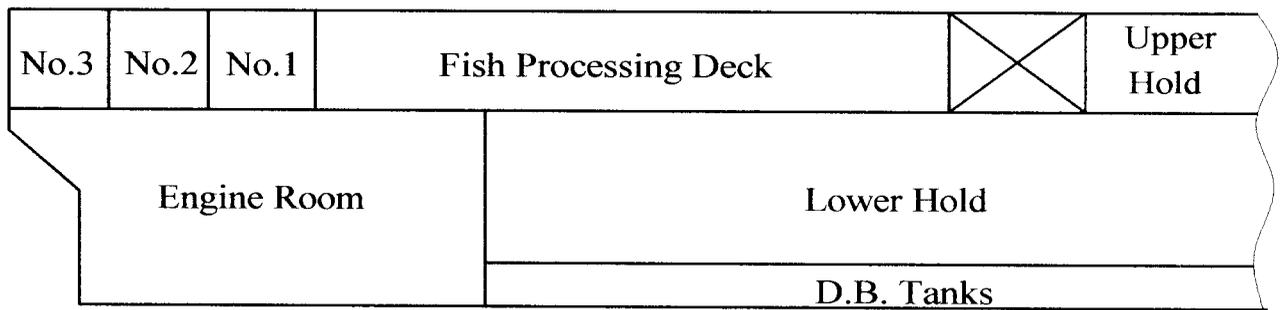
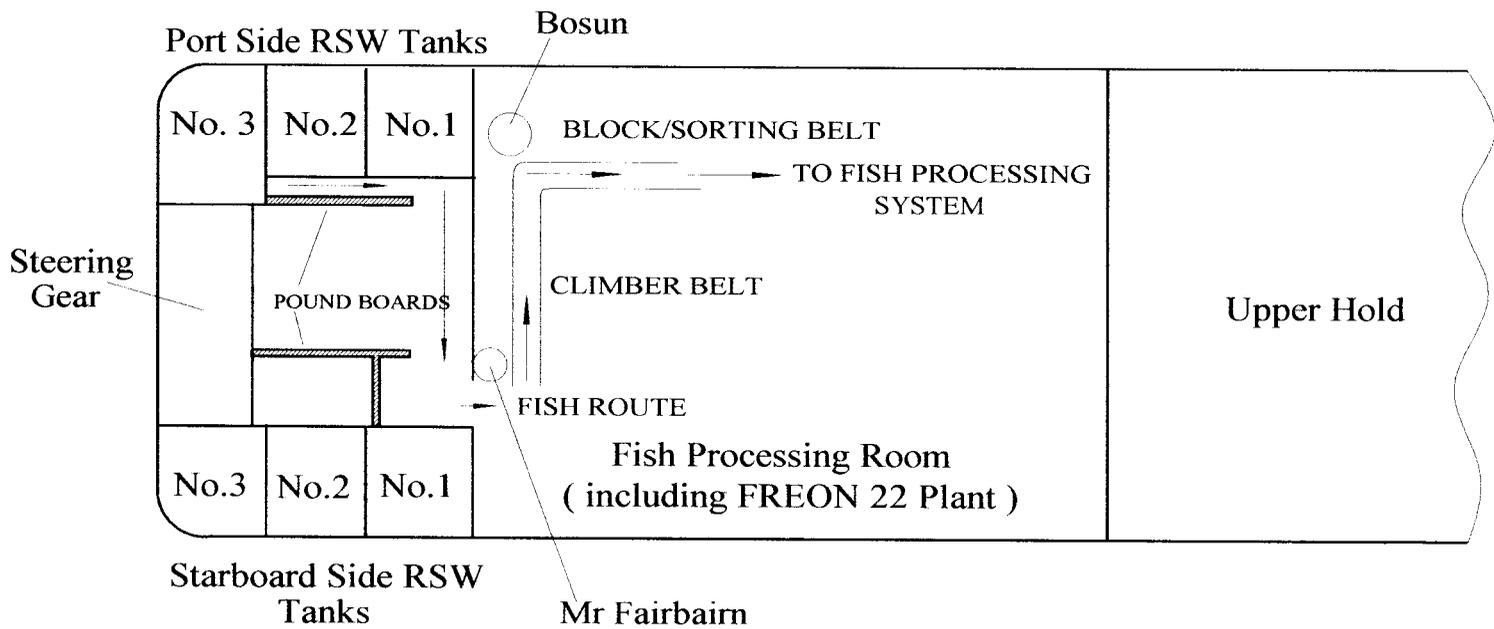
Figure 3

Small fish were being fed to the climber and block belts (see Figure 3), while larger fish were manhandled from the ramp deck to the top of the climber belt. On this occasion the third deckhand on the ramp deck, Mr Fairbairn, was passing them to the Bosun, Mr Hannath, who placed the fish onto the block belt.
