Report on the investigation of the
fire and subsequent foundering of
the passenger transfer catamaran

ECC Topaz

while conducting engine trials
off the east coast of England

14 January 2014

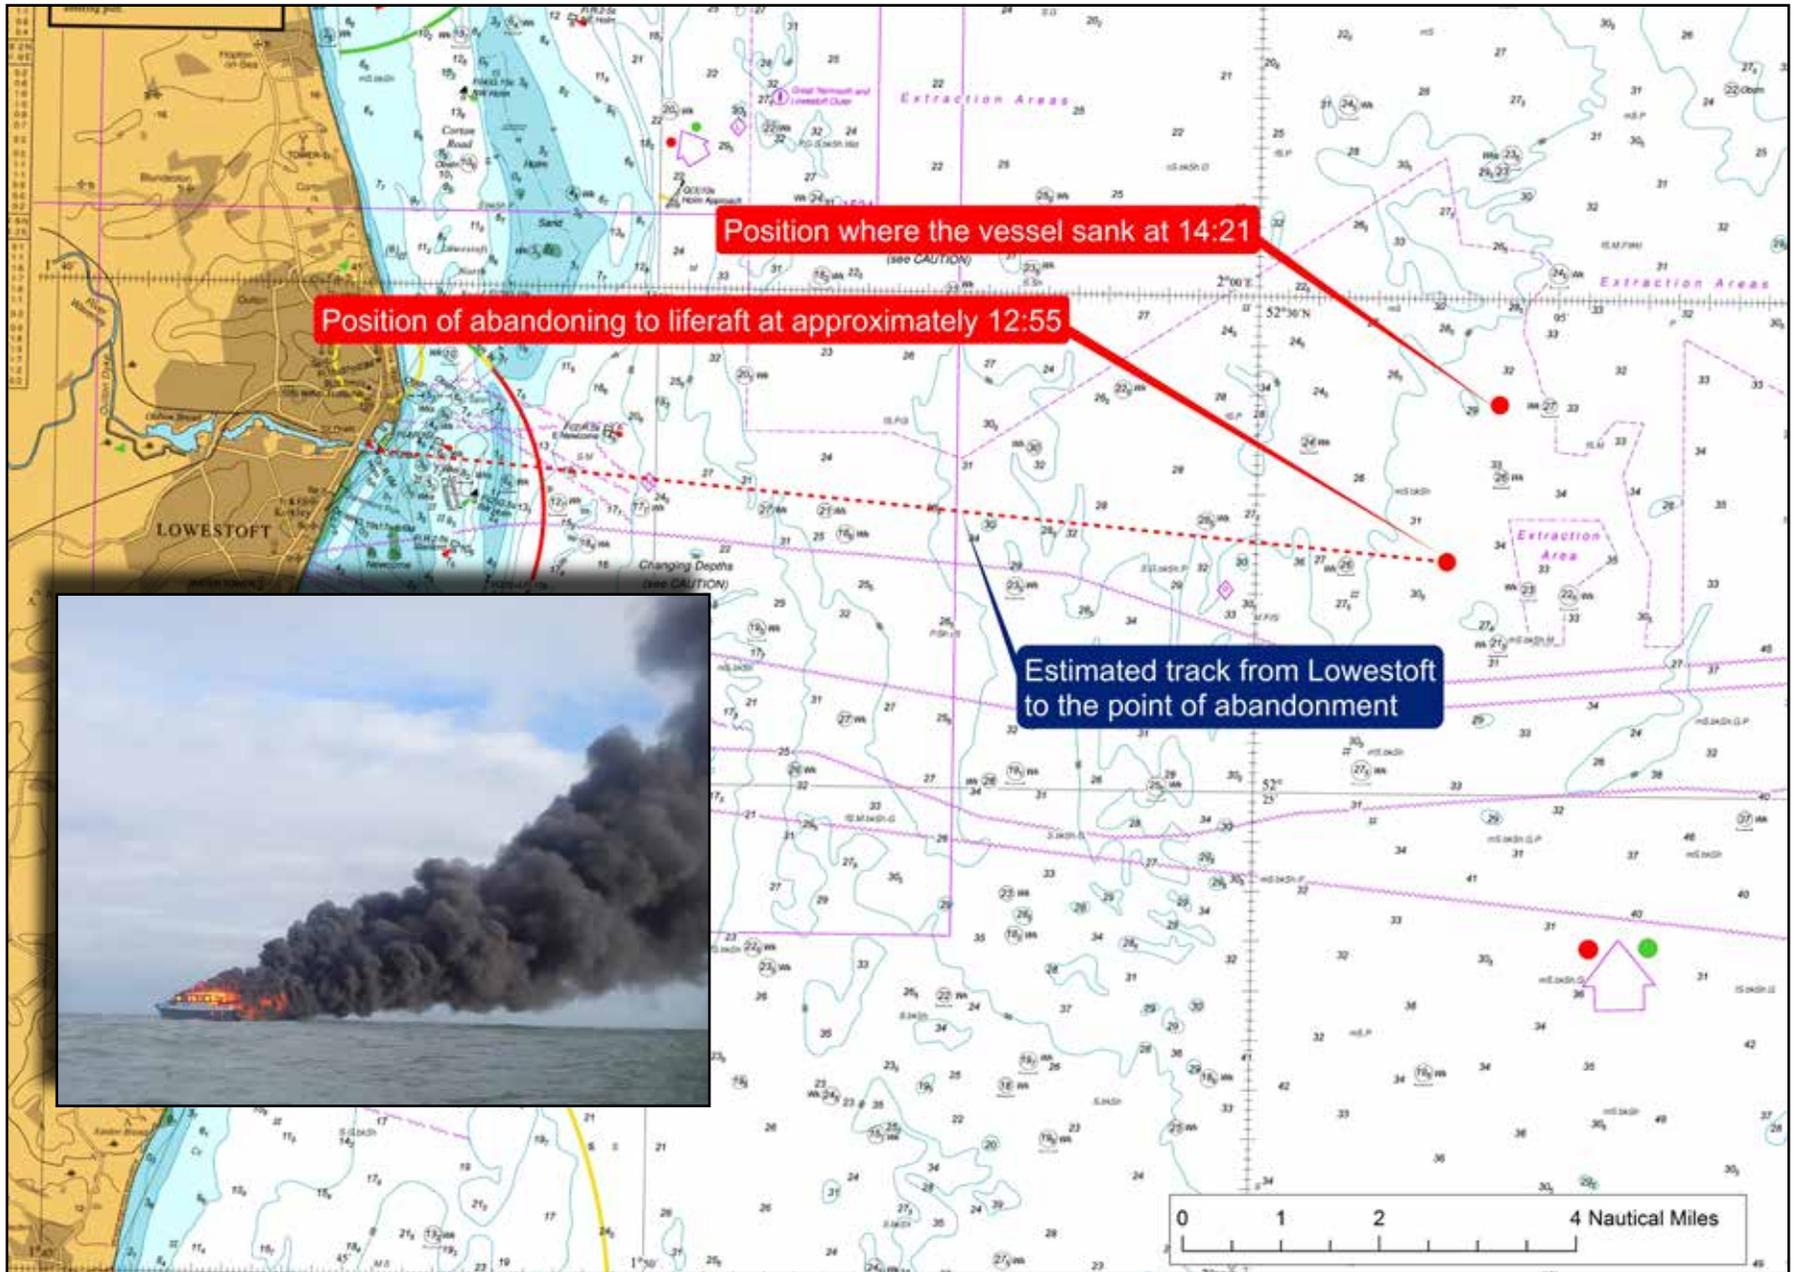
On 14 January 2014 at approximately 0915, the skipper and two deckhands of *ECC Topaz* arrived at Lowestoft Marina to take the vessel for a test run in order to investigate an intermittent technical problem with the port side main propulsion engine. Immediately after boarding, the skipper started the diesel fired air heater and set it to run for 5 to 6 hours. The vessel cleared the A12 Bascule Bridge during its 1115 opening and headed south-east of Lowestoft at around 12kts. The two deckhands were on the aft deck, and at around 1230 one of them opened the port engine hatch to inspect the engine. Noticing a water leak, he asked the skipper to slow down and entered the engine compartment to rectify the leakage. The vessel continued on its original course at 3-4kts for the next 15 minutes (**Figure 1**). The vessel's automatic identification system (AIS) track for 14 January was not available.

Figure 1: Approximate track of *ECC Topaz* with the position of the abandonment and sinking (inset: *ECC Topaz* on fire)

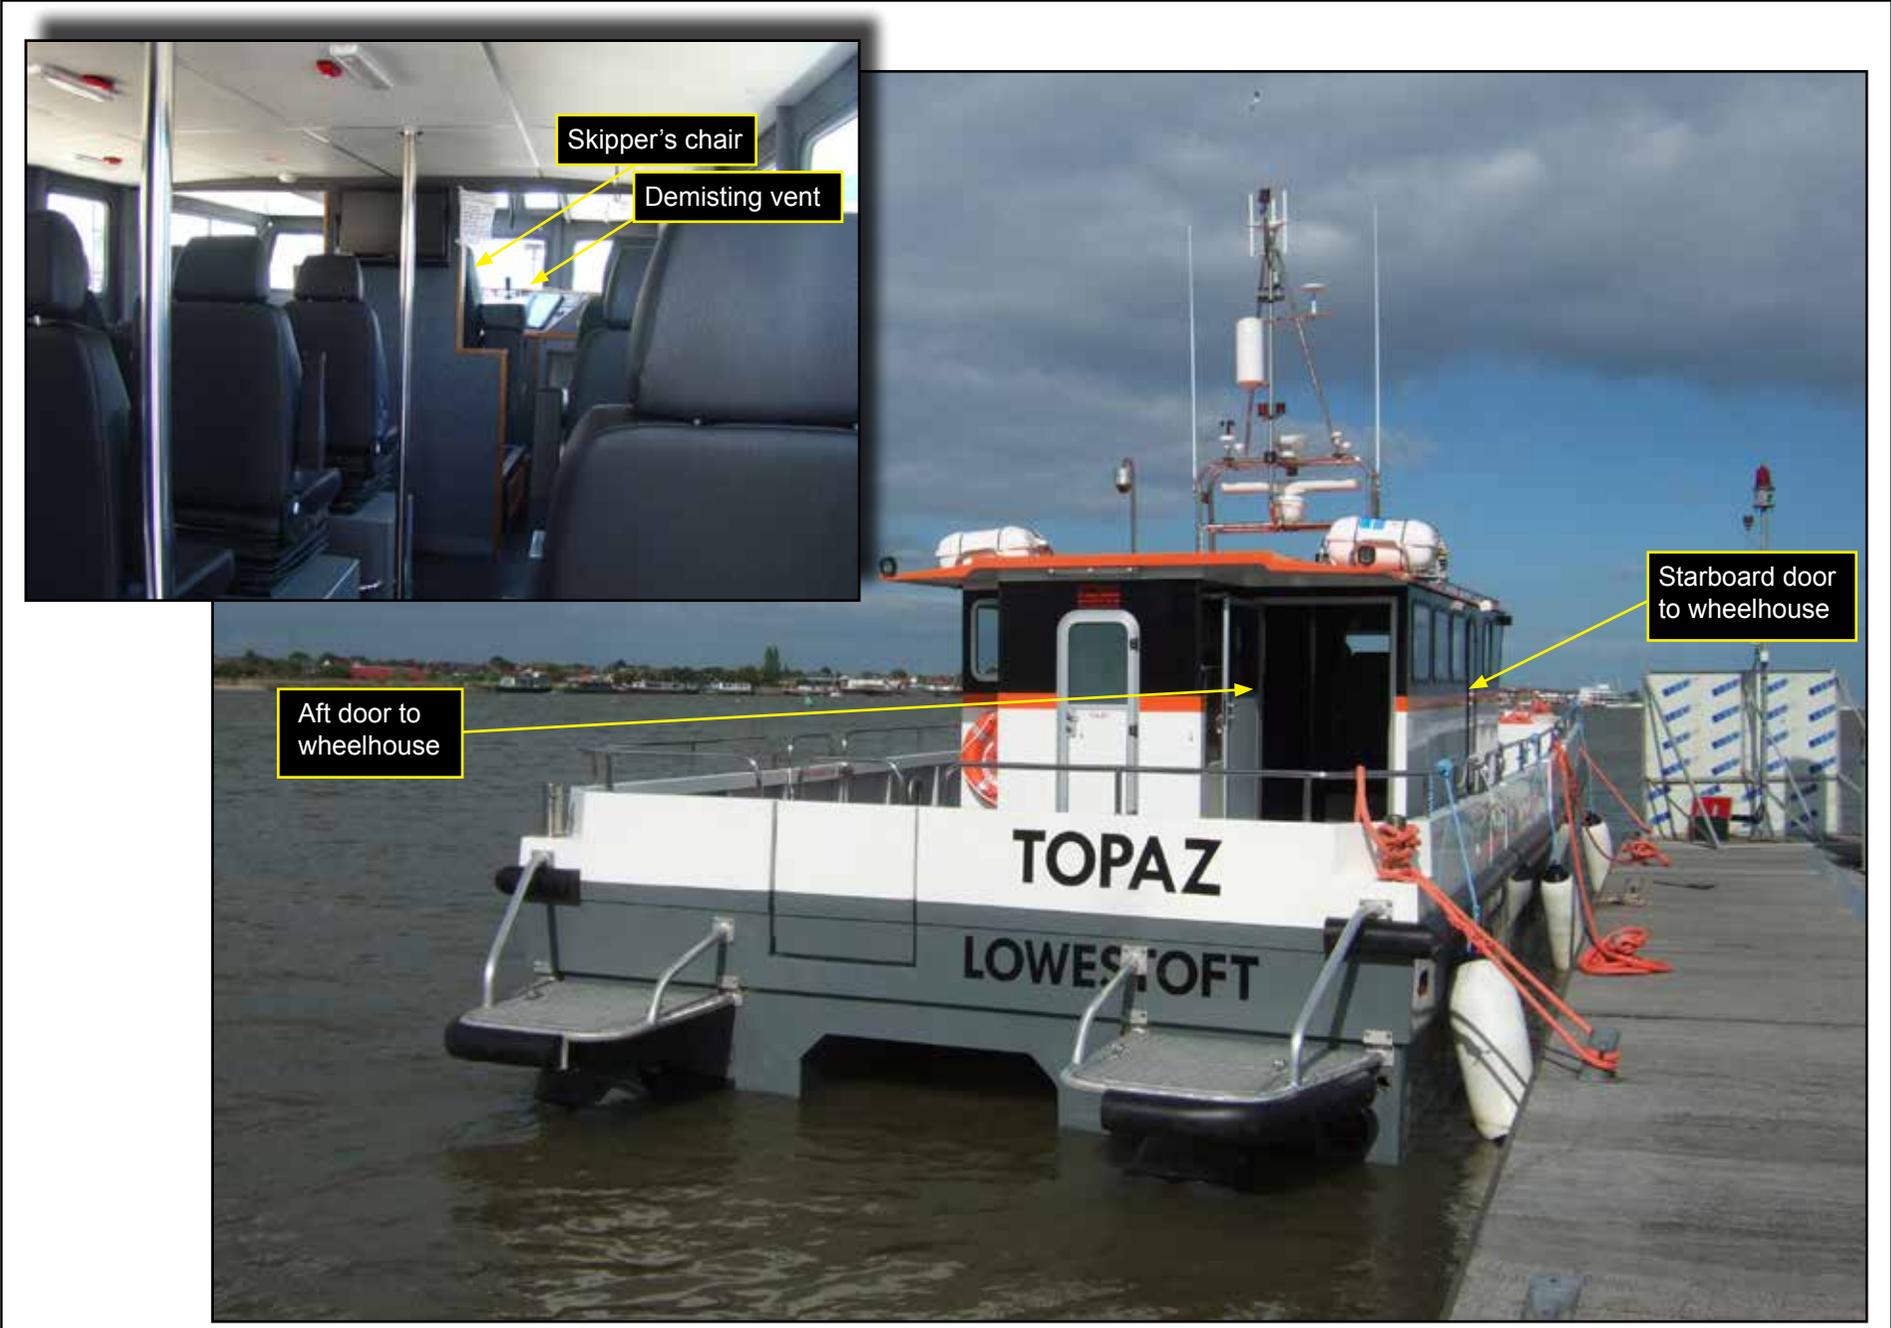
The skipper was sitting on the wheelhouse chair and the starboard access door for the wheelhouse was open (**Figure 2**). At approximately 1245, he noticed a puff of grey smoke followed by black smoke from one or both of the demisting vents for the bridge window. Immediately afterwards, he saw thick black smoke issuing from an opening on the deck below the wheelhouse dashboard. This opening, which was reported to be around 15cm in diameter, was used to route the air circulation trunking from the diesel fired air heater that was located in a compartment directly below the wheelhouse.

Figure 2: ECC Topaz in service (inset: Inside the wheelhouse/passenger space)

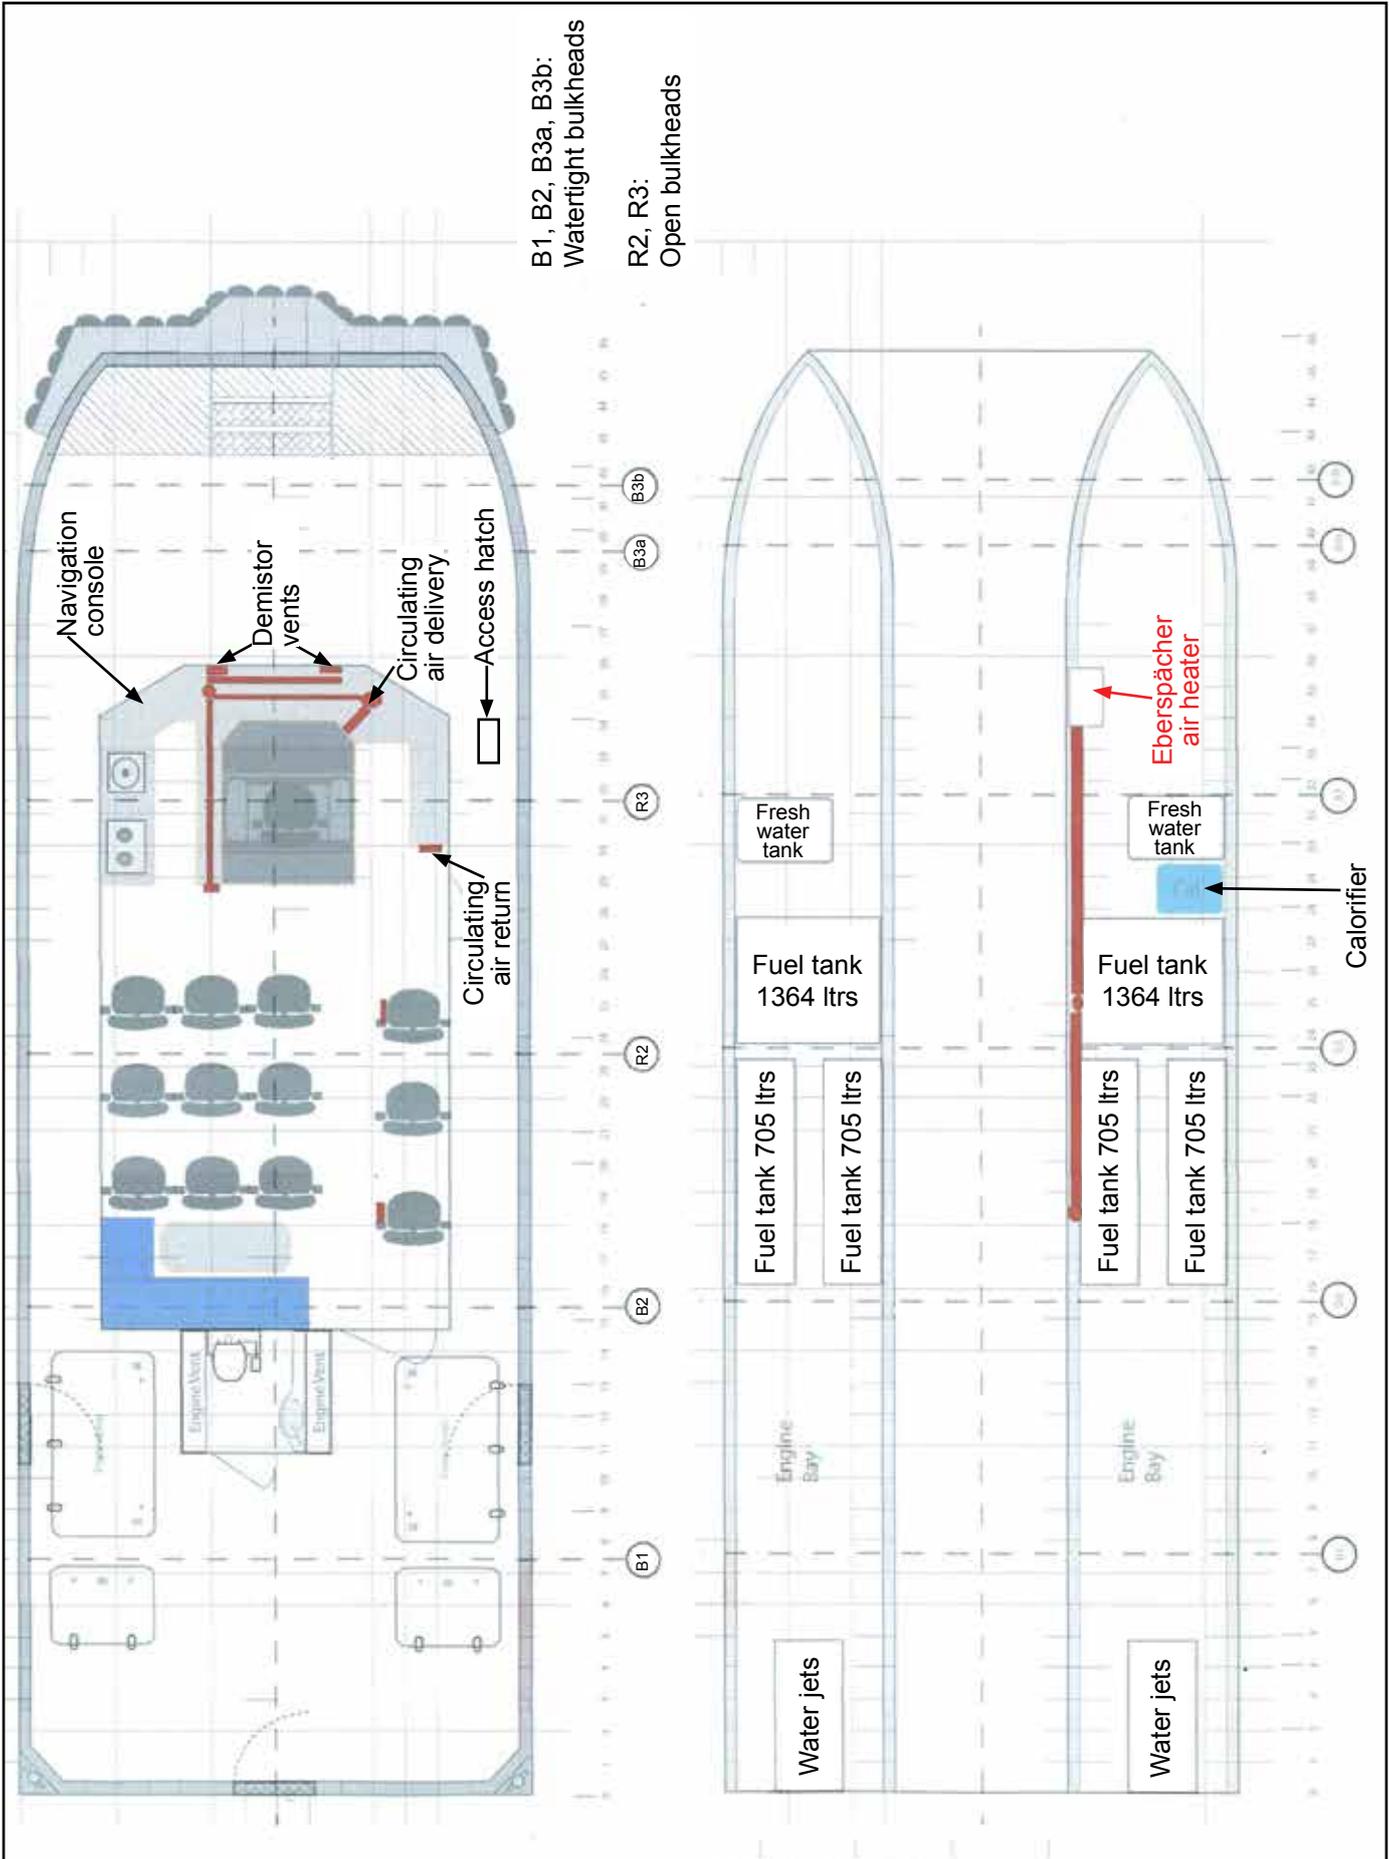
Both hulls had five compartments, each divided by solid bulkheads (**Figure 3**):

The compartment containing the air heater was accessed through a hatch on the starboard deck outside the wheelhouse. In addition to the oil fired air heater, this compartment was used to store several sacks of cleaning rags, rolls of paper towels, 5 litres of diesel in a plastic container, and a few cans of lubricating and hydraulic oils.

Figure 3: General layout of ECC Topaz showing the location of Eberspächer heater

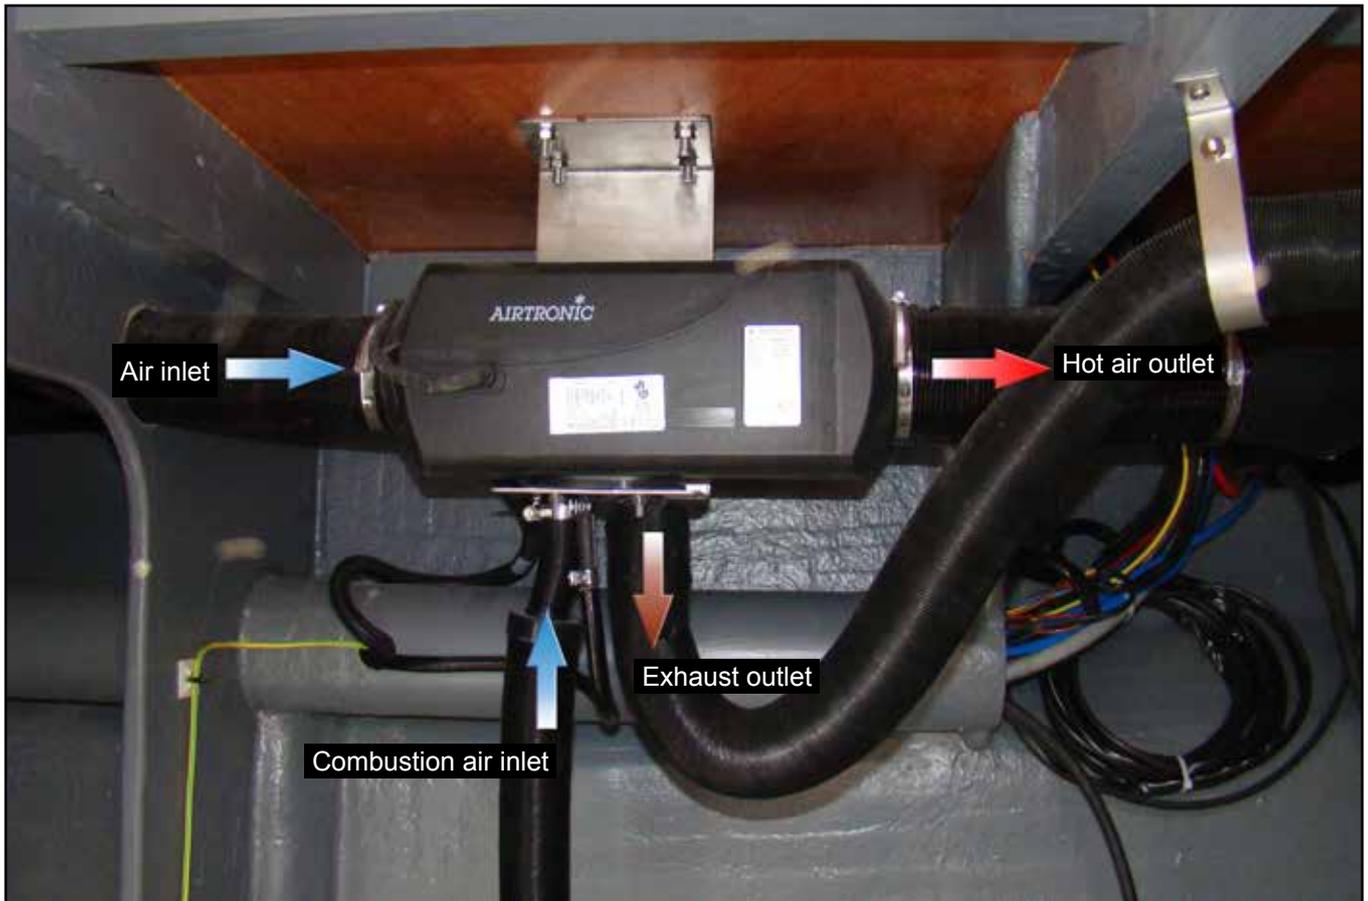
The air heater fitted on *ECC Topaz* was the Eberspächer Airtronic D4 Plus model which had a heat output capacity of 4kW (**Figure 4a**). Its sequence of operation was as follows:

Figure 4a: Eberspächer (model D4 Plus) heater as installed in *ECC Opal*

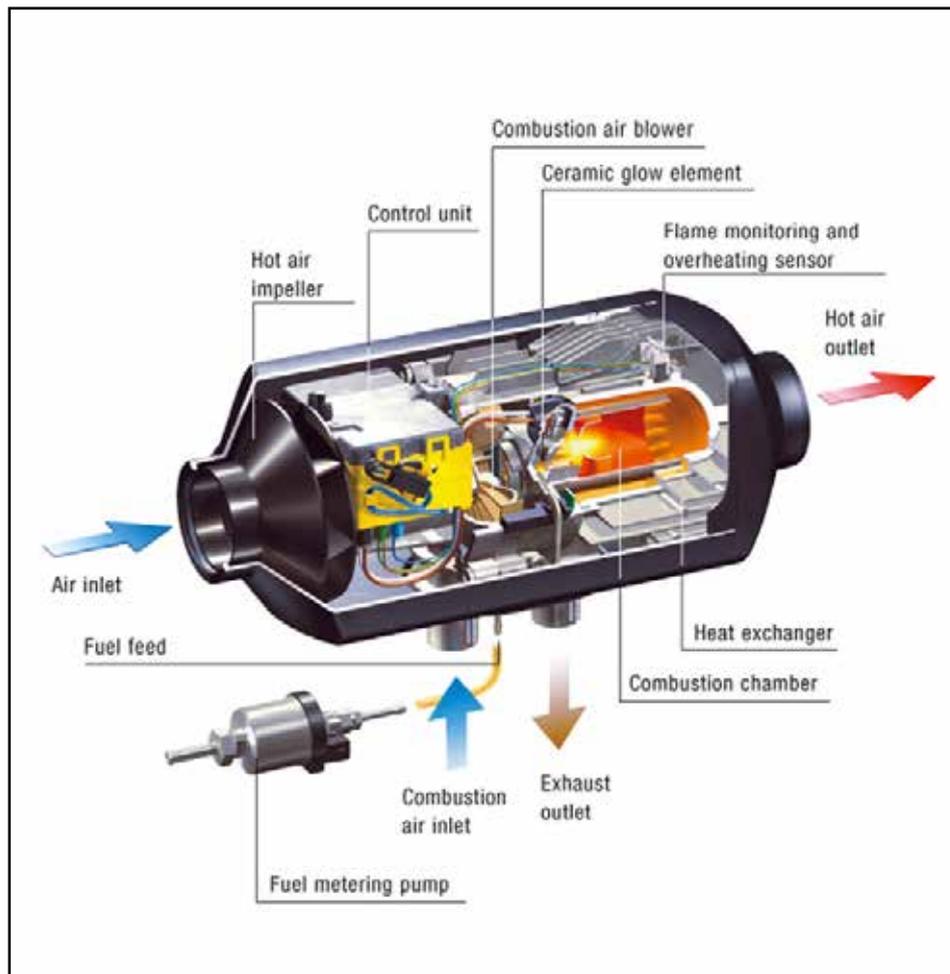
The heat energy of the burning air fuel mixture was transferred to the circulating air, which was forced through a heat exchanger surrounding the combustion chamber. The heated air was delivered to several outlets in the wheelhouse, including the de-misting vents, via delivery trunking. The air for combustion was supplied through a separate inlet pipe that was open to the air heater compartment (**Figure 4b**), the heated air was continuously recirculated through the delivery and suction trunking.

Figure 4b: Heater air and gas flows

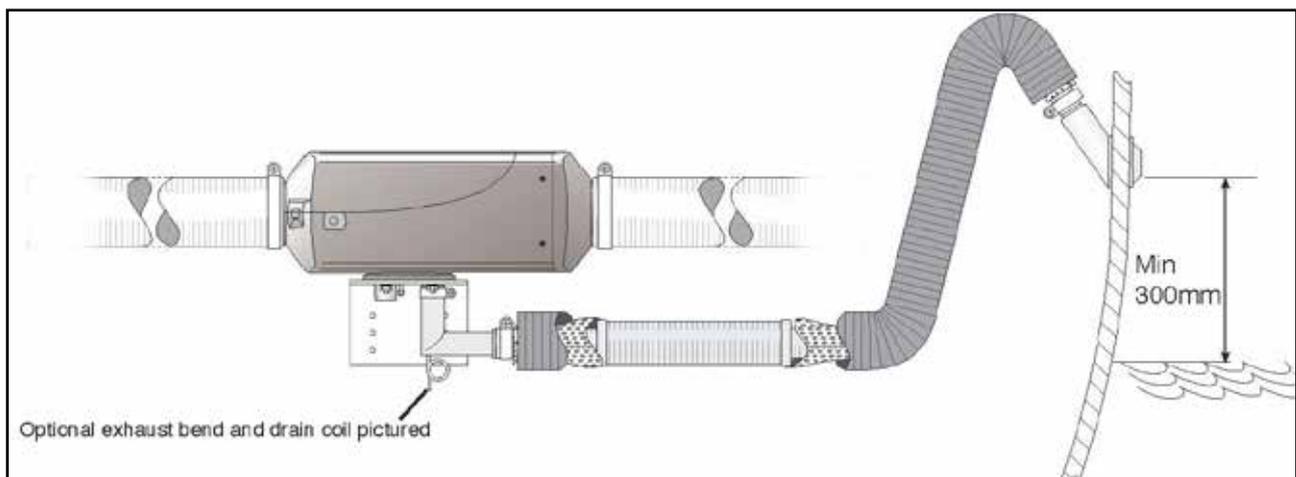
The installation manual explicitly stated that flammable items, including fuel canisters, oil cans, cleaning rags and paper rolls must not be stored or transported on or next to the heater. The manual also required the flexible exhaust to be routed *giving clearance and consideration to heat sensitive components...* A distance of 300mm was recommended as the minimum height of the overboard discharge above the waterline (**Figure 8**).

Figure 8: Manufacturer's recommended installation method

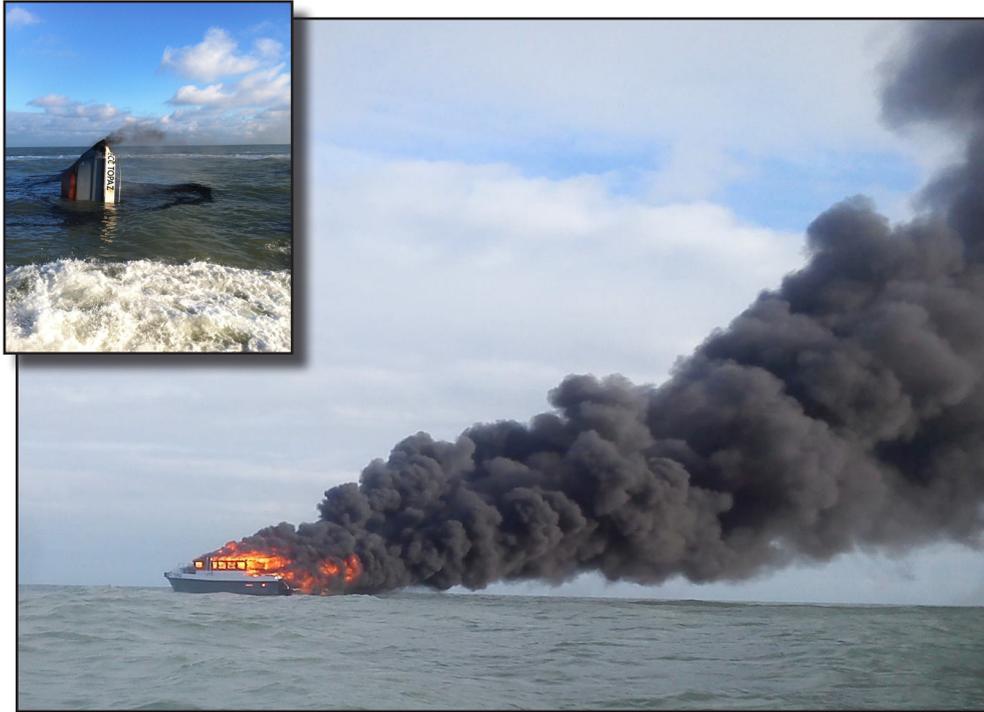
Figure 1: *ECC Topaz* on fire (inset: subsequent foundering)
