Report on the investigation of  
a serious injury to a crew member  
on board

***Wanderer II***

1 mile south-east of Wiay Island,  
Outer Hebrides

19 November 2013

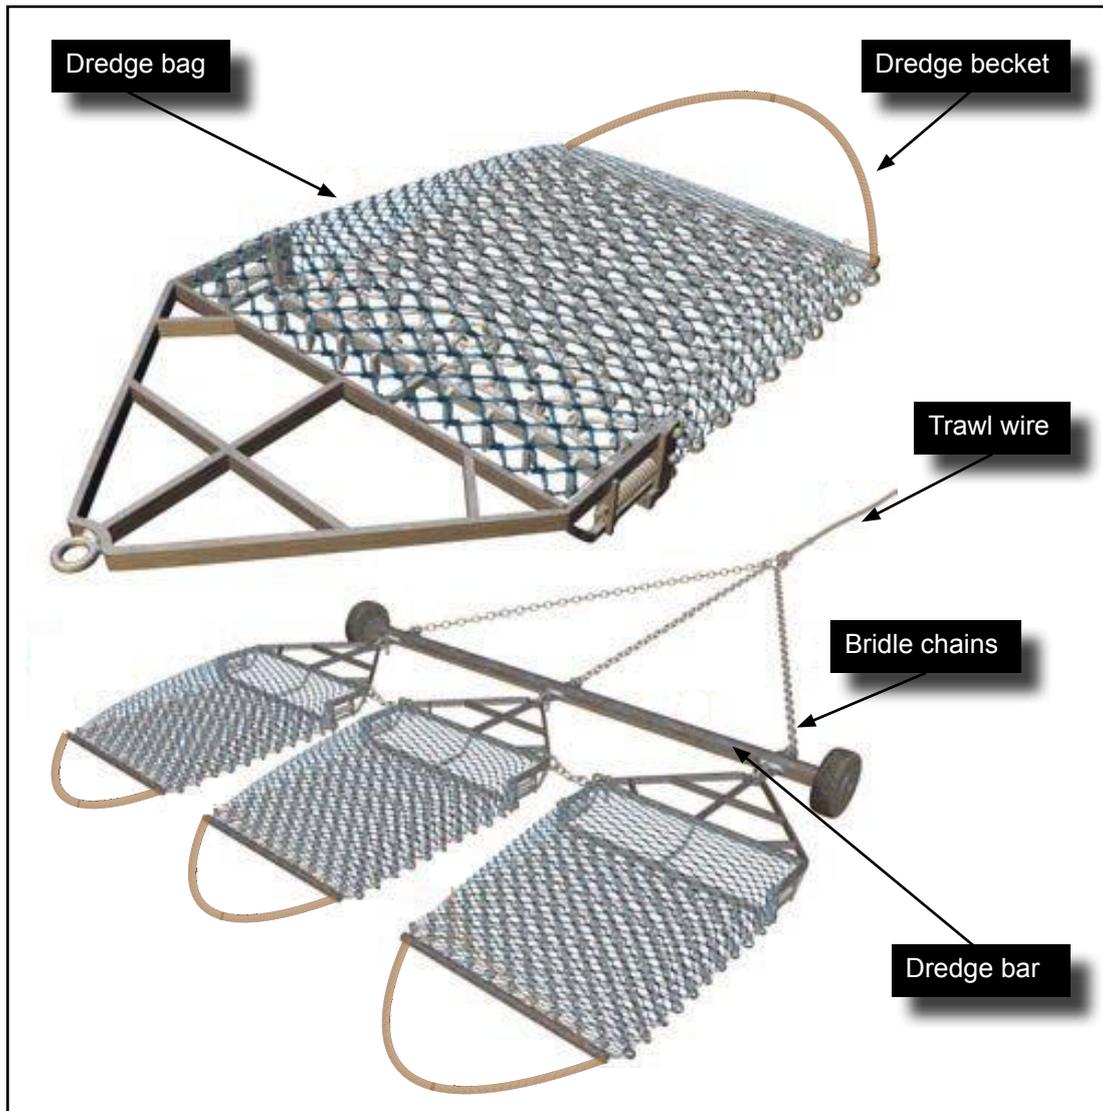
**Figure 4:** Typical dredging arrangement

As the name of this type of fishing suggests, the gear is dragged along the seabed to dredge up king scallop shellfish. A sketch of a typical arrangement of dredging gear with three dredge bags, known as dredges, is shown at **Figure 4**. *Wanderer II* had six dredges attached to each bar. On each side, the six dredges, the bar and the chain bridles that comprised the dredge gear weighed around 850kg.

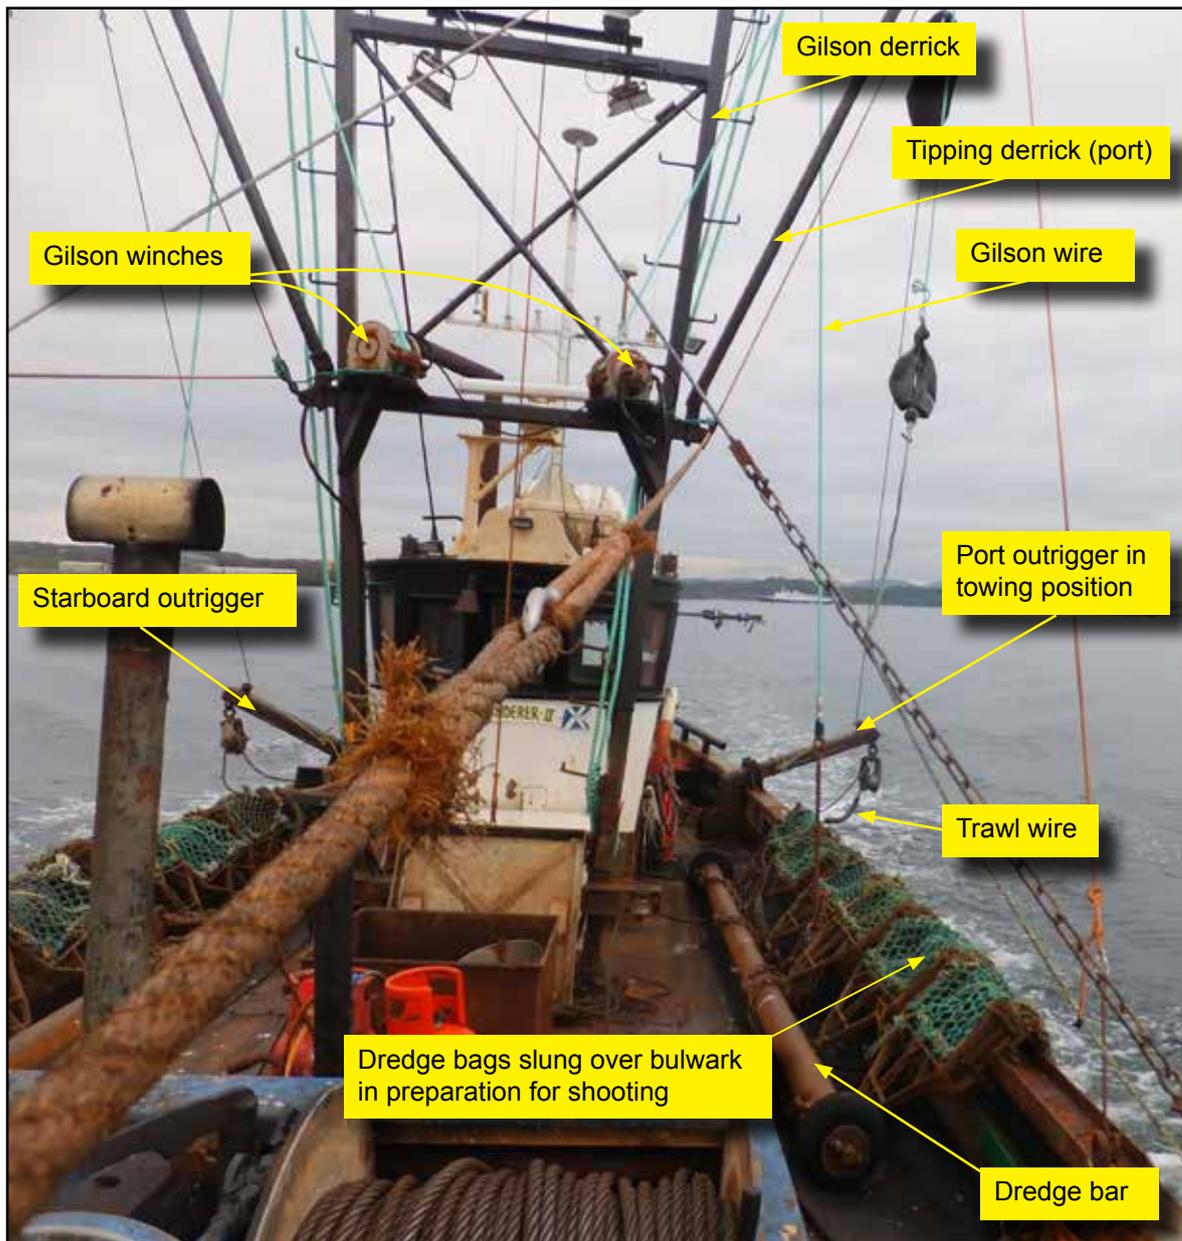
**Figure 5:** *Wanderer II*'s arrangement and gear on deck

When not in use the bars lay on the deck inboard of the port and starboard bulwarks with the dredge bags hanging over the bulwarks in readiness for shooting (**Figure 5**).

Two dedicated hydraulic gilson winches were fitted by the lower cross bar of the main gilson derrick frame (**Figure 5**). These were used for lifting the complete dredge gear inboard and outboard during hauling and shooting and were controlled by spring-loaded levers mounted on either side of the forward safety rail on the main trawl winch (**Figure 2**).

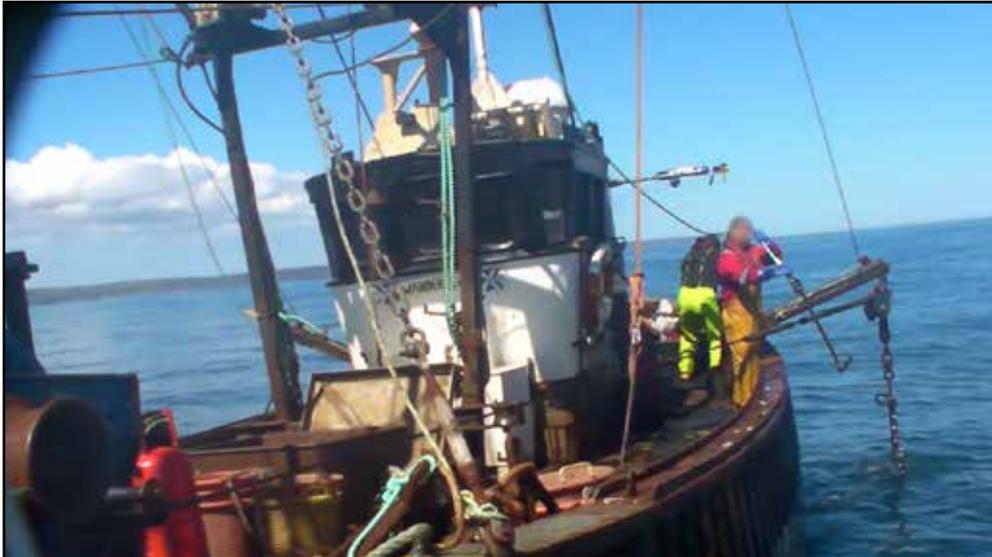
**Figure 6:** Gilson hook being removed from the dredge bridle by the port outrigger in preparation for shooting

To shoot the dredge gear, each side was lifted in turn from the deck by the gilson winches. These winches were normally operated by the senior deckhand. Once above the bulwark the dredge gear was lowered outboard and the tension taken on the trawl wires. This enabled the gilson hooks to be disconnected by the junior deckhand and skipper from positions near the outriggers (**Figure 6**).

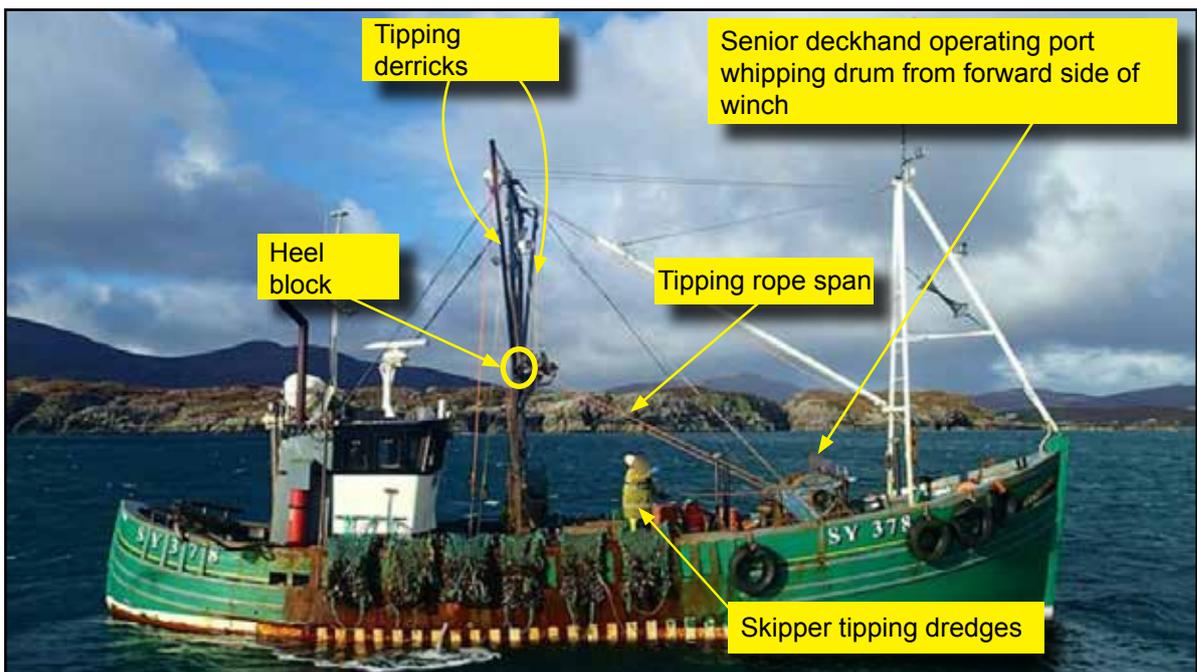
**Figure 7:** *Wanderer II* tipping dredges at sea

When recovering the dredge gear, the senior deckhand would haul in the trawl wire with the winch until the dredge bar bridles reached the outriggers. The skipper and junior deckhand then attached the gilson hooks and the dredge bars were lifted inboard by the senior deckhand using the derrick mounted gilson winches. Once at a suitable height above the gunwale, the dredge bars would be lowered to the deck and bowsed-in if required, leaving the dredge bags hanging outboard of the bulwark in preparation for tipping (**Figure 7**).

*Wanderer II* had been modified a number of times over its 42-year life. The modification to scallop dredging required the installation of amidships fixed gilson derricks for lifting the heavy dredge gear inboard and outboard. Additional self-positioning tipping derricks (**Figure 7**) were fitted halfway up the main derrick legs to accommodate dredge tipping. The tipping ropes led directly from heel blocks on the tipping derricks over 6m forward to the whipping drums. There were no guides or fairleads in the span to keep the rope leading directly to the whipping drum.

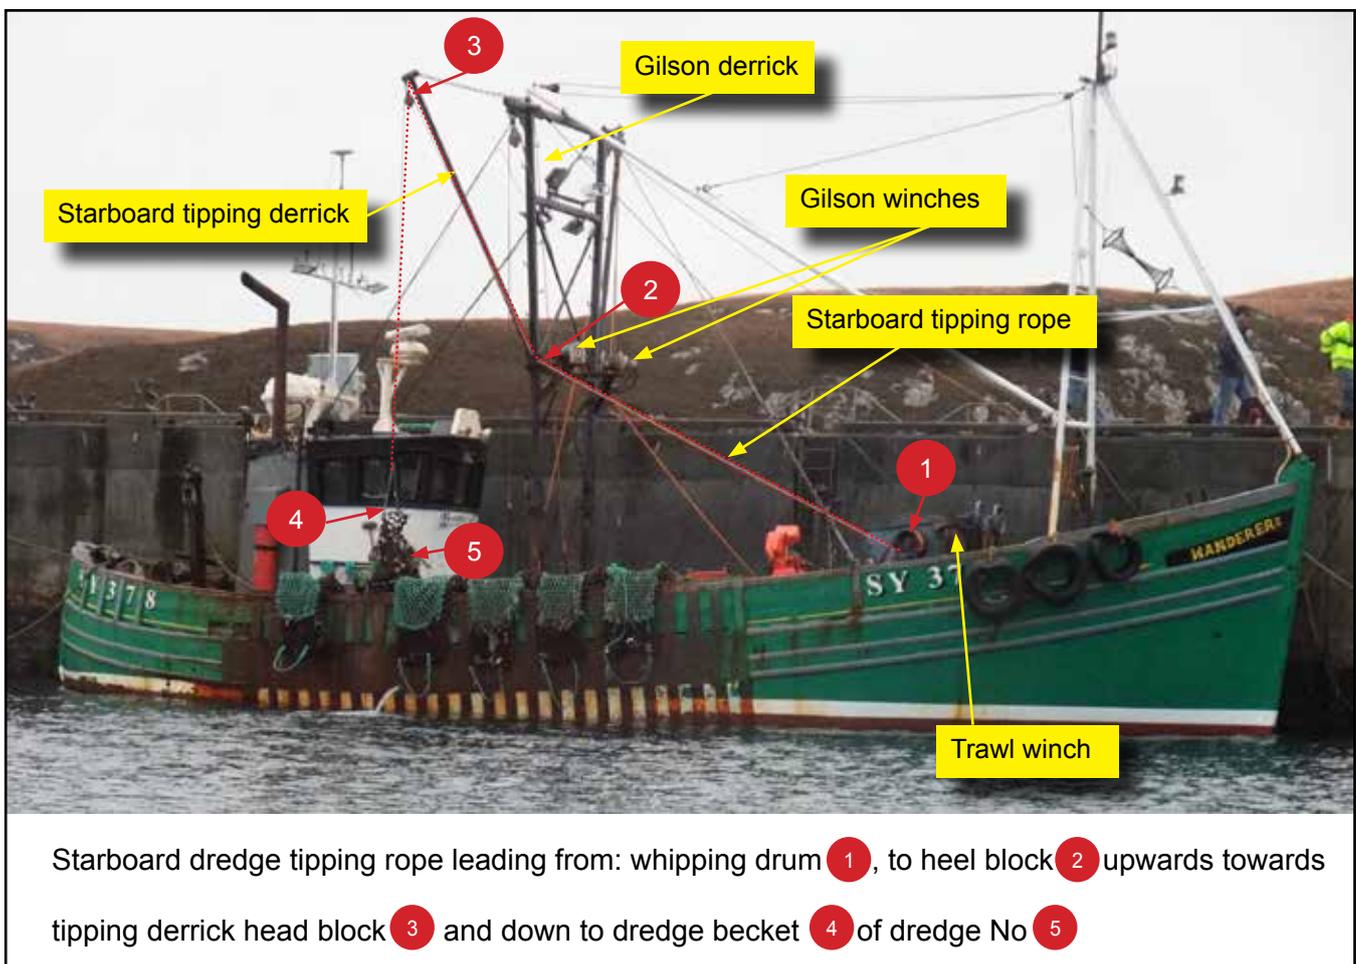
**Figure 8:** *Wanderer II's* derrick and tipping arrangements

Dredge tipping was carried out by the two deckhands working in partnership on the port side while the skipper tipped the starboard dredges on his own. 18mm polyethylene tipping ropes led from 600mm long hooks, up to self-positioning tipping derricks attached to the main derrick and then from the heel blocks of these derricks some 6m forwards towards the whipping drums on either side of the trawl winch (**Figure 8**). With the trawl barrel dog-clutches disengaged, the senior deckhand set the whipping drums to rotate continuously at a speed of about 24 revolutions per minute (rpm) before he moved to attend the port side tipping rope. Tipping commenced from forward at dredge No.1 and worked aft towards dredge No.6 on each side simultaneously. It was the junior deckhand's role to hook the tipping rope hook into the lifting strop, or becket, on the tail of the dredge bag on the port side. This enabled the senior deckhand to invert the dredge bag by applying tension to the tipping rope, which had two turns around the whipping drum, from his position forward of the whipping drum. The junior deckhand would then shake any remaining scallops and debris from the inverted bag before moving aft to the next dredge bag.
