**Report on the accident to
Shorts SD3-60 EI-BEM
3.5 km from East Midlands Airport
on 31 January 1986**

Aircraft Accident Report No. 6/87
(EW/C947)

<i>Operator:</i>	Aer Lingus Commuter
<i>Aircraft: Type:</i>	Shorts SD3-60
<i>Nationality:</i>	Irish
<i>Registration:</i>	EI-BEM
<i>Place of accident:</i>	3.5 km from East Midlands Airport Latitude 52° 49.3' N Longitude 001° 23.5' W
<i>Date and Time:</i>	31 January 1986 at 1851 hrs
	All times in this report are UTC

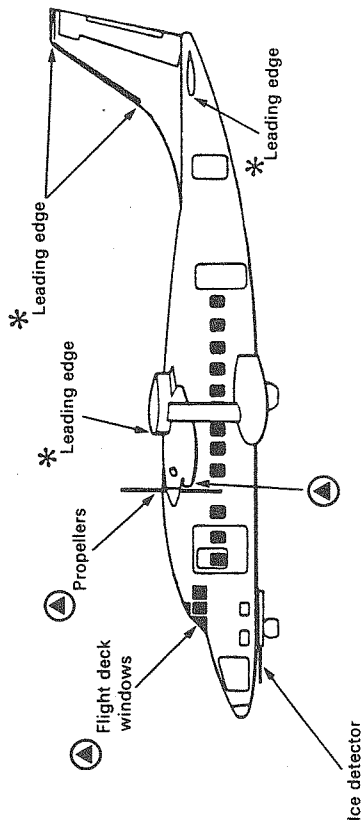
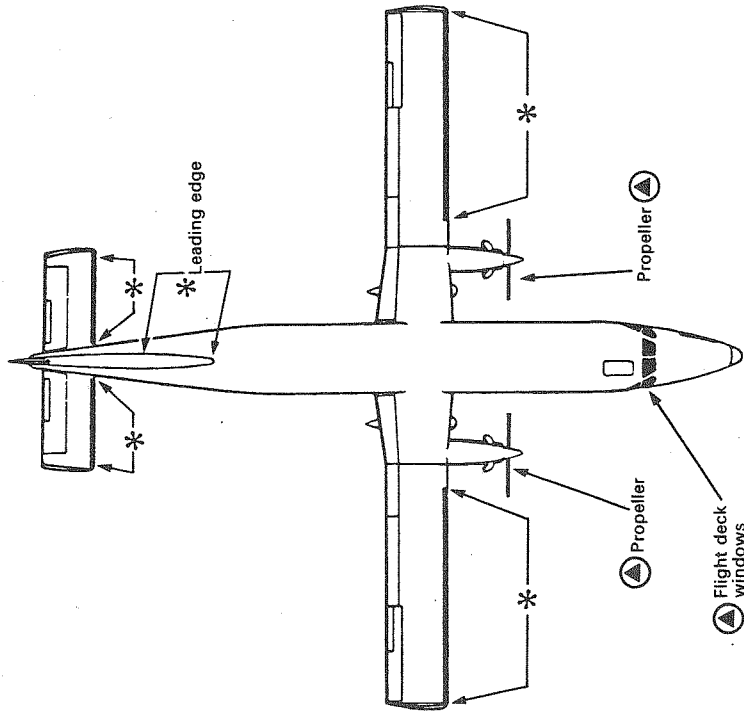
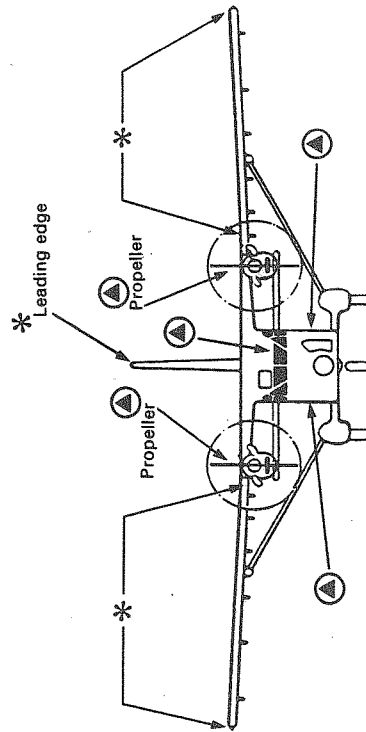
ICE PROTECTION EQUIPMENT (Protected Surfaces)

It is concluded that the departure from controlled flight was linked with the build up of ice and it is likely that the accretion of ice upon the airframe had modified the aerodynamics of the aircraft such that its normally good roll stability had been severely degraded so that the aircraft was not responding to the application of roll controls in the normal manner. Nevertheless, the precise shape or position of the ice which modified the aerodynamics is not known, as, by the very nature of icing, the evidence had disappeared before examination was possible.

▲	ANTI-ICING HEATING
*	DE-ICING "BOOTS"

- 4.1 The Civil Aviation Authority should give consideration to the continued design philosophy of inflatable boot de-icing as opposed to other airframe ice protection systems on aircraft cleared for all known types of icing.
- 4.2 Pneumatically inflated wing and tail de-icing systems be exercised during the final approach to land, when an aircraft is flying, or has recently flown in conditions conducive to the accretion of ice.
- 4.3 Consideration be given to the effectiveness of the ice detection spotlight on the SD3-60 and to whether they should be fitted to both sides of the aircraft.

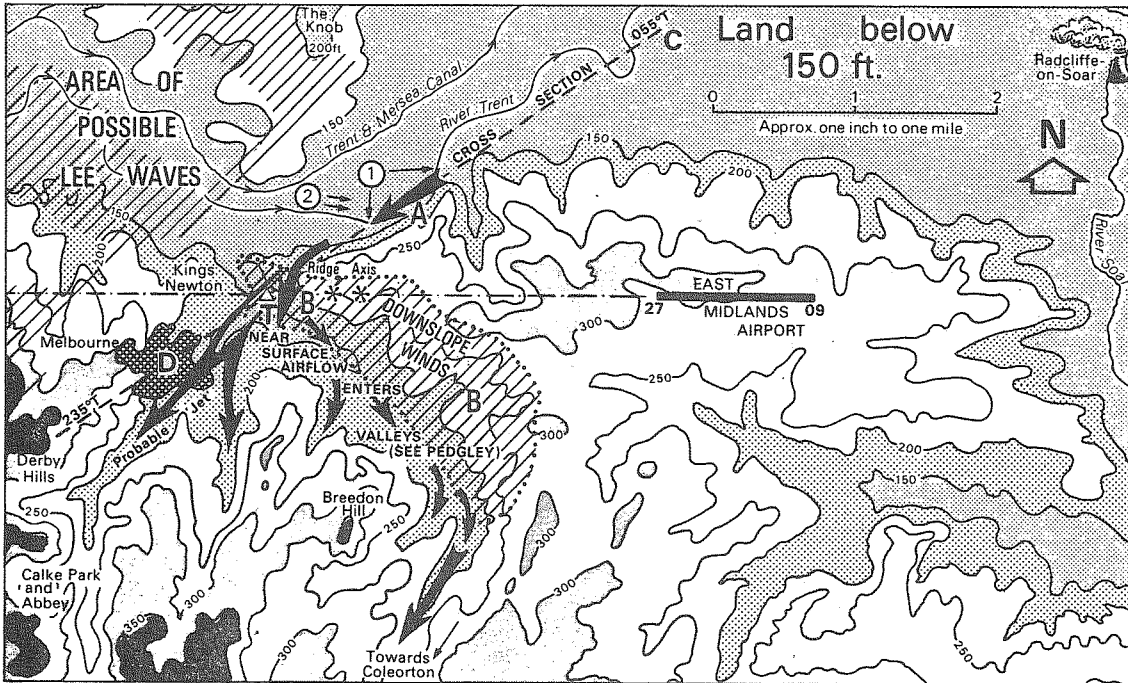
LOCAL TOPOGRAPHY: EFFECT OF STRONG WINDS ENTERING A VALLEY

- ① R. Trent 'Enlarging' it's valley here
- ② Strengthening wind 'Funnels' along steeper valley side

Pioneering work on winds entering a side valley has been done using a group of observers with hand-held anemometers around Llyn Idwal in Snowdonia. Although the 'model' is for August in much more mountainous terrain, certain similarities apply to the nameless valley between Melbourne and Donington Park lying at right angles to prevailing winds. Airflow near the surface tends to follow height contours and enter valleys.
