Rail Accident Report

Derailment of an empty passenger train at Paddington station 25 May 2014

Report 03/2015
April 2015

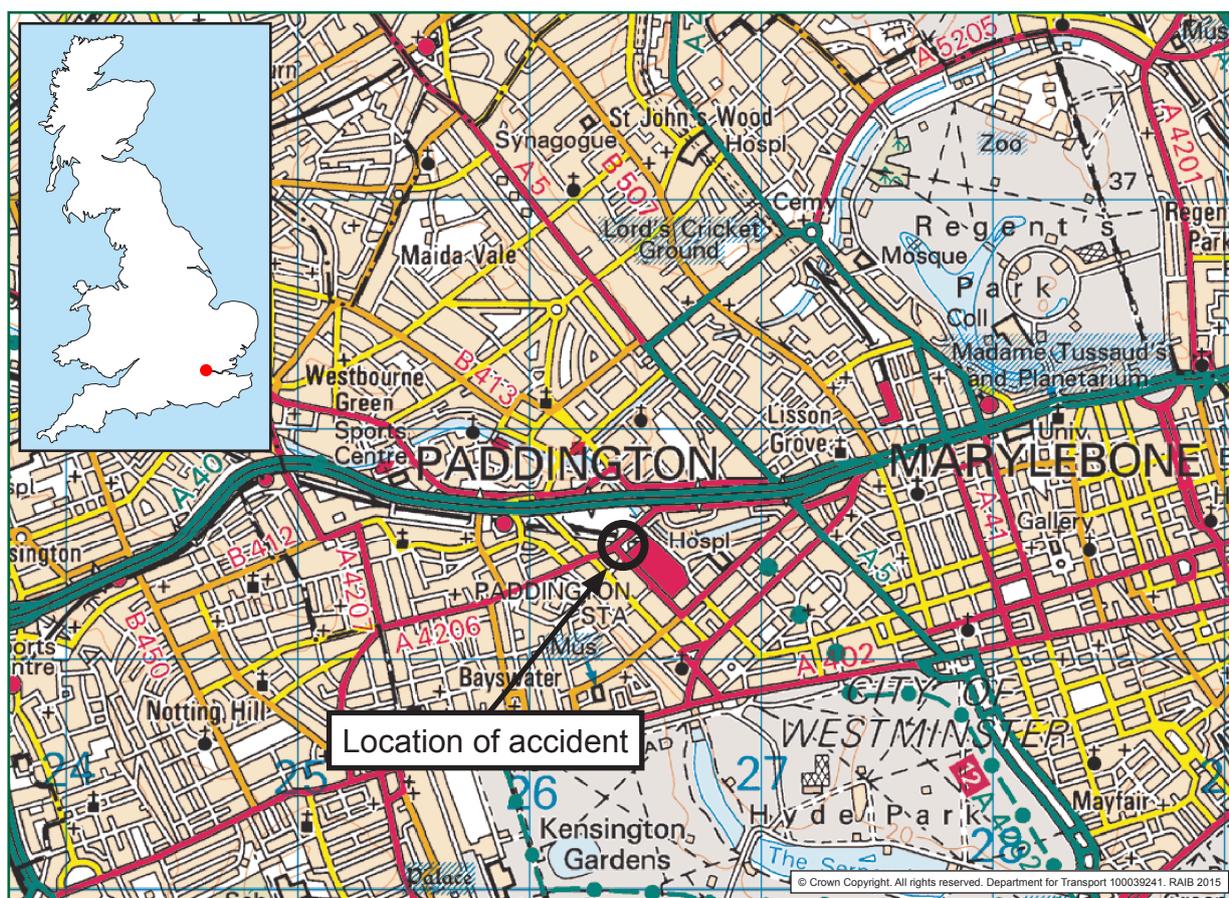
Figure 1: Location of the derailment

- 6 On Sunday 25 May 2014 train reporting number 5T08¹, the 05:04 hrs Heathrow Express empty stock movement from Old Oak Common to Paddington, derailed in platform 3 at Paddington station. As this was the first move of the day in preparation for the train entering passenger service, the only person on board was the driver. He was not hurt during the derailment. The RAIB has investigated this accident as it had the potential, under slightly different circumstances, for more serious consequences.

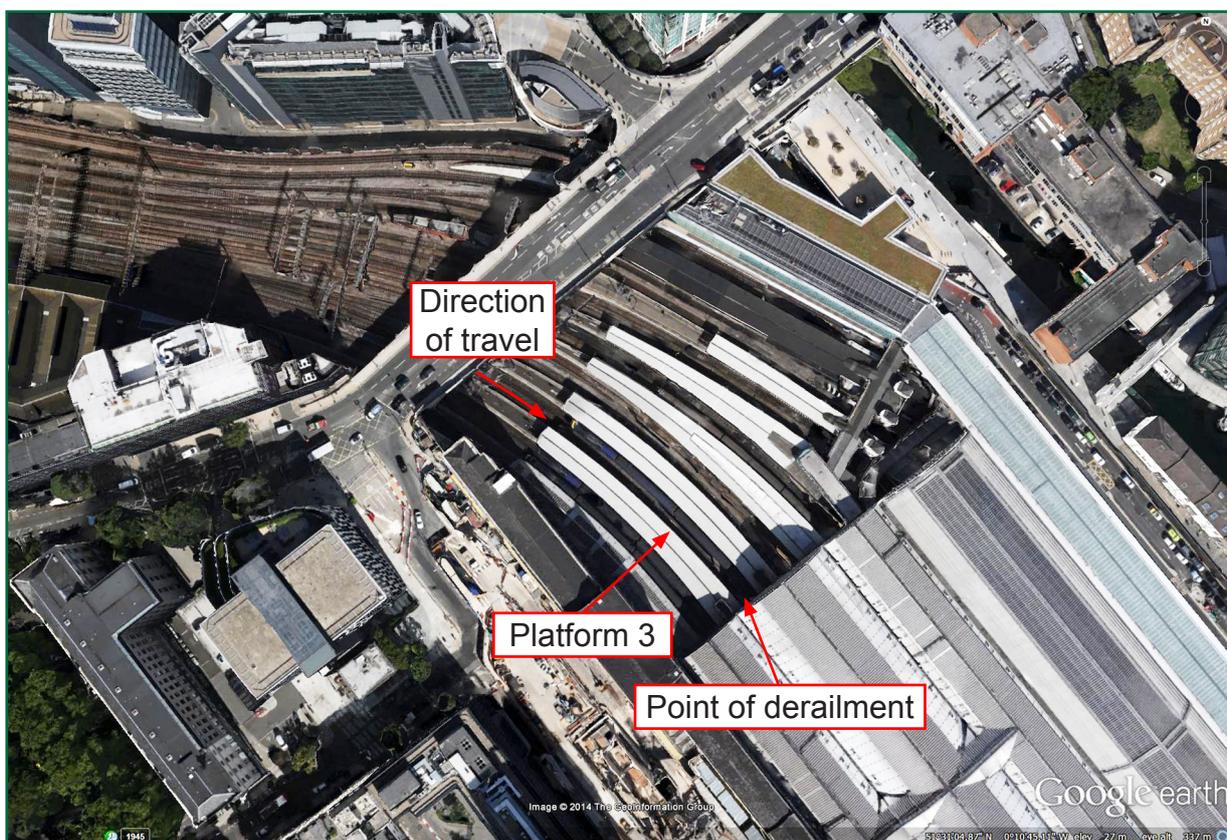
Figure 3: Overview of the derailment location

- 8 Paddington station has 14 mainline platforms. It is the London terminus for First Great Western services to and from the west of England and South Wales. It is also the terminus for local services including Heathrow Express services to and from London Heathrow airport.
- 9 The derailment of the third vehicle of train 5T08 took place adjacent to platform 3, approximately 153 metres from the buffer stops (figure 3). The track at this location and in the direction of travel is on a transition from a 300 metre radius right-hand curve to straight track. The curve radius at the point of derailment is approximately 500 metres and according to Network Rail's *Sectional Appendix*, the maximum linespeed at this location is 40 mph (64 km/h). Trains in and out of Paddington station travel slower than this as they are either slowing down to stop or accelerating from rest.

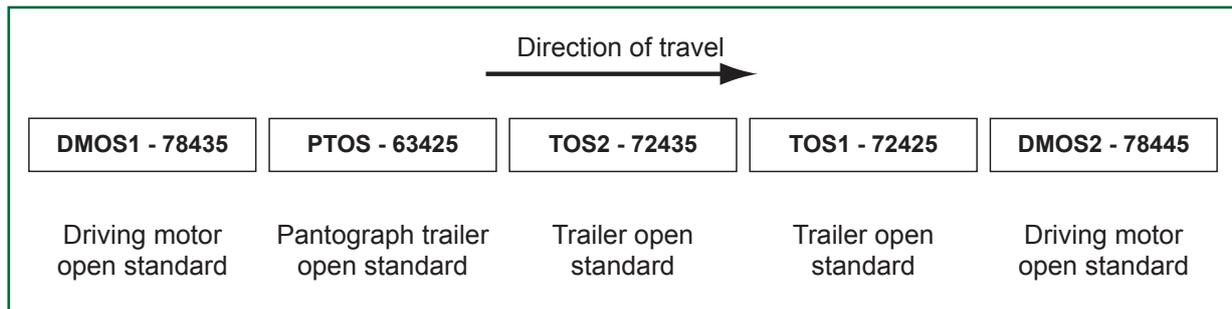
Figure 4: unit 360205 formation

- 13 The class 360/2 fleet was designed and manufactured by Siemens in Germany based on the Desiro UK family of multiple unit vehicles. These vehicles are fitted with bogies of the SF5000 type, which was designed and manufactured by Siemens in Austria.
- 14 The formation of unit 360205 is shown in figure 4. The derailed vehicle was the TOS2 vehicle, number 72435.

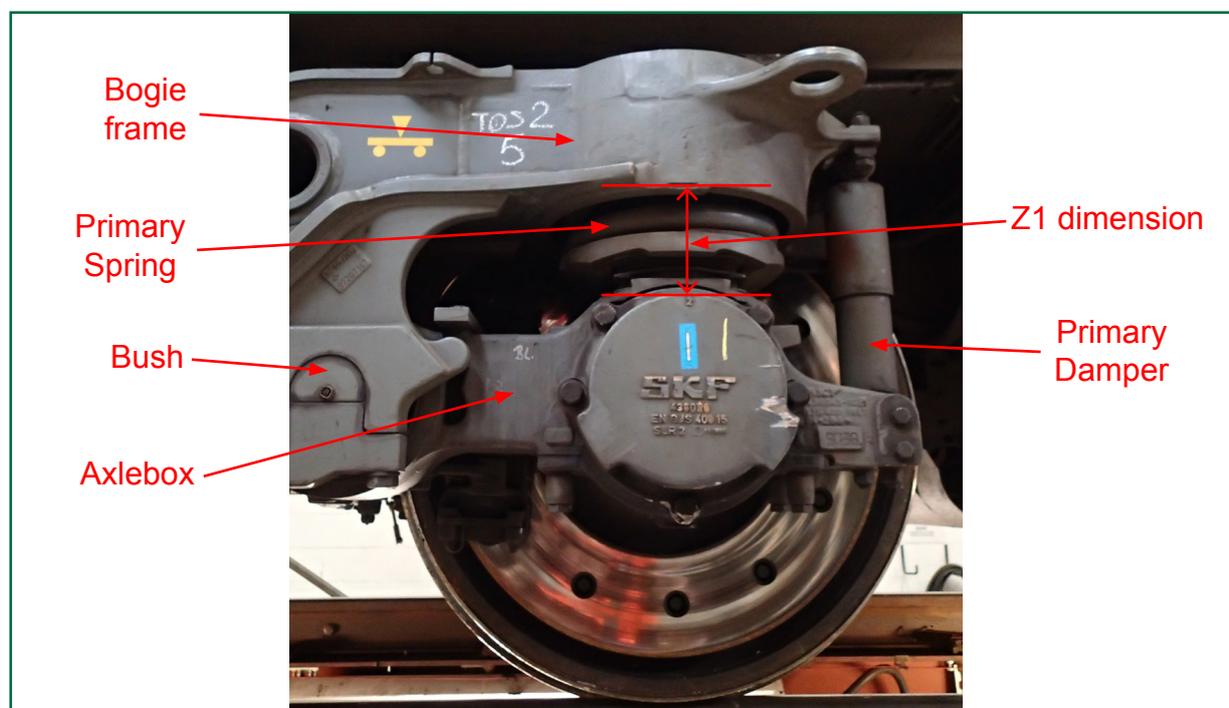
Figure 6: Primary suspension (SF5000 bogie)

- 16 The primary suspension is normally formed by a set of springs and dampers located between the *axleboxes* and bogie frame. The primary suspension reduces the accelerations transferred to the bogie frame. Figure 6 shows the primary suspension using a *radial arm axlebox* as fitted to the SF5000 bogie. Figure 6 also illustrates the dimension known on the SF5000 bogie design as the Z1 dimension: this is the distance between the top of the axlebox and the underside of the bogie frame.

- the Z1 dimensions (figure 6) were high on the left-hand side (150 mm instead of the nominal 141 mm) and low on the right-hand side (130 mm instead of 141 mm) of the leading bogie and the opposite way round on the trailing bogie.

- 85 The investigation established that there is a strong link between uneven wheel loads and the distance between the axleboxes and the bogie frame (the Z1 dimension, see figure 6). This was confirmed on the TOS2 vehicle when these dimensions were measured after the derailment. The measurements showed that on one side of the bogies, the Z1 dimensions were significantly lower than the expected value (130 mm instead of 141 mm) whereas the measurements were significantly higher on the other side (150 mm instead of 141 mm). In comparison, the carbody was only showing an apparent twist of 2-3 mm at the same time which was probably lost in the inaccuracy of the measuring technique of the ride heights.

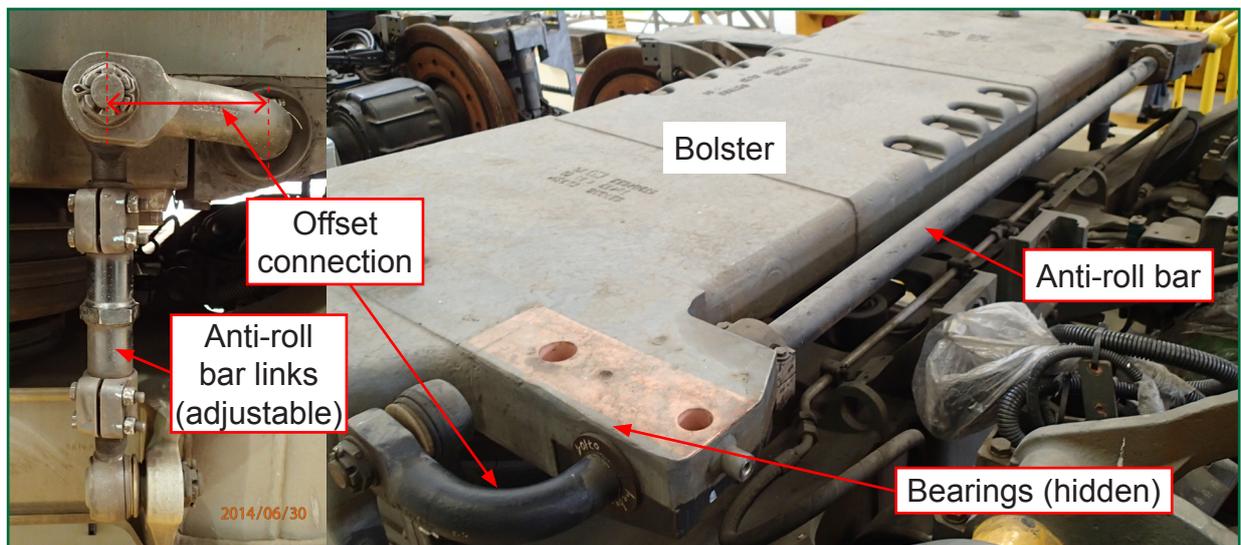
Figure 8: Anti-roll bar on SF5000 bogie (bolster mounted)

- 19 The anti-roll bar is a round bar (51 mm diameter solid steel bar on class 360/2) which runs transversely beneath the carbody (figure 8). The bar is supported by bearings connecting it to the carbody at either end which means that it can freely rotate along its axis. There is normally one anti-roll bar per bogie (two per vehicle). The ends of the bar are formed to create an off-centre connection to the bogie frame via the anti-roll bar links. It is this offset connection which defines the behaviour of the anti-roll bar. As the carbody bounces up and down, both ends of the bar are pushed up or pulled down by the links and the bar rotates in its bearings without adding any resistance to the vertical movement. As the body rolls, one end of the bar is pushed up by the link and the other side is pulled down by the other link. This has the effect of loading the bar in torsion. As the bar is torsionally stiff, it limits the differential movement that can be experienced at the ends and hence it controls the amount of roll seen by the carbody. This is a fairly typical arrangement on a modern passenger vehicle².

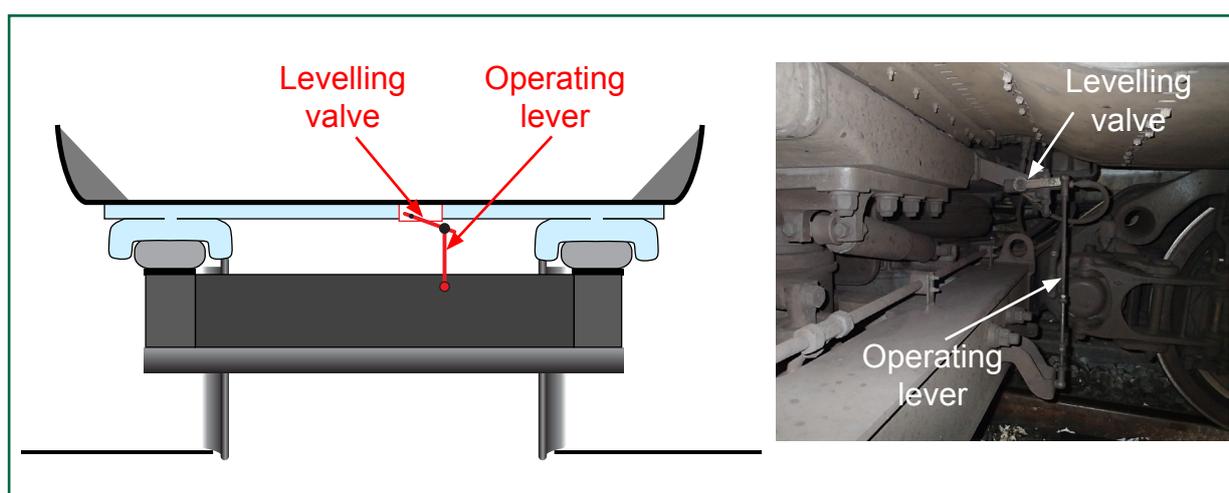
Figure 9: Single levelling valve system (SF5000 bogie)

- 20 Another important connection between the carbody and the bogie frame is the levelling valve. For *gauge clearance* purposes and to maintain the ride quality, it is necessary to keep the carbody at a consistent height for all loading conditions (ie from an empty vehicle to a vehicle full of passengers). This is achieved by the levelling valve and its operating lever. The operating lever actuates the levelling valve in response to changes in the vertical distance between the underside of the carbody and the bogie. If the distance decreases because of an increase in passenger load, the lever activates the valve to increase the pressure in the airbags which raises the carbody. If the distance increases because of a decrease in passenger load, the lever activates the valve to reduce the pressure in the airbags which lowers the carbody. In normal running, the levelling valve is designed to ignore small vertical movements and responds only to large deflections. On the SF5000 bogie, in common with many other Siemens' designs, both airbags are interconnected through the bolster on each bogie and the air pressure controlled by a single levelling valve, as shown on figure 9. Other designs may have separate levelling valves independently controlling the pressure to each airbag.

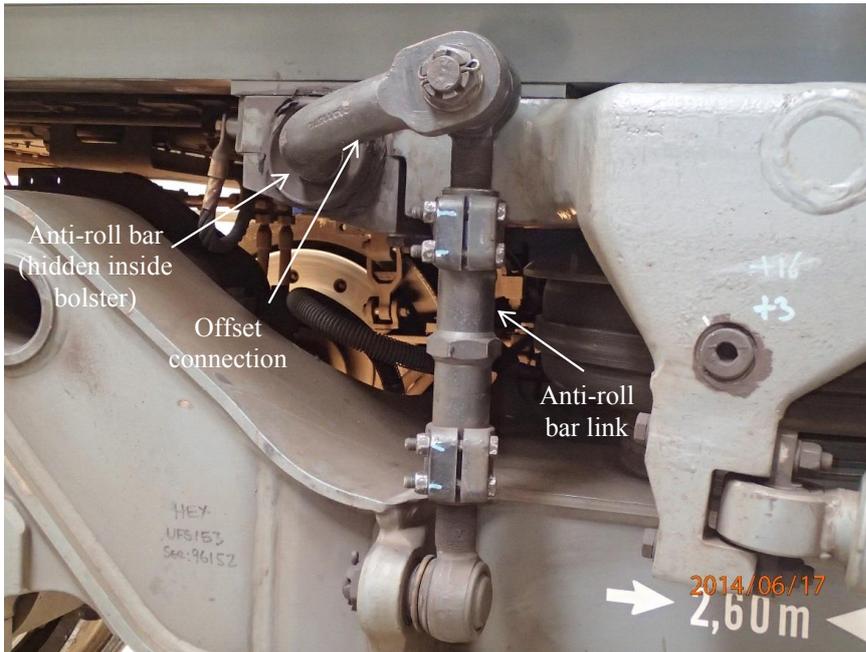
Figure 2 Anti-roll bar system

2. URGENT SAFETY ADVICE	
USA DATE:	18/06/2014
TITLE:	Setup of SF5000 bogies and other bogies with similar suspension arrangements
SYSTEM / EQUIPMENT:	Bogie, anti-roll bar
SAFETY ISSUE DESCRIPTION:	<p>Class 360/2 trains are fitted with SF5000 bogies. These bogies have anti-roll bars to react any dynamic roll in the body as a vehicle travels along the track. On each bogie, the anti-roll bar sits inside the bolster and is fitted with an offset connection at both ends (see figure 2). As the body rolls, the offset connection loads the bar inside the bolster in torsion which transfers loads from the body to the bogie frame.</p> <p>On flat and level track, the anti-roll bars should be set so as not to carry any load. This is checked by the maintainer post-tyre turning or after wheelset replacement as part of Siemens' procedure for setting the vehicle ride height (Maintenance Procedure No. UOP001). The procedure describes the actions needed if the anti-roll bars are found to be under load after setting the correct body height following tyre turning or wheelset replacement. This involves adjusting the length of the links connecting the anti-roll bar to the bogie frame. The procedure also states that the operator should ensure that the links are set to the same length on either side of the bogie.</p> <p>If the links have been set incorrectly and are of different length, it is possible for the anti-roll bars to permanently carry a load even on flat and level track. This load in the anti-roll bar system will result in the vehicle body loading the bogie frame in a manner which will lead to an uneven wheel load distribution.</p>

REASONS FOR ISSUE AND SAFETY ADVICE:	<p>This USA is being issued to raise awareness of these initial bogie-related findings among owners, operators and maintainers of Siemens Desiro trains, and owners, operators and maintainers of trains with similar bogie design.</p> <p>The RAIB investigation will include an examination of the methods of bogie setup on Class 360/2 units. It will also assess the condition of the track and the contribution of the track twist that was detected close to the point of derailment.</p> <p>In the interim we advise that owners, operators and maintainers of Siemens Desiro trains, and owners, operators and maintainers of trains with similar bogie designs to:</p> <ul style="list-style-type: none"> • gather information on the length of anti-roll bar links on each bogie and how they compare side-to-side; • gather information on the position of the bogie frame in relation to the axleboxes by measuring the distance Z1 (or equivalent) on all corners (see figure 3); • confirm whether anti-roll bars are loaded in the way described in this urgent safety advice; and • establish measures for ensuring that the anti-roll bar links are correctly adjusted so as to avoid uneven wheel loading. <p>As the data relates to an on-going investigation, the RAIB will need access to this data once it has been collated.</p>
