Report on the investigation of
the collision between the dredger

Shoreway

and the yacht

Orca

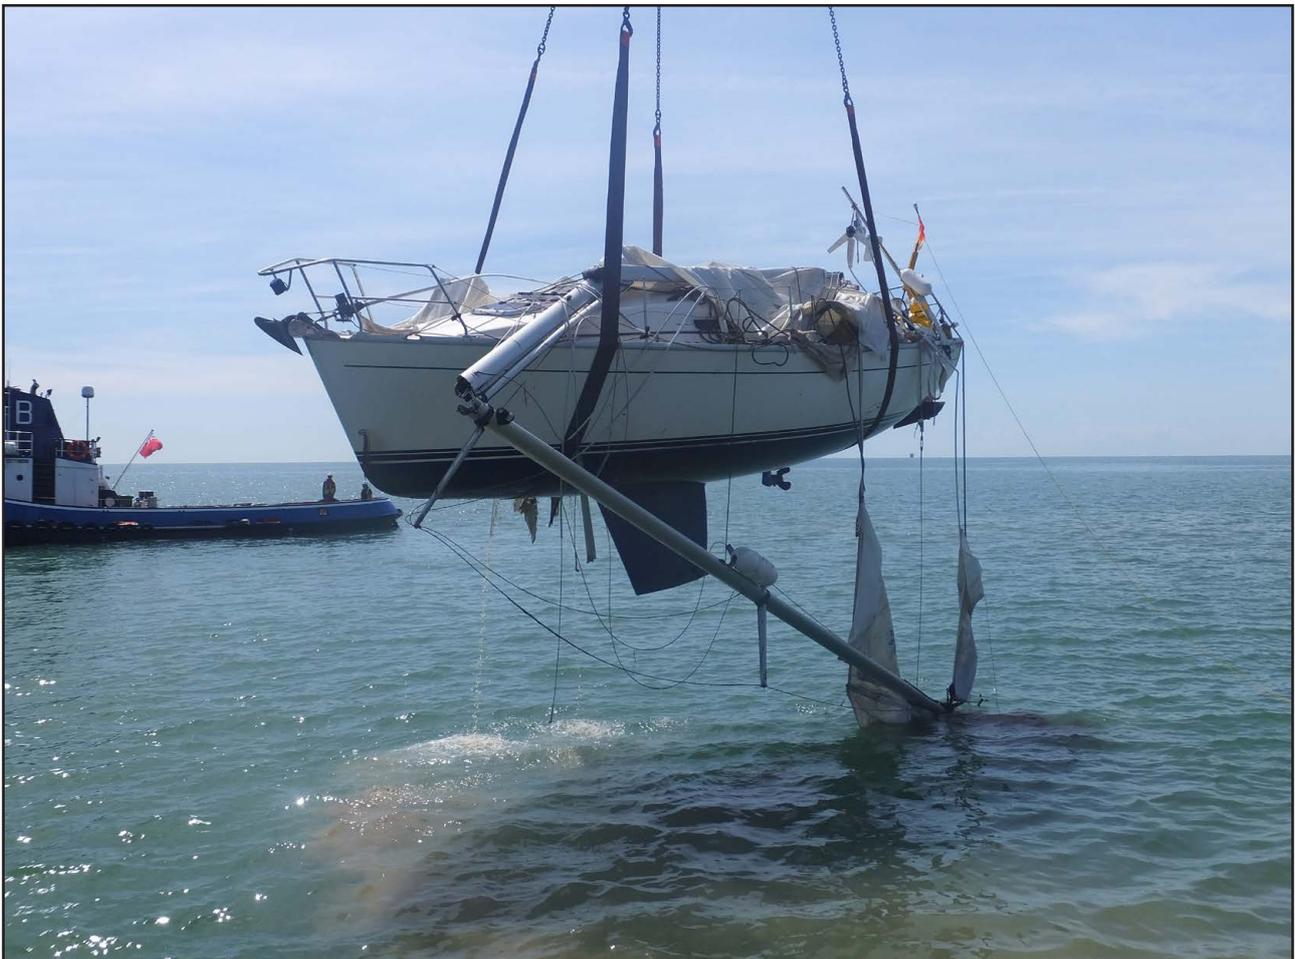
Figure 6: Recovery of *Orca*

On 12 June 2014 *Orca* was recovered from the seabed and taken ashore to Harwich by marine contractors employed by its insurers (**Figure 6**).

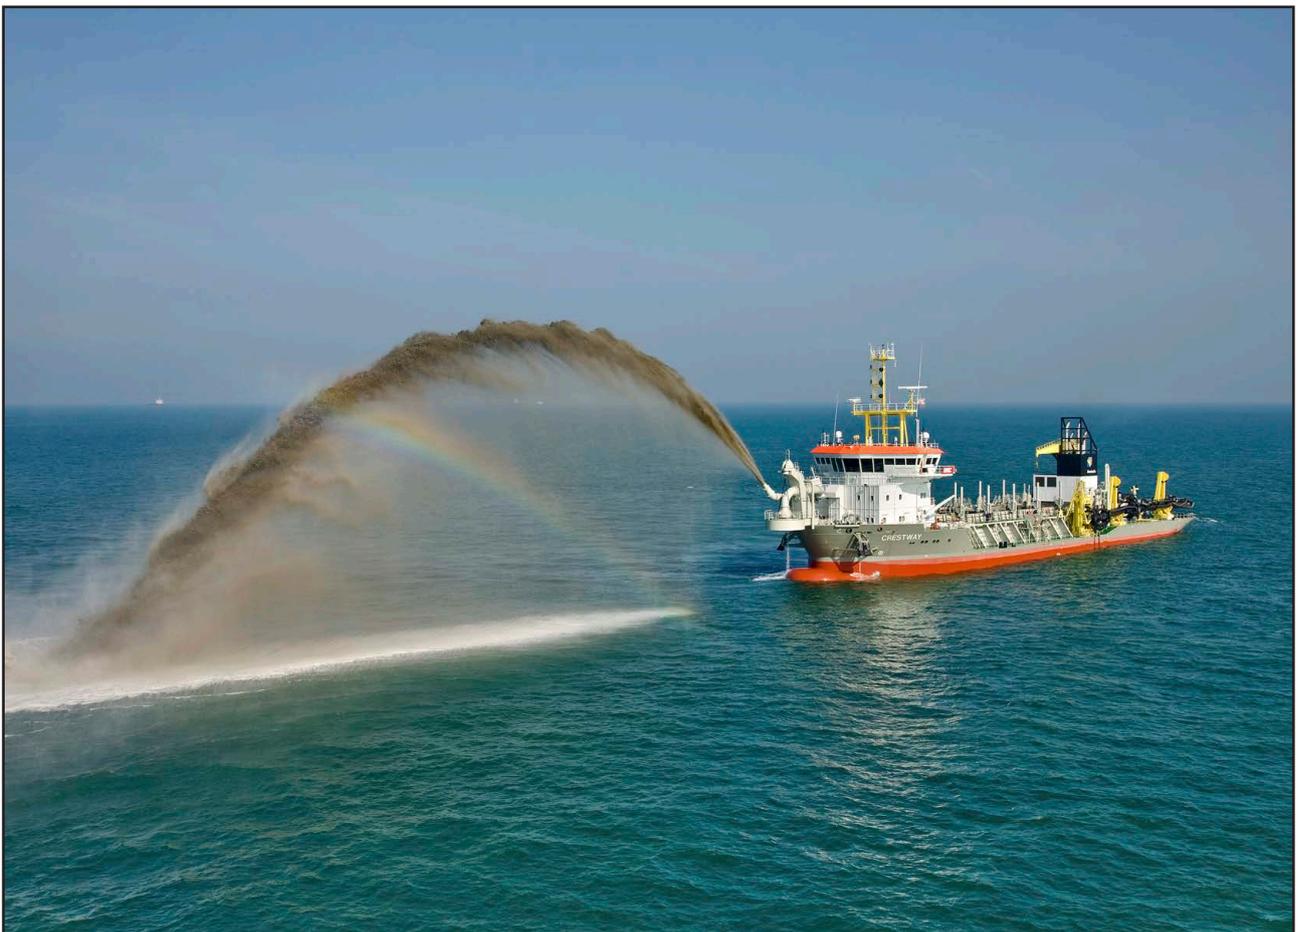
Figure 11: Rainbow discharge installation, *Crestway*

- Following an alteration of course by the chief officer on *Shoreway*, *Orca* entered a blind sector caused by the vessel's bow-mounted rainbow discharge equipment and remained unseen by the chief officer until seconds before the collision.

Shoreway was fitted with a rainbow discharge installation at the bow. This was made up of a coupling that enabled dredged materials to be pumped ashore via a floating pipeline and a rainbow nozzle which enabled direct discharge of dredge materials overboard at the bow (**Figure 11**).

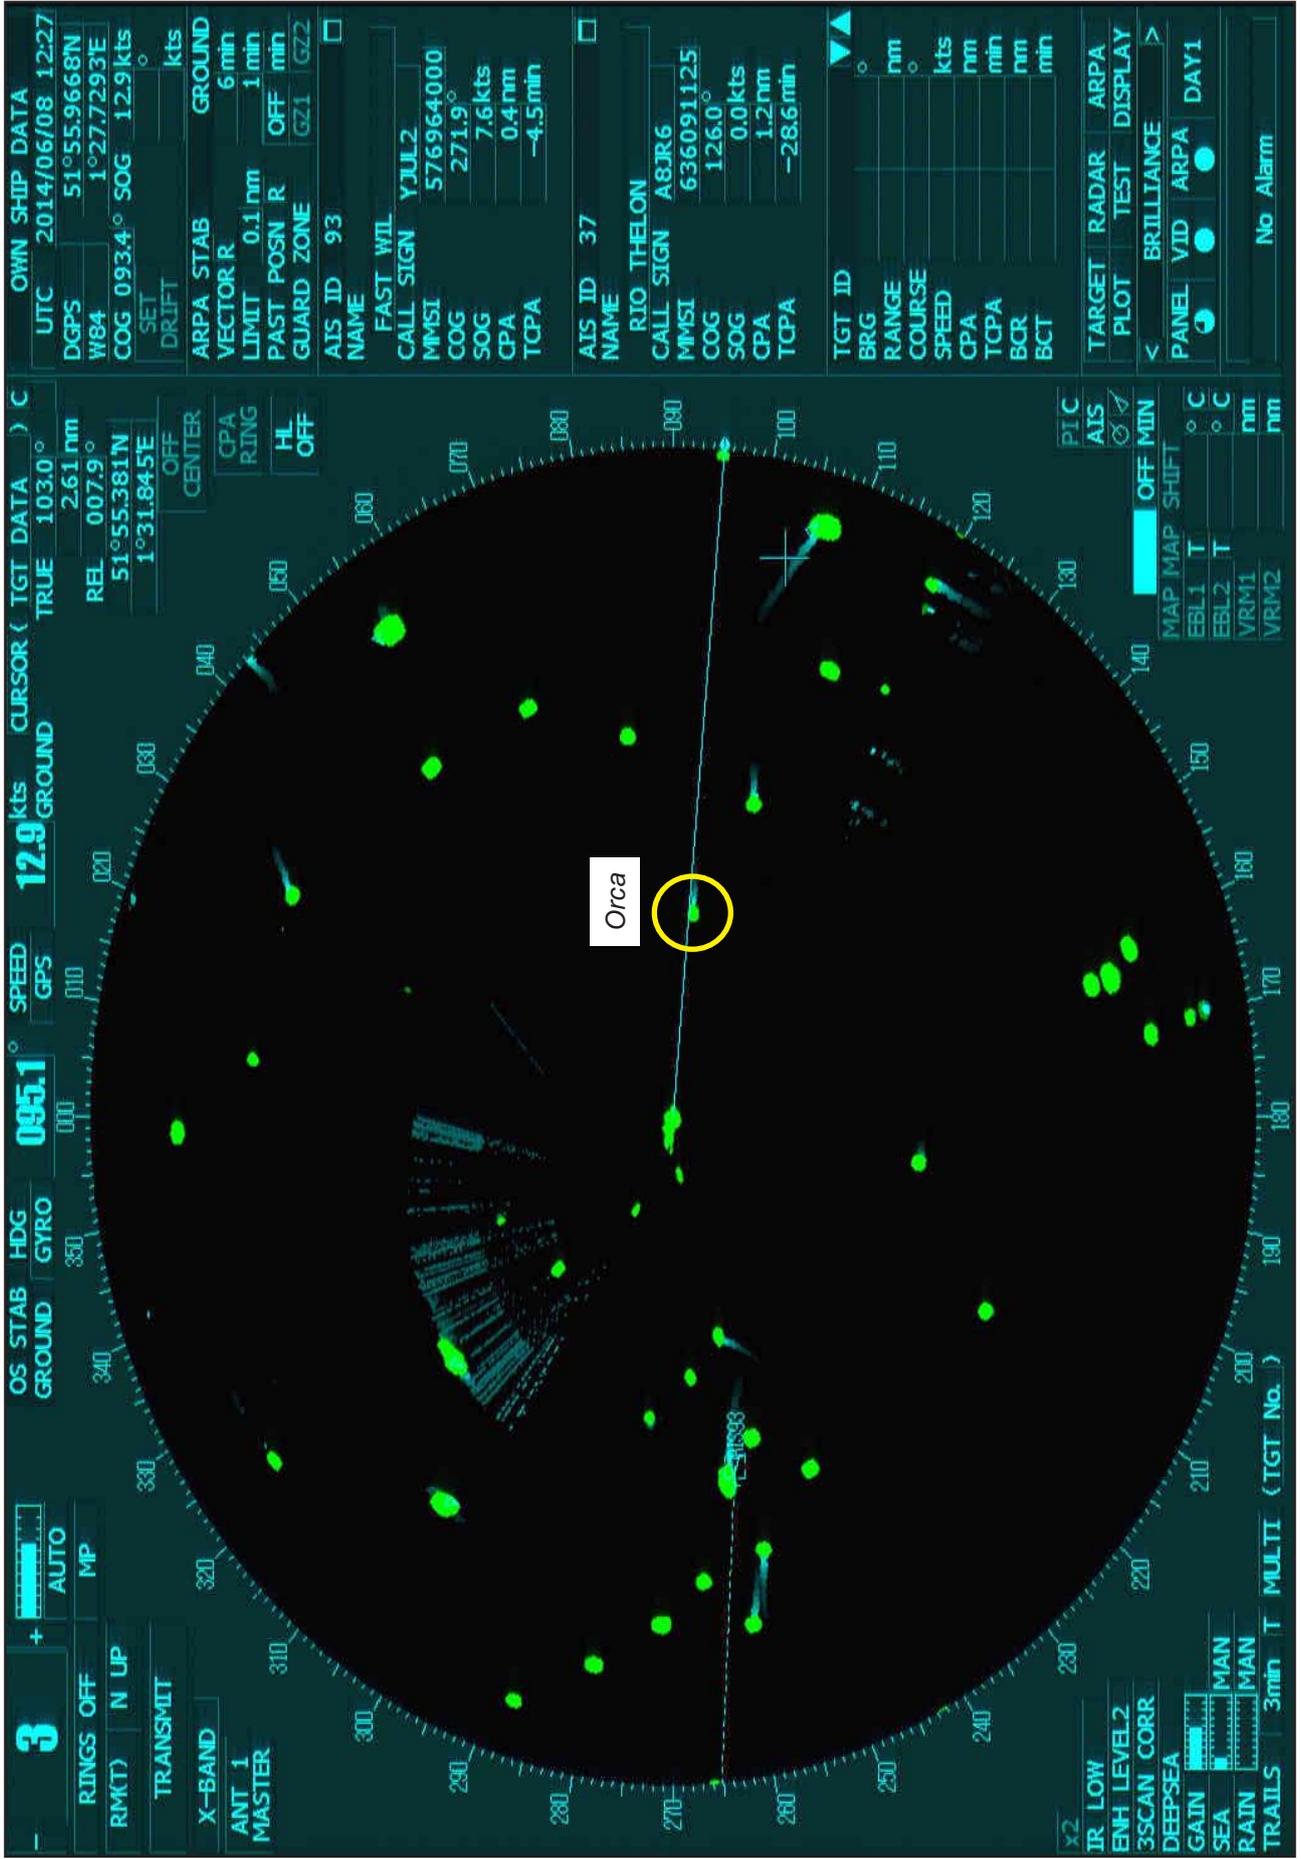
Figure 19: Radar picture from VDR (aspect ratio as captured by VDR)

Shoreway's 3cm radar was set on a 3-mile range. It was not affected by the visual blind sector caused by the rainbow discharge equipment and was the main conning radar. Its display was positioned on the starboard side of the horseshoe workstation facing the chief officer (**Figure 18**). *Orca* had generated a clear radar target that had been visible on the display for 11 minutes prior to the collision (**Figure 19**). Two AIS targets had been automatically acquired earlier in the watch, and had passed clear with target data still displayed on the radar display. However, the weather conditions were good and the chief officer had not recognised the need to look at the radar or make use of its ARPA function. Therefore *Orca*'s target had not been seen, acquired or plotted.

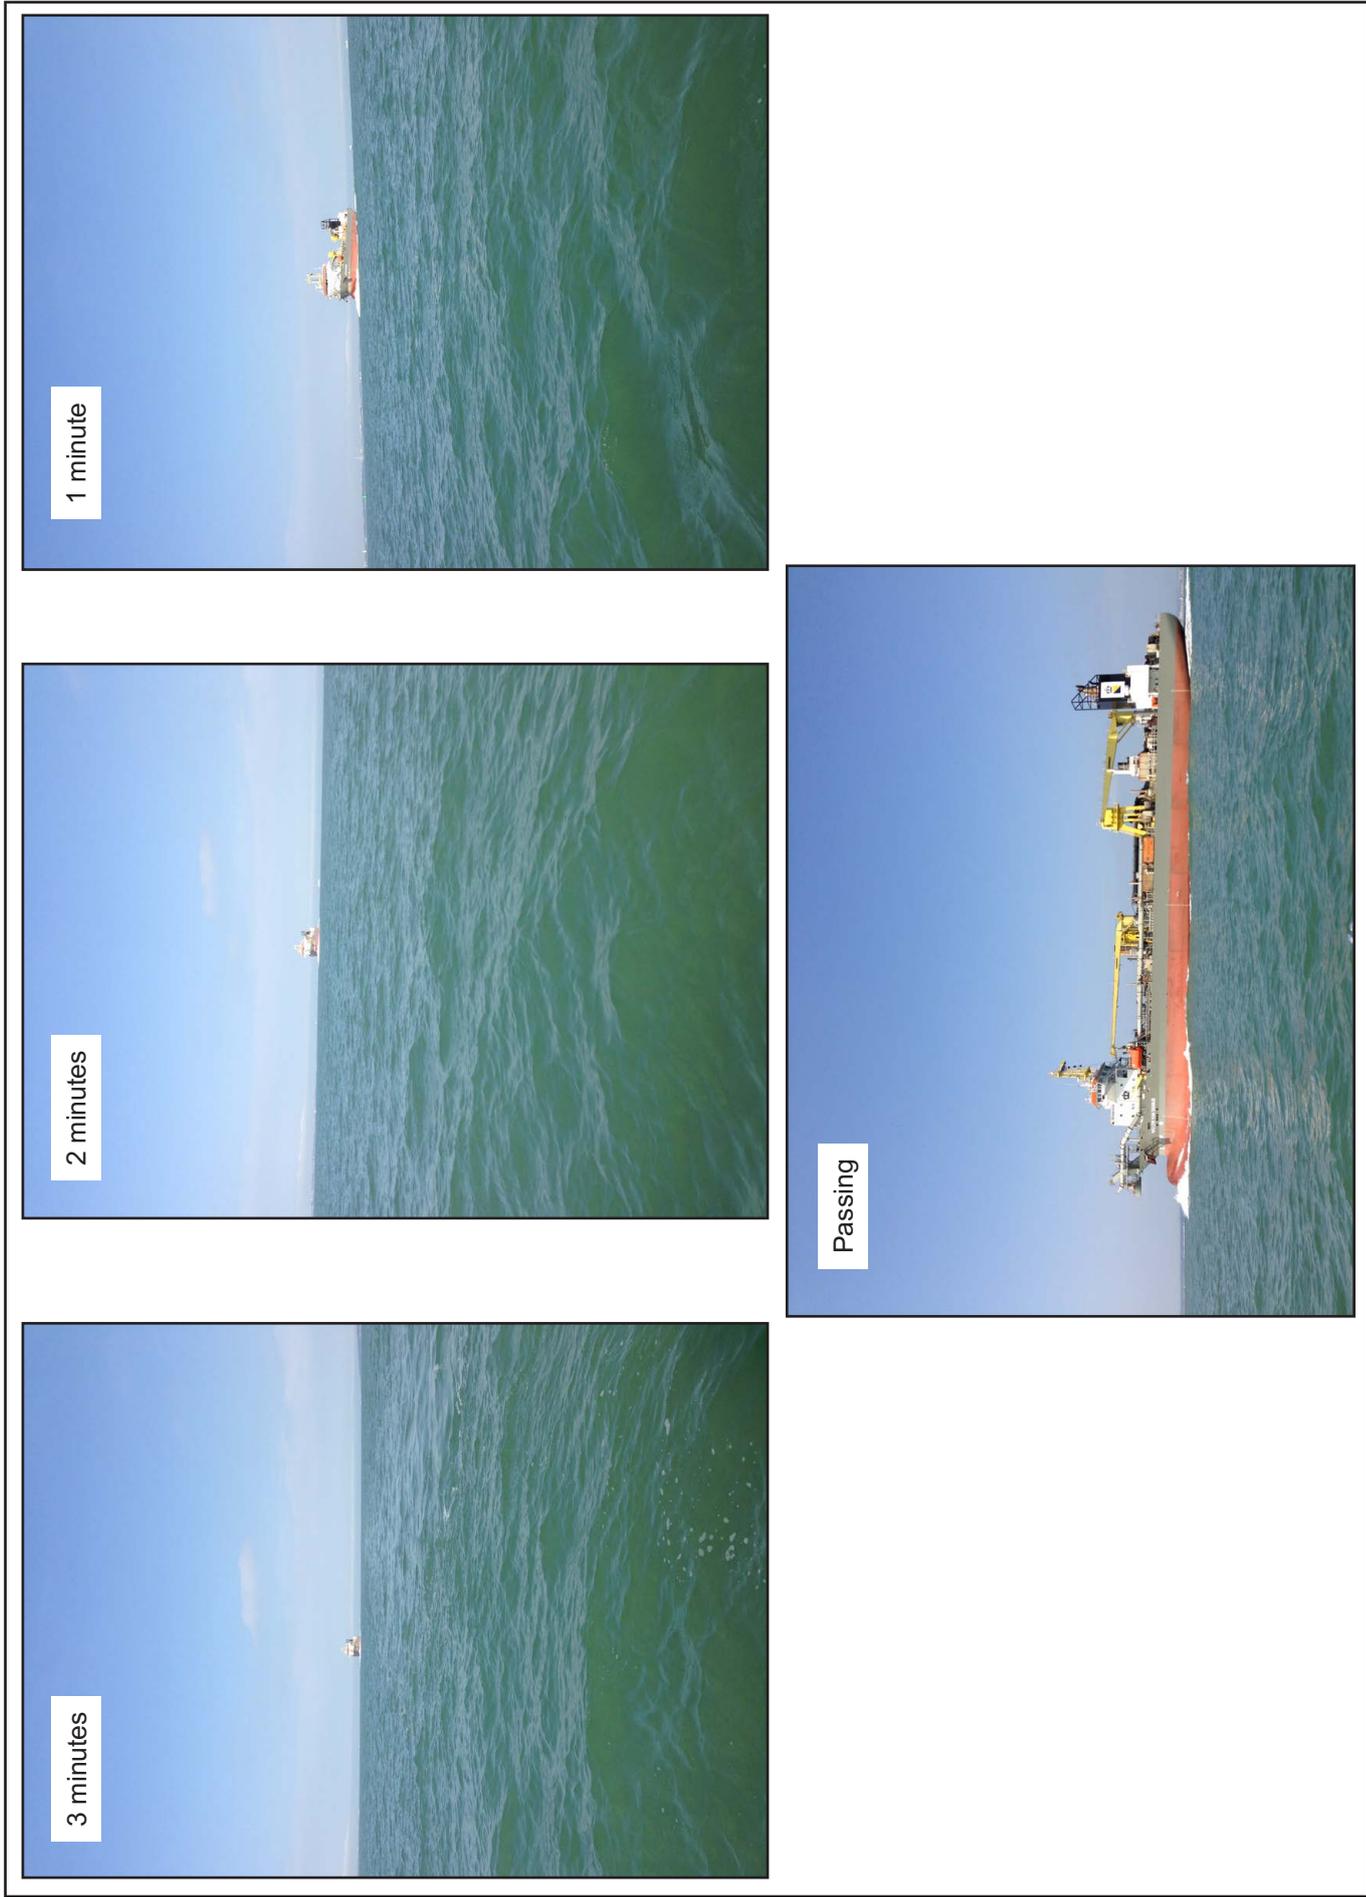
Figure 20: Dredger closing sequence

A sequence of photos, taken from a stationary vessel gives an indication of how rapidly a vessel (in this case a dredger) can approach (**Figure 20**).
