Report on the investigation
into the flooding and abandonment
of the general cargo ship

Sea Breeze

11.6nm off Lizard Point, Cornwall

9 March 2014

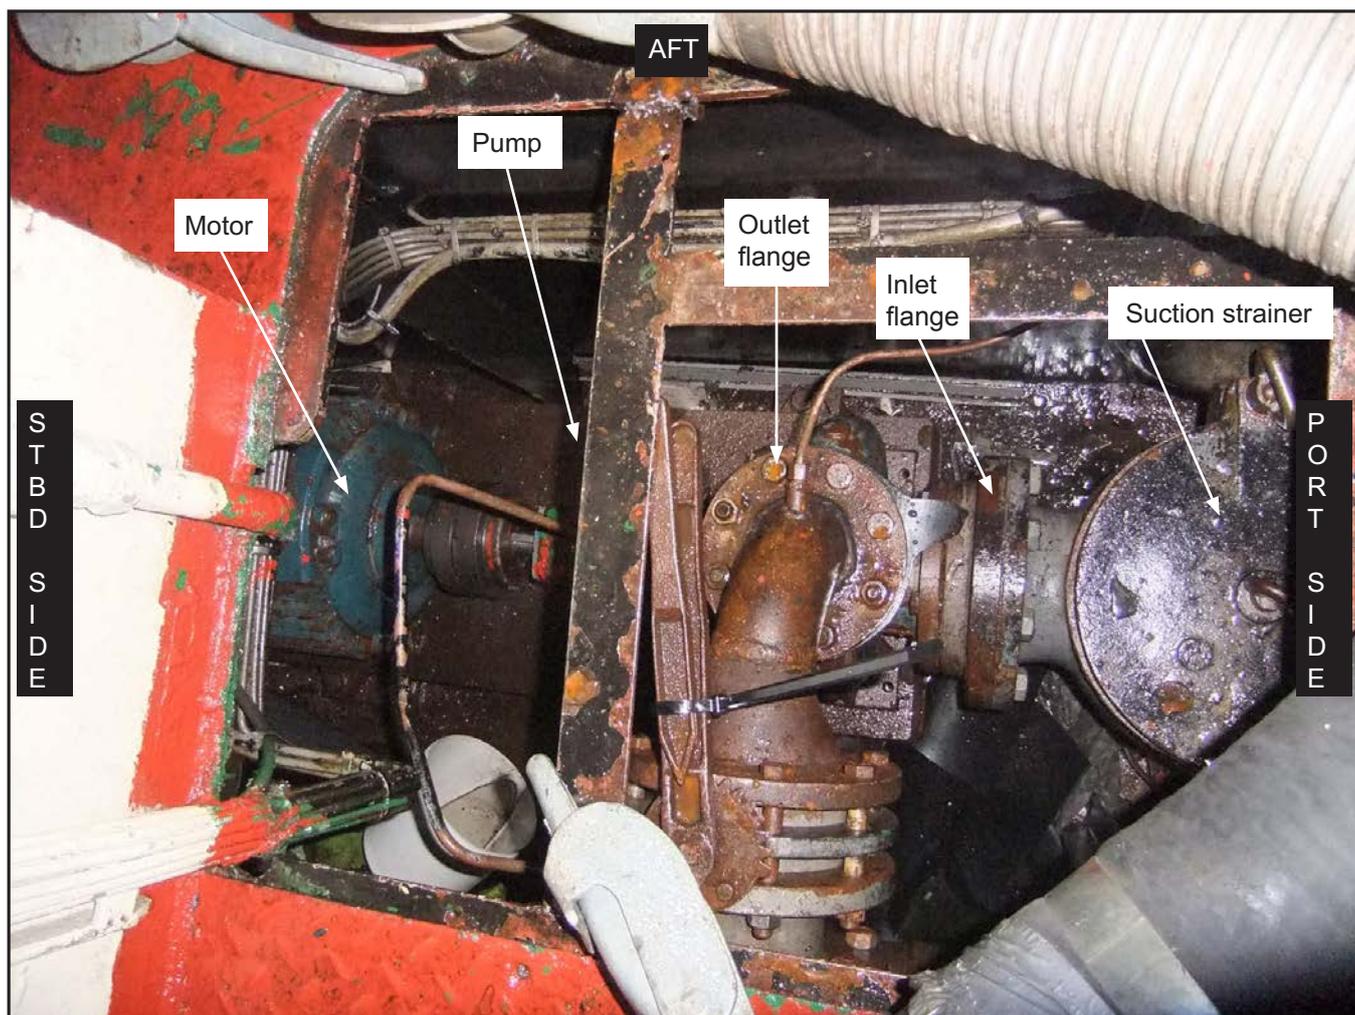
Figure 6: Starboard ballast pump viewed from above

At the time of the accident, maintenance work was being carried out on the port side ballast pump. *Sea Breeze* had two identical, electrically-driven ballast pumps, one on each side of the engine room, each with a maximum pumping capacity of 150m³/hour. The starboard ballast pump (**Figure 6**) was also designated as an emergency bilge pump and general service pump. *Sea Breeze* had 15 dedicated ballast tanks, with a combined capacity of 1504t.

On 3 and 4 March, while *Sea Breeze* was on passage from Moerdijk to Liverpool, the chief engineer, motorman and AB had replaced the mechanical seal on the starboard ballast pump. Both pump's shafts were known to be worn in way of their mechanical seals but the replacement of the seal on the starboard pump had successfully stopped the leakage.

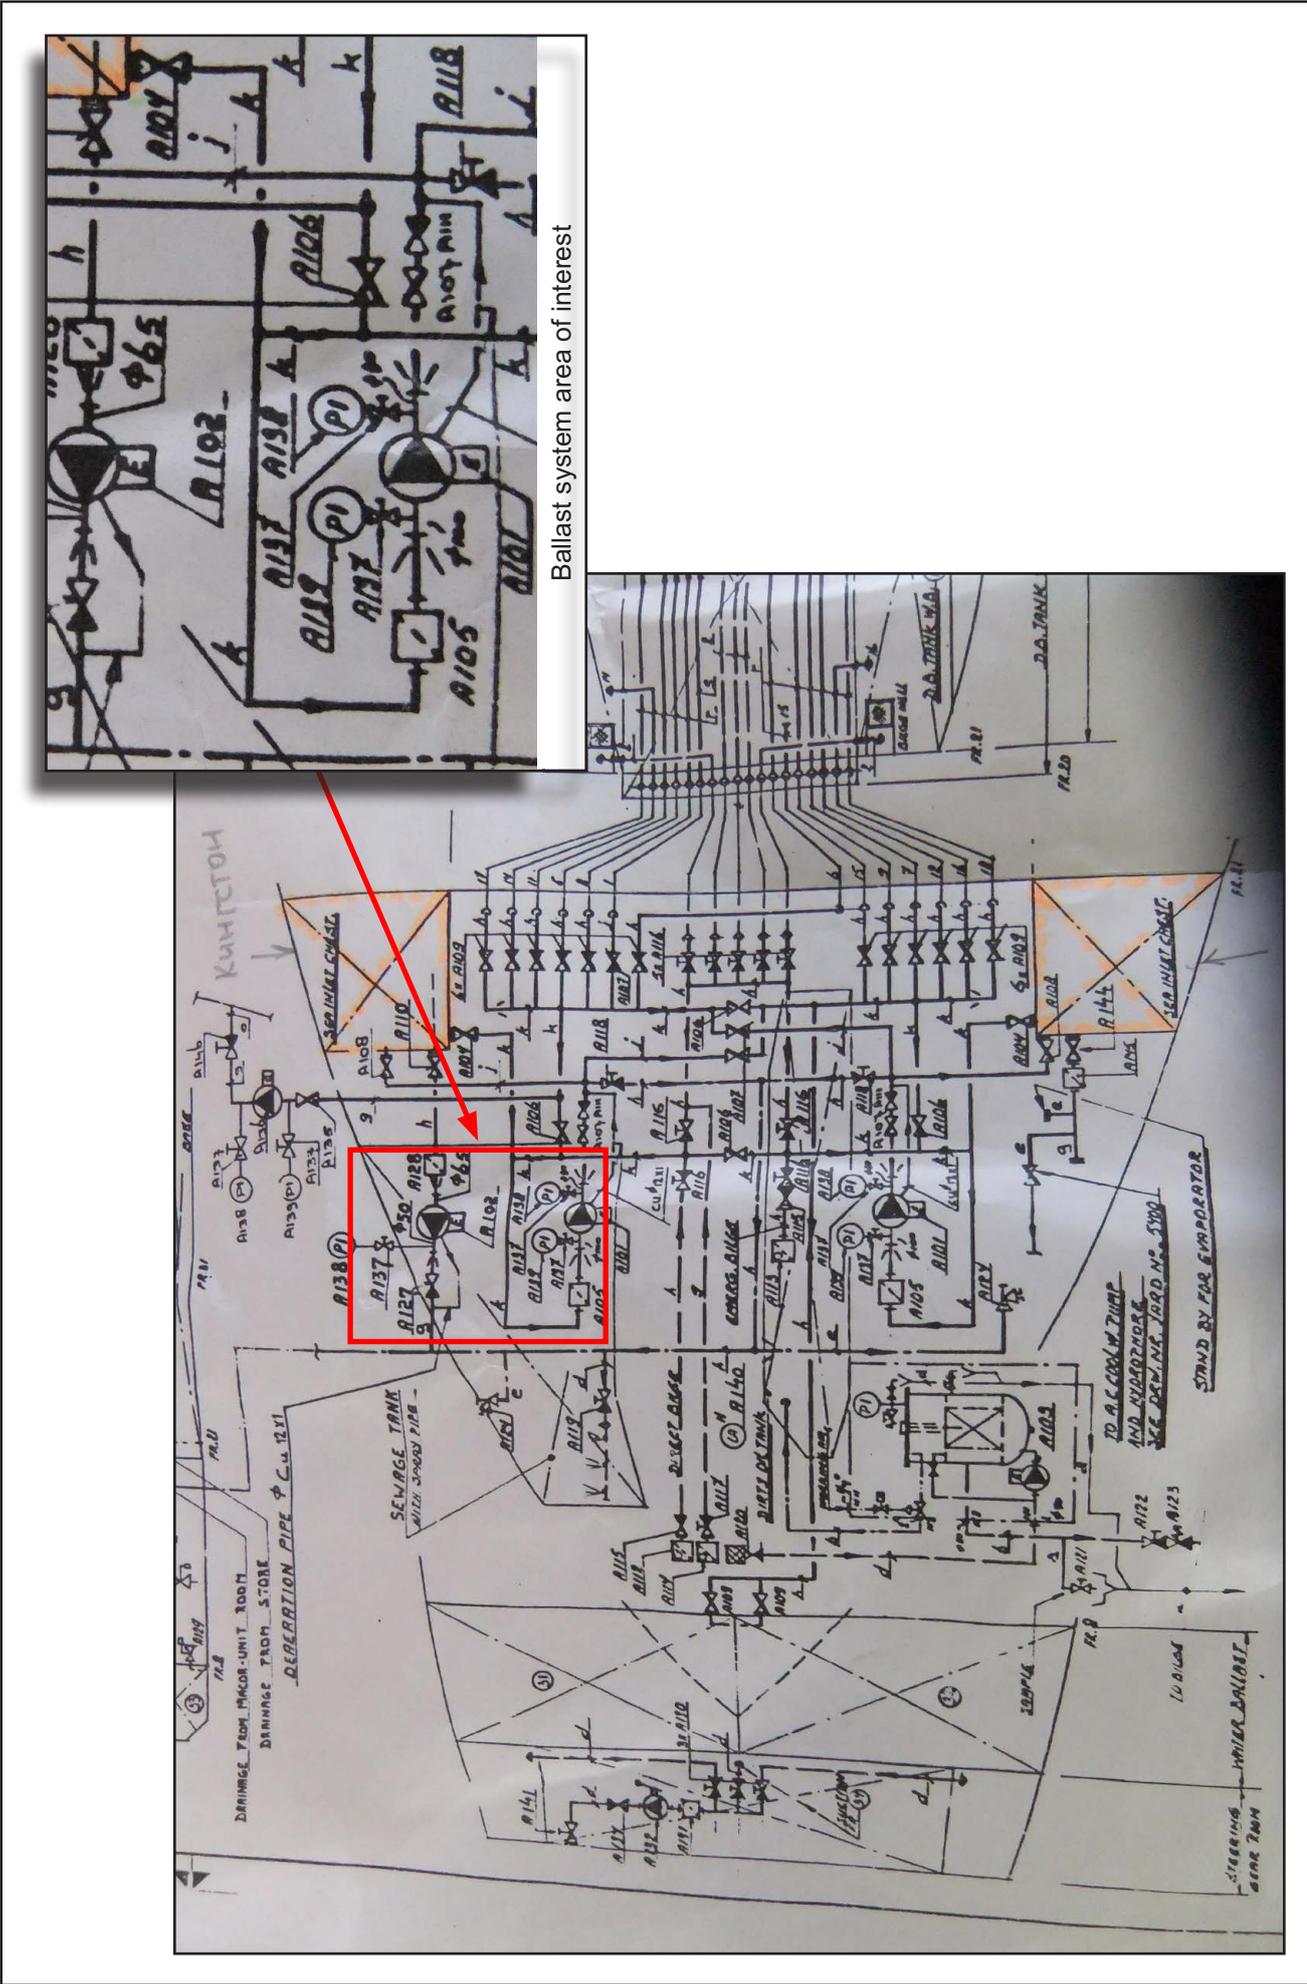
Figure 10: Ballast system drawing - with inset

There were no written procedures on board *Sea Breeze* that covered the removal of a ballast pump. However, with appropriate prior planning, the job was straightforward and should not have caused the crew any difficulties. The ballast system drawing (**Figure 10**) was accurate and identified all the valves that needed to be shut in order to isolate the pump. Furthermore, the same three crew had successfully completed maintenance on the vessel's starboard ballast pump 5 days earlier, when all the necessary valves had been properly closed.
