Grounding of the general cargo ship

Vectis Eagle

Gijon, Spain

30 November 2014

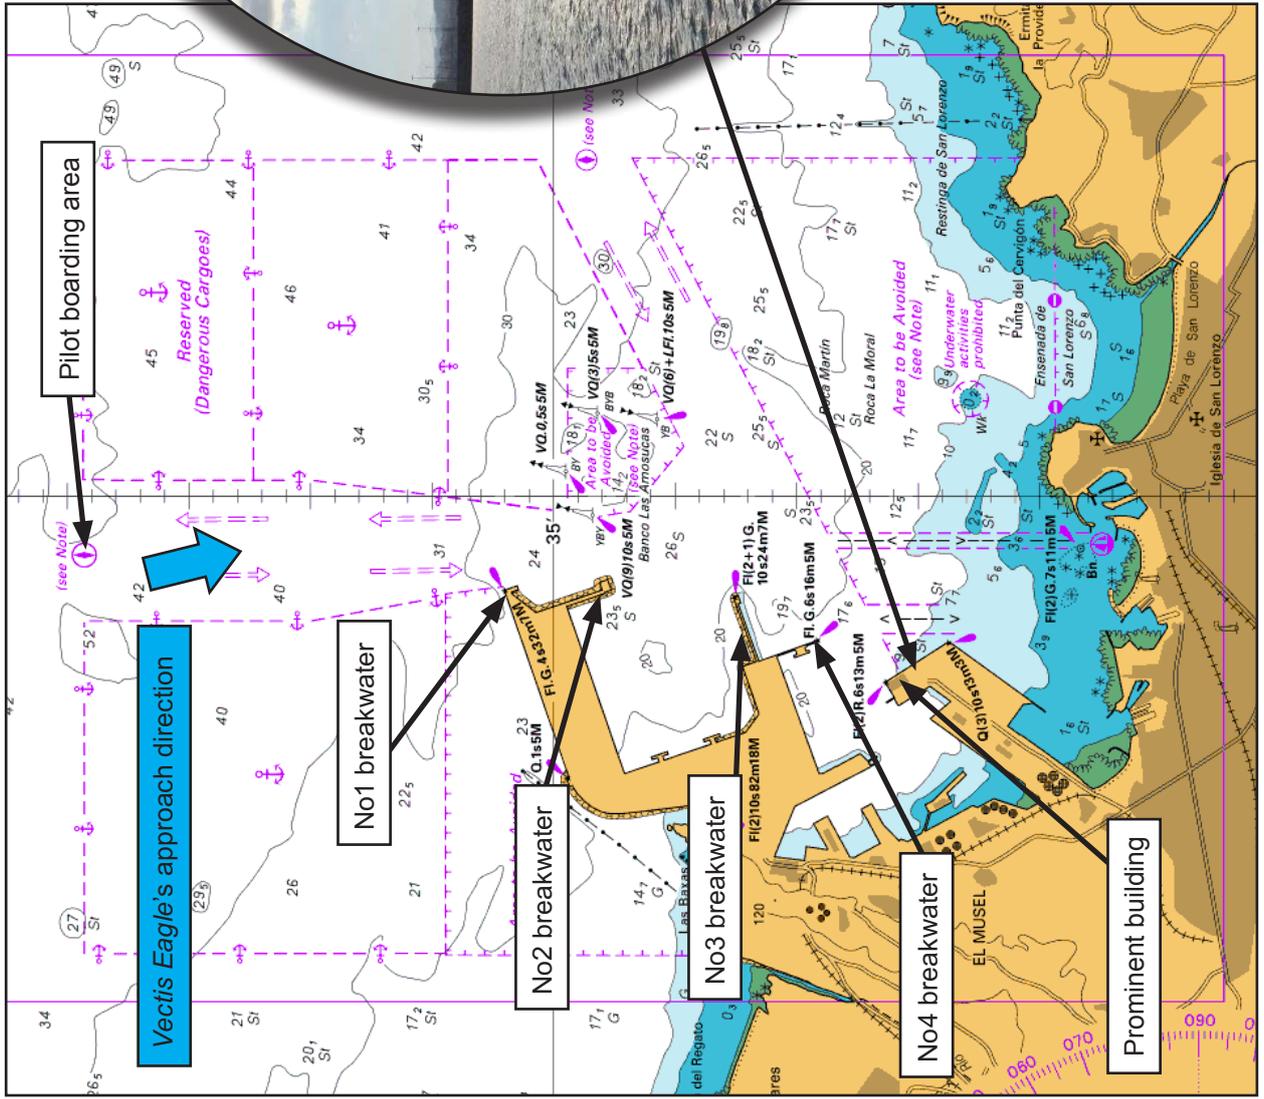
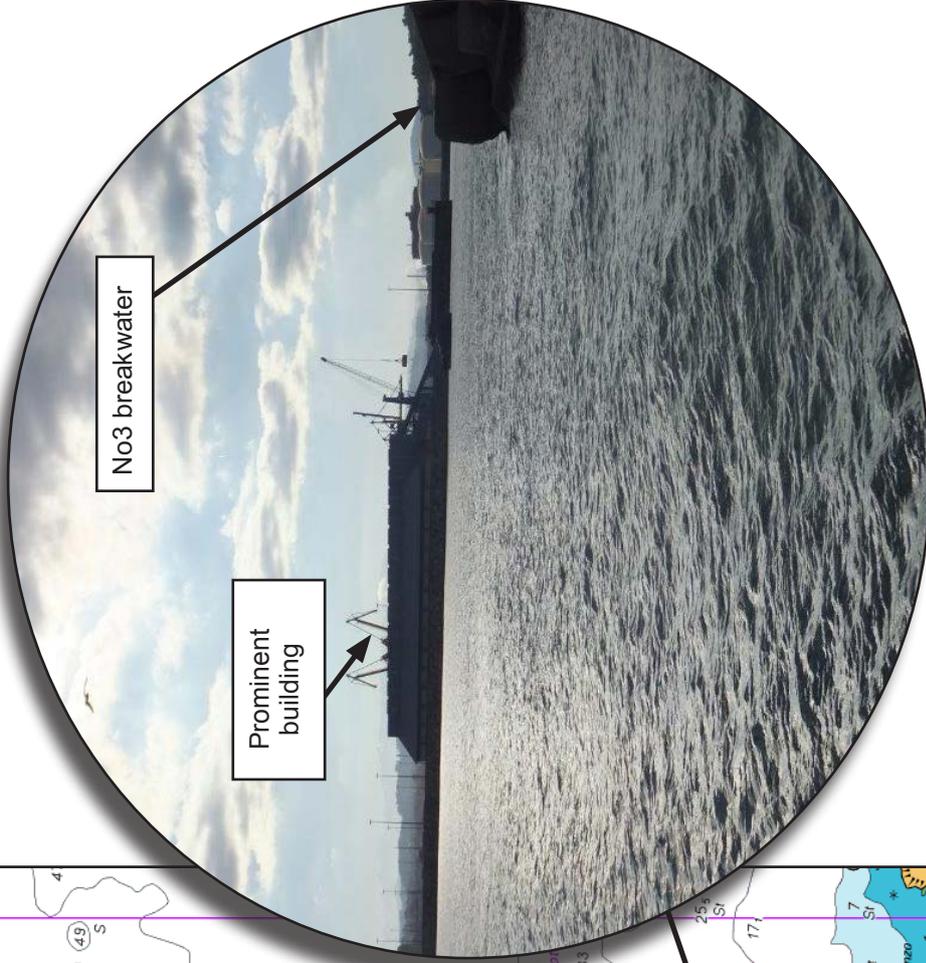
Figure 1: Port of Gijón

The pilot navigated primarily by eye and routinely used a prominent building sited on the southern side of the port (**Figure 1**) as a visual reference. It was the pilot's usual practice on passing breakwater No3 to keep the western side of the building open from the end of breakwater No4. The distance the pilot planned to pass off No4 breakwater took into account the draught and size of the relevant vessel; the larger the ship, the greater the distance. He routinely piloted smaller cargo vessels within 50m of the breakwater ends. The pilot did not document his passage plan.

The pilot also started to turn the vessel around the southern end of No4 breakwater too early. It is not clear why he made this error of judgment, although his use of the prominent building (**Figure 1**) as a visual reference was prone to inaccuracy, and his view of the breakwater was possibly obscured by *Vectis Eagle*'s deck cranes (**Figure 1**). It is also possible that the pilot had not fully appreciated the manoeuvring characteristics of the vessel.

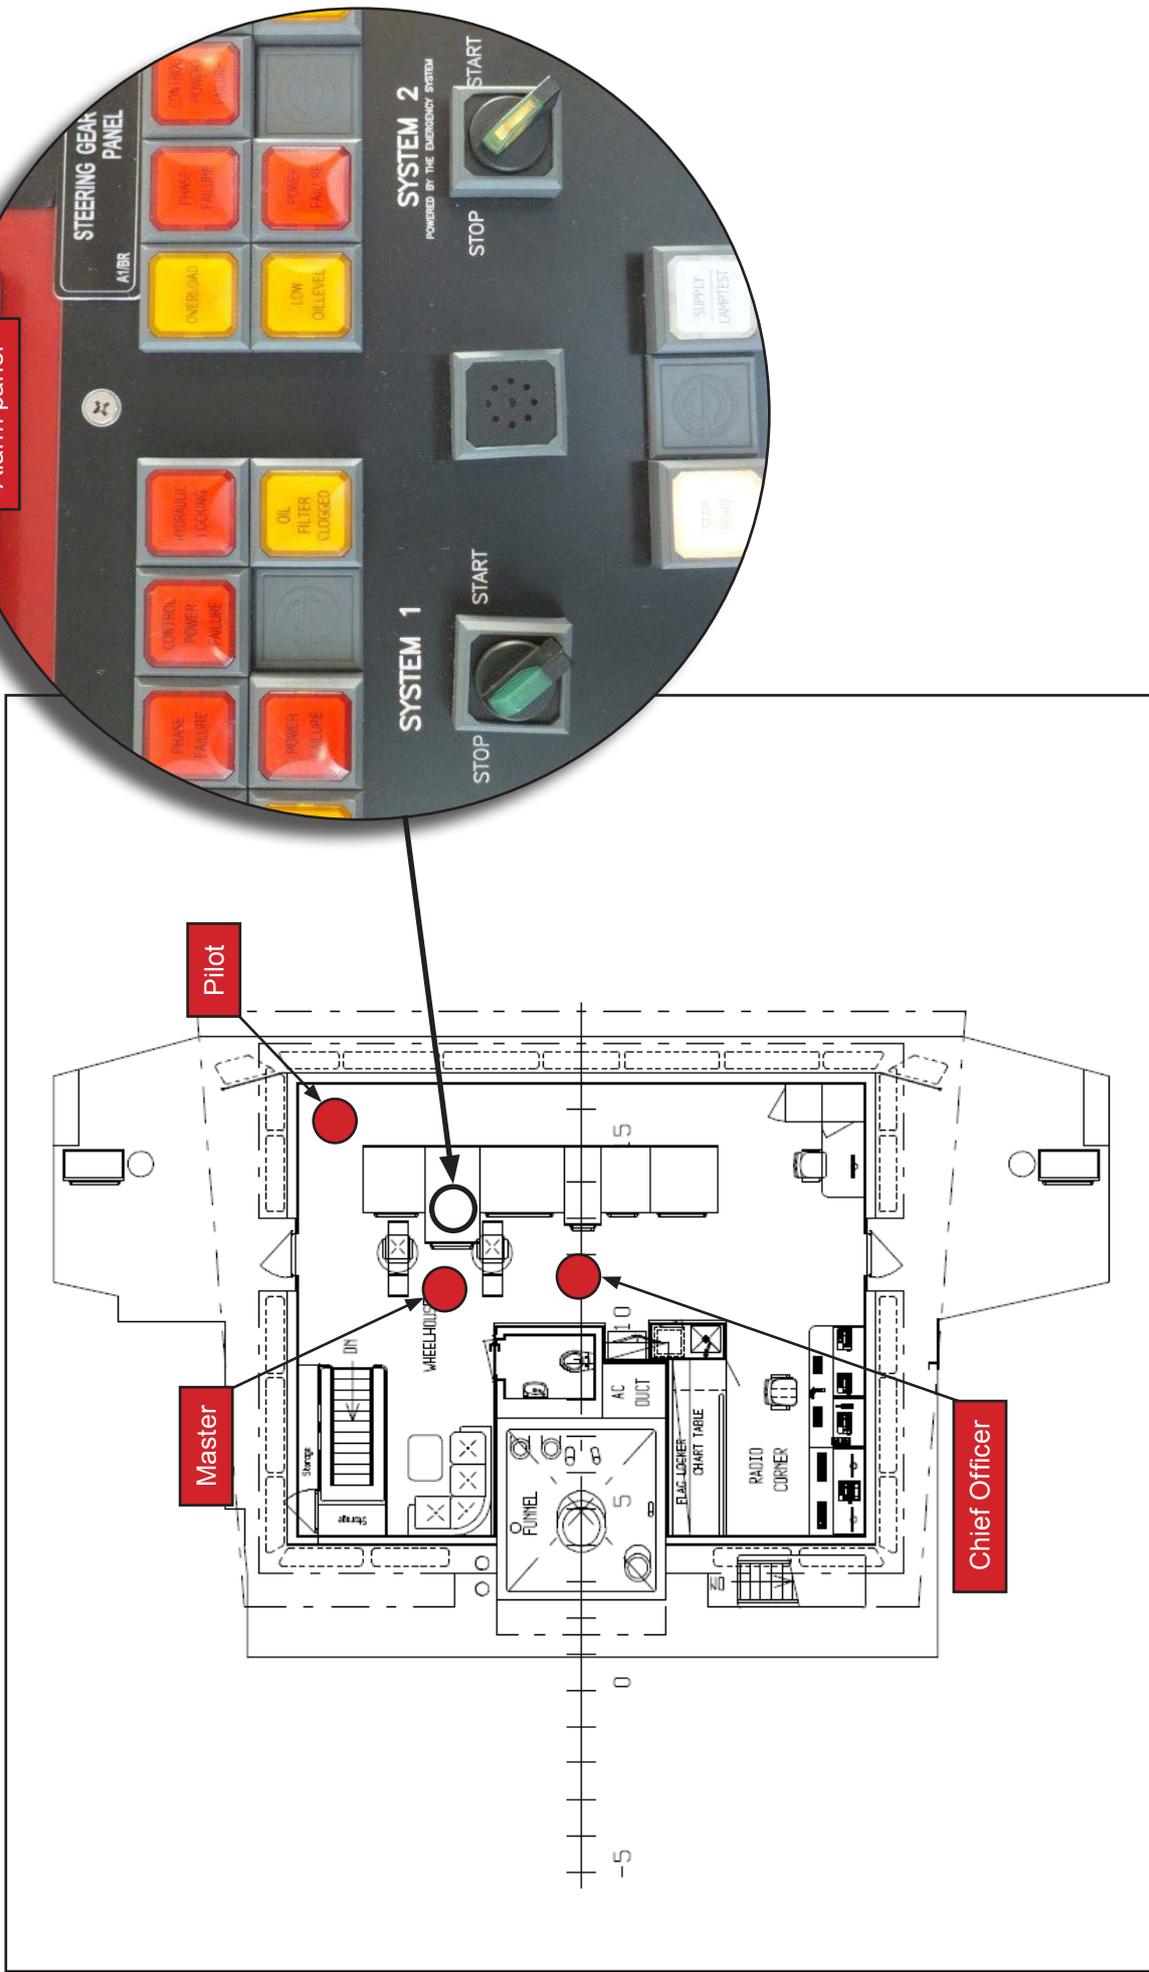
Figure 2: Bridge layout

For the entry, the pilot had the conn and generally stood at the front of the bridge, forward of the console (**Figure 2**). The master stood to port of the ship's helm, adjacent to the engine and the bow thruster controls and the VHF radio. He could see the ECDIS³ from this position. The master and the pilot continued to exchange information regarding the ship's characteristics and local conditions. Neither the pilot's nor the ship's plan for the vessel's passage to its berth were discussed.

The hydraulic steering motors were controlled independently and each system was fitted with seven alarms that sounded and were displayed on the bridge (**Figure 2**). Steering alarms were recorded on an electronic alarm log in the engine control room, which showed that no system alarms had been activated during the vessel's entry into Gijon.
