Rail Accident Report

**Near miss involving track workers near Hest
Bank, Lancashire
22 September 2014**

Report 08/2015
July 2015

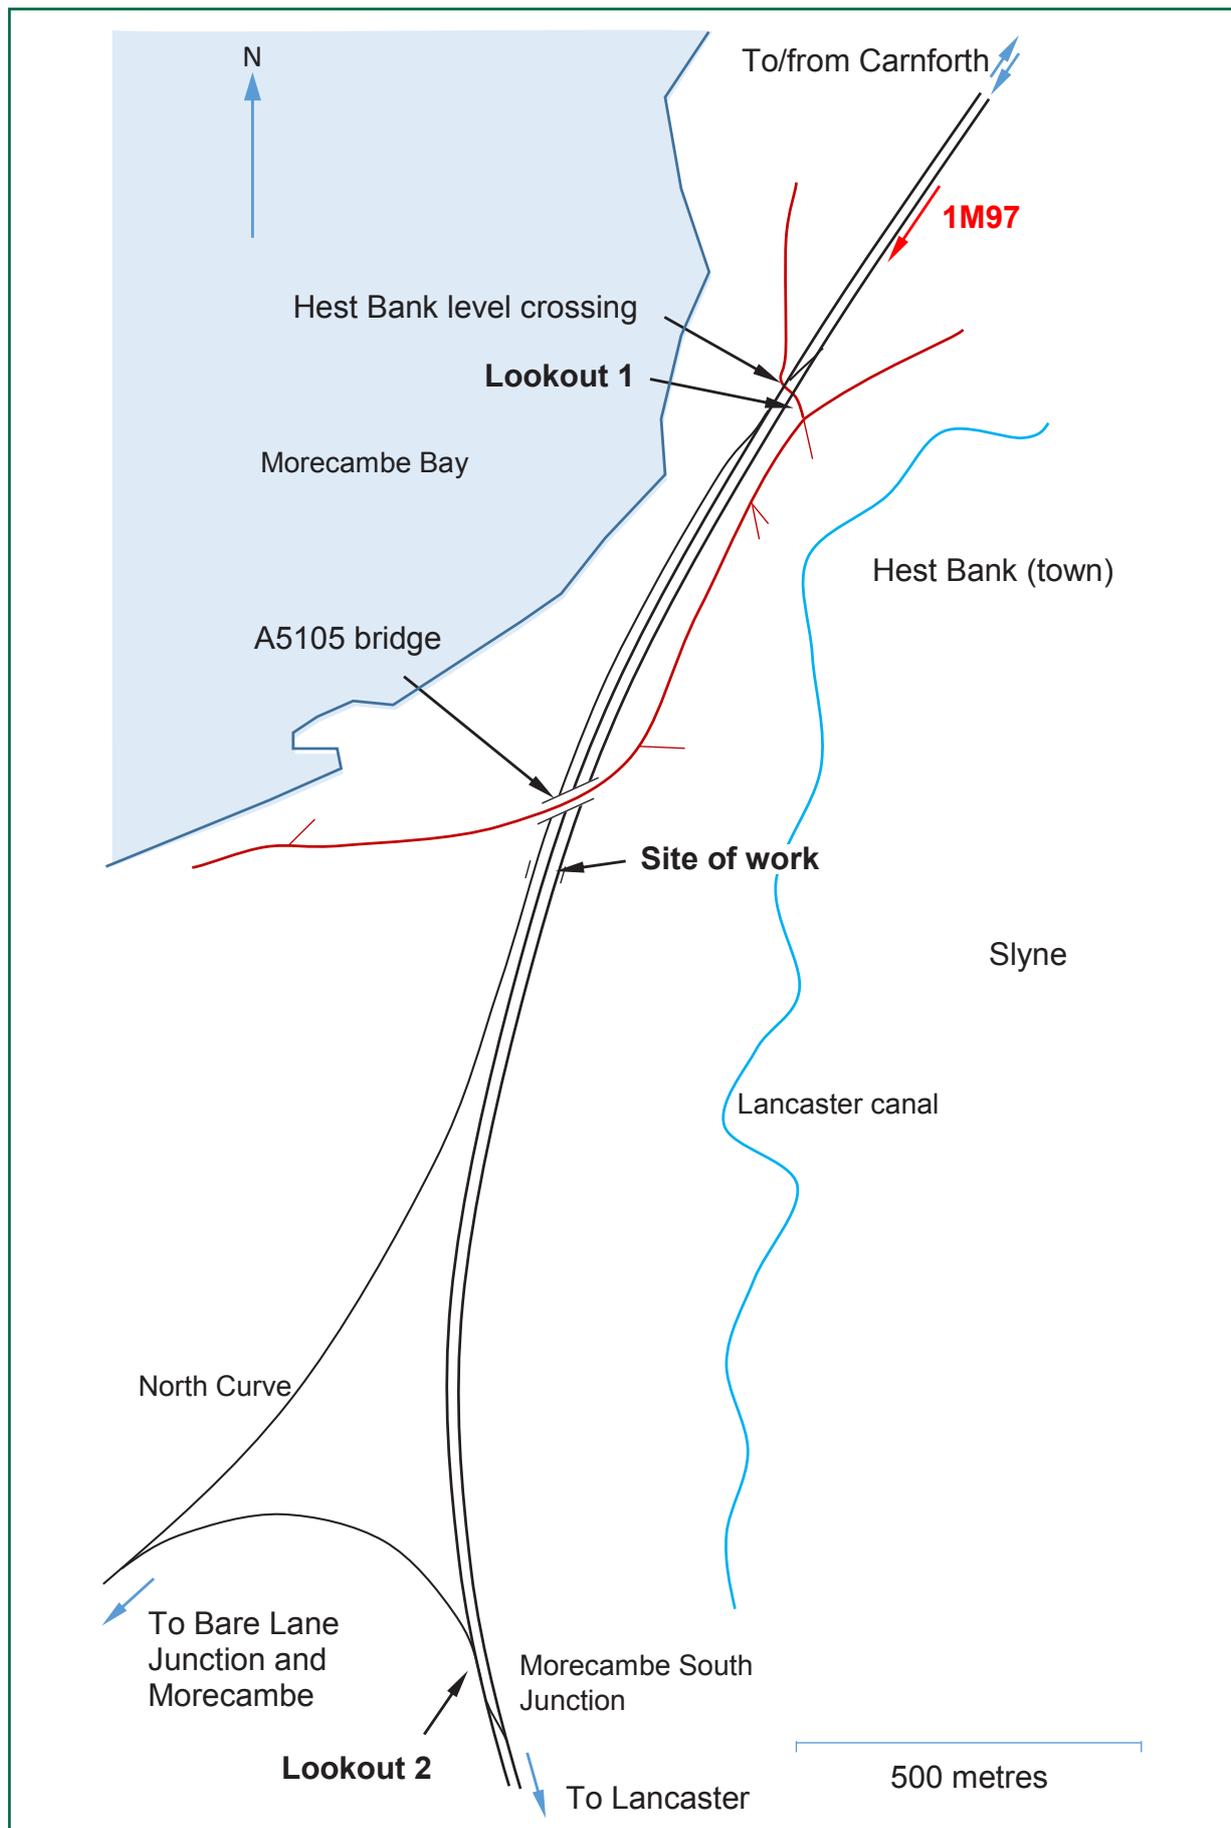
Figure 3: map showing track layout and location of staff

- 7 The site of work was located at 2 miles 52 chains² on the West Coast Main Line, 780 metres (853 yards) south of Hest Bank level crossing (Engineer's Line Reference CGJ7). At this location, the up and down main lines run parallel to the single line Down & Up Morecambe (North Curve) leading to Bare Lane Junction. The main lines, on which trains can travel at up to 125 mph (201 km/h), are electrified with 25 kV overhead equipment. An overhead neutral section is located 280 metres south of the site of work. The North Curve, on which trains can travel at up to 45 mph (72 km/h) in either direction, is not electrified (figure 3).

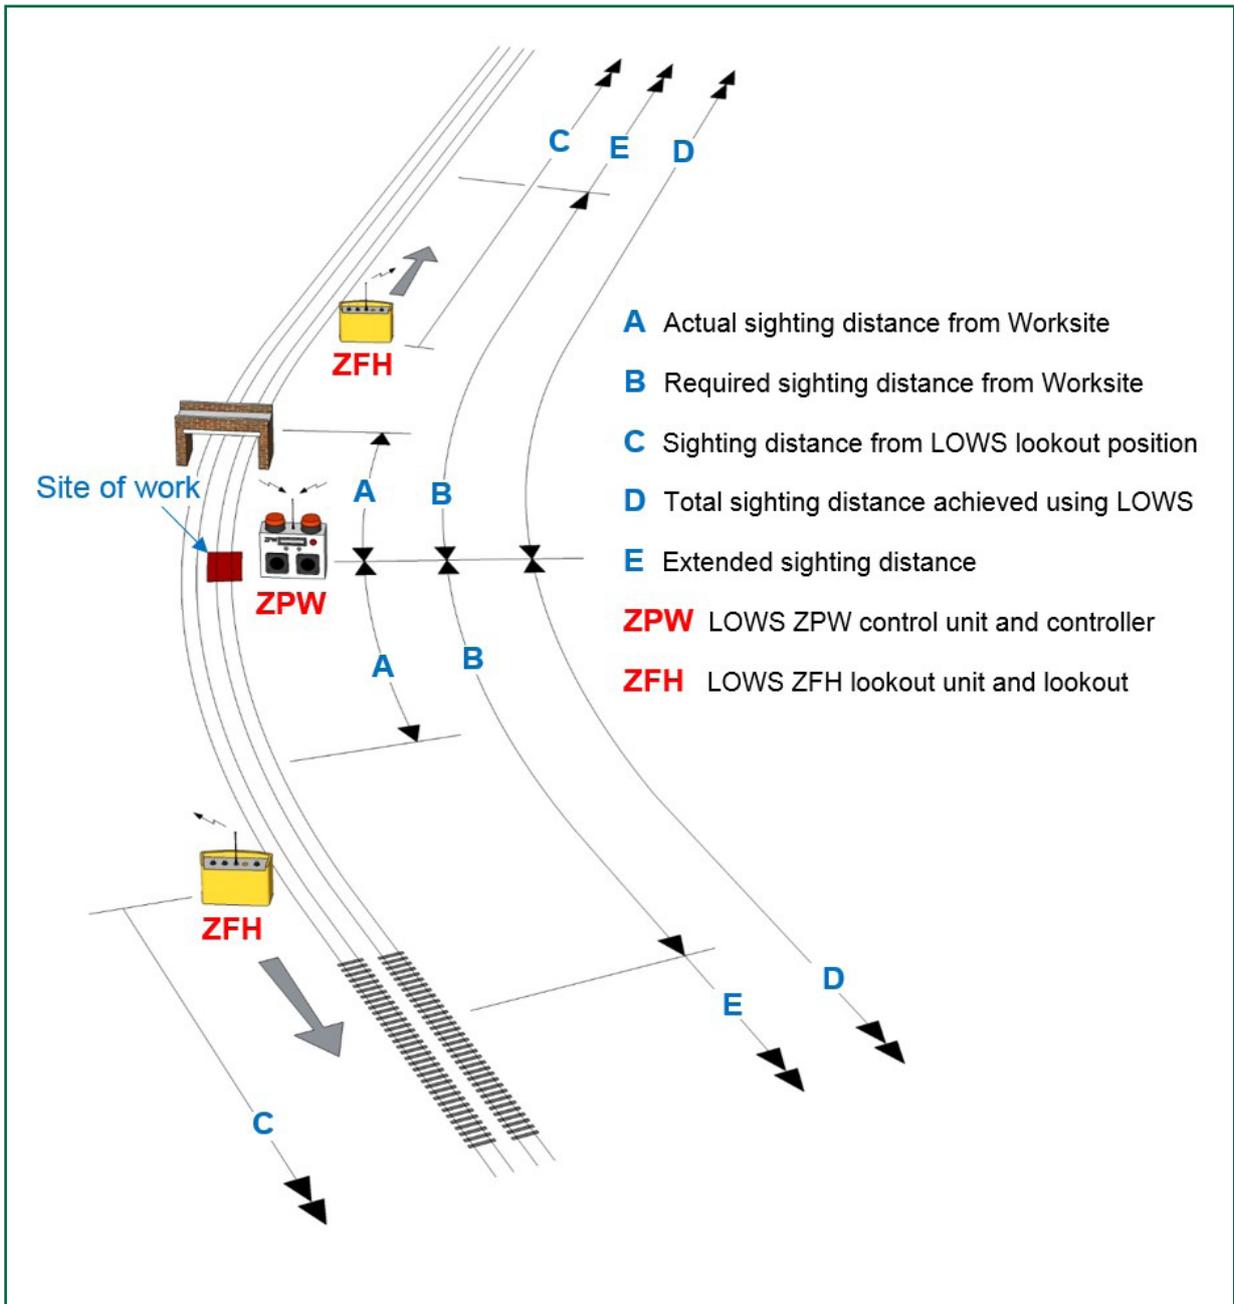
Figure 4: Schematic diagram of LOWS equipment in use

- a. the Lookout mistakenly operated the operator vigilance switch instead of the warning activation switches (paragraph 58); and/or
 - b. the Lookout forgot about the need to send a warning after delaying his response because of the extended sighting distance available (paragraph 65 and figure 4).

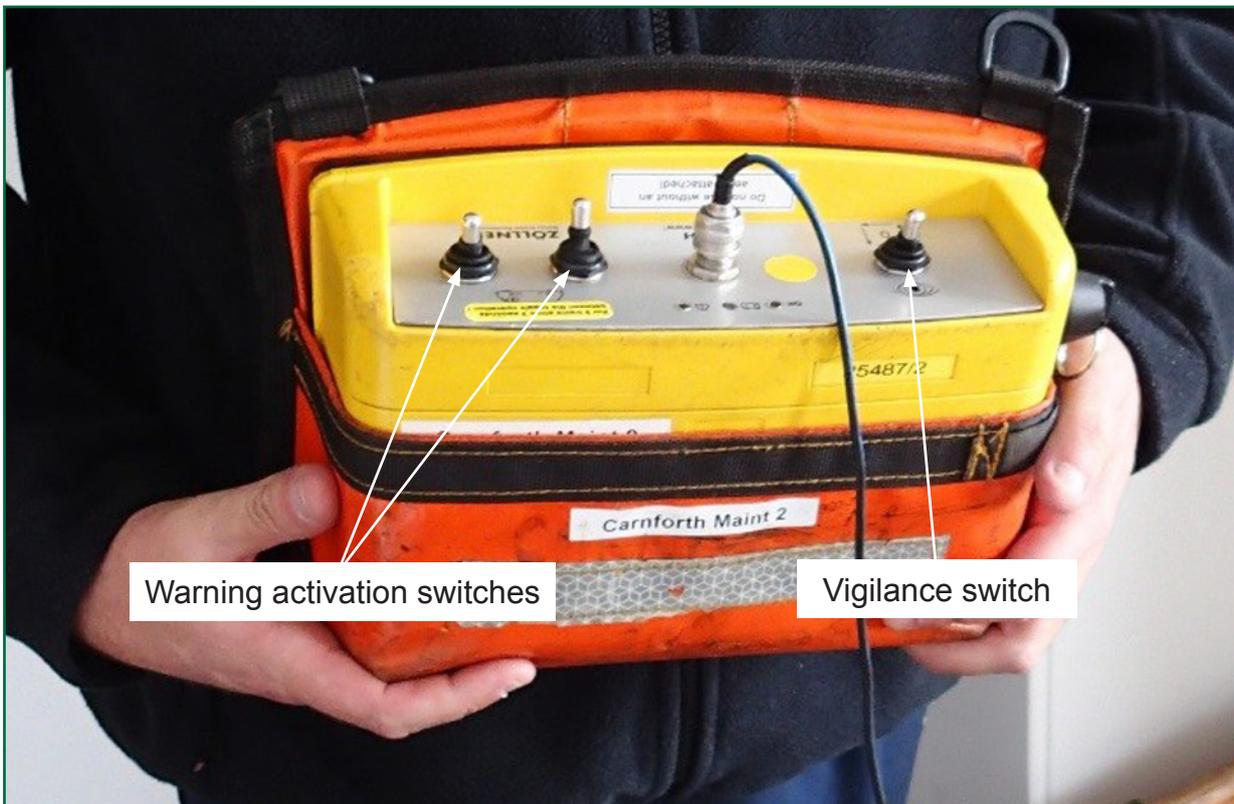
Figure 6: ZFH lookout operated transmitter unit

- 60 The vigilance toggle switch is the same size and shape as the warning activation toggle switches (figure 6). The ZFH lookout unit emits similar tones for both the vigilance alarm and operation of the warning activation switches. These audible warnings are distinguished only by the vigilance alarm being a continuous tone and the warning activation being two short bleeps.
