Combined report on the investigations of  
Two fatalities connected with the  
operation of the workboat

***GPS Battler***

off Almeria, Spain

in Marin, Spain

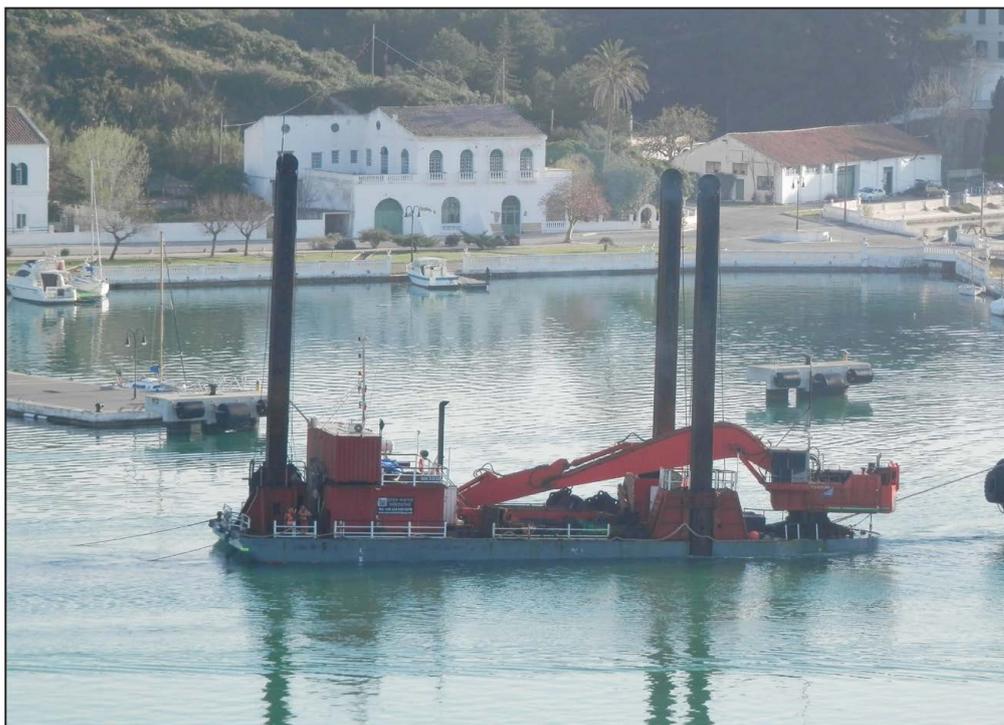
**Figure 1:** *Von Rocks*

*GPS Battler* sailed from Mahon, Menorca with the unmanned dredger *Von Rocks* (**Figure 1**) in tow on 6 August 2014 for passage to Marin on the north coast of Spain. The workboat was expected to complete the 1040 mile voyage before 3 September. No stops were planned.

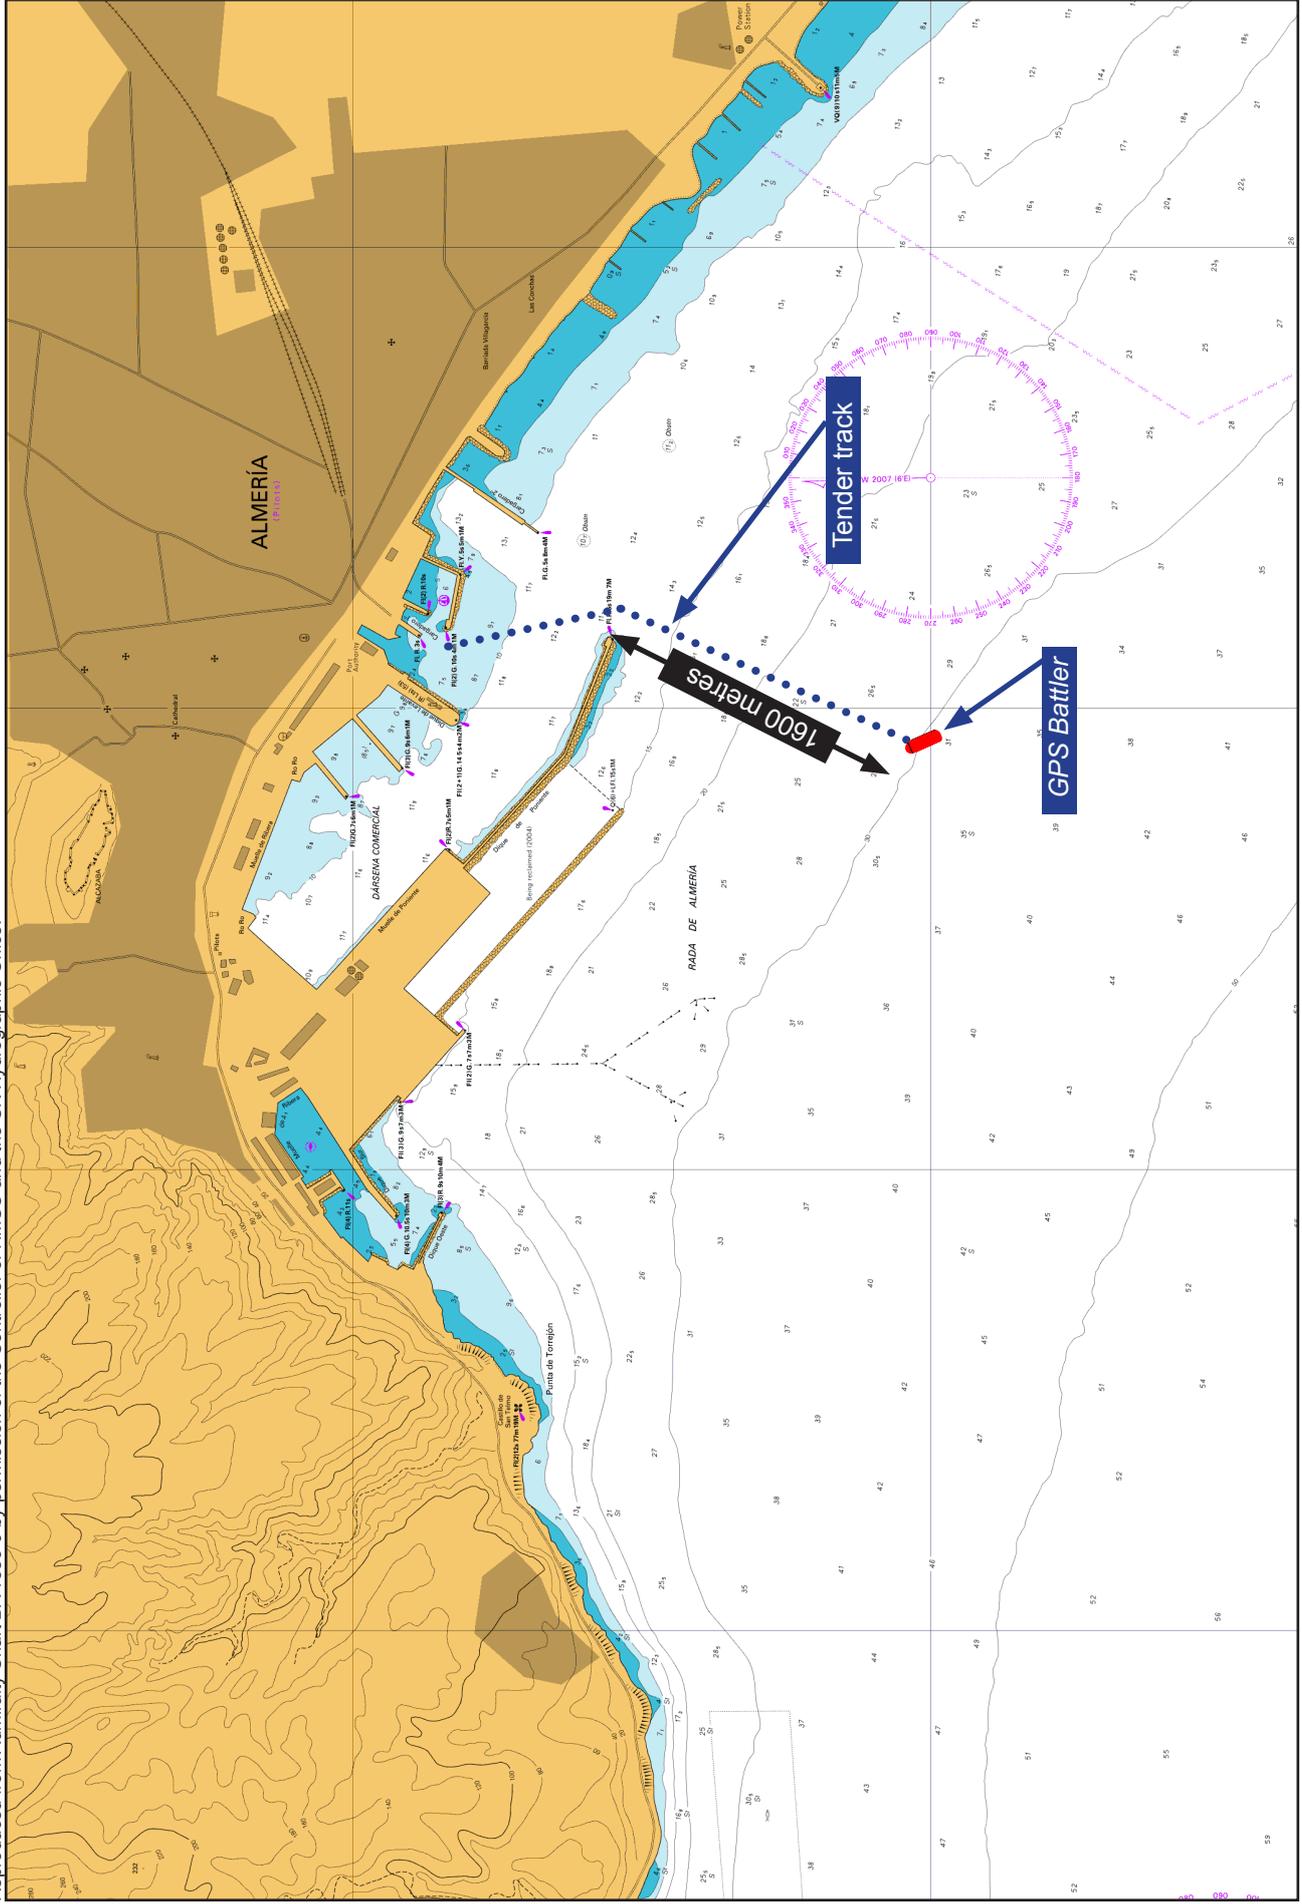
Figure 2: Plan of Almería port and anchorage position

On 11 August, the master requested permission from GPS Marine Contractors Ltd to stop at Almeria, Spain in order to shelter from adverse weather conditions that had been forecast and to potentially repair a minor engine defect. The workboat's operator agreed but instructed the master to go to anchor in order to avoid paying port dues. *GPS Battler* anchored 1100m south of the harbour breakwater in Almeria, Spain, the same day (**Figure 2**).

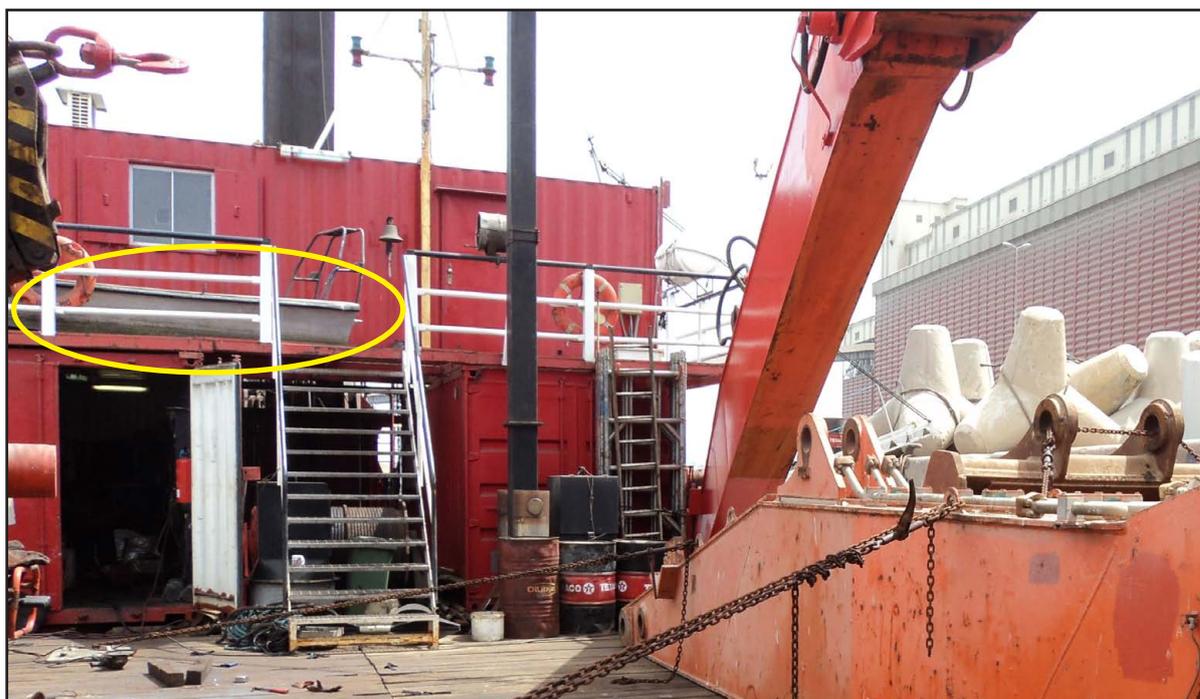
**Figure 3:** Tender stowed on *Von Rock's* deck

At 0600<sup>2</sup> on 13 August, *GPS Battler's* master, Paul Heritage, arrived in the wheelhouse to take over the anchor watch from the mate. During the watch handover, the master and the mate agreed to go ashore in the afternoon using the tender carried on board *Von Rocks* (**Figure 3**) to purchase provisions and to have a meal.

The Sweden registered dredger *Von Rocks* was owned and operated by Open Water Dredging AB. The tender was on board the dredger when it was purchased in August 2011 and was approximately 6m in length with a beam of approximately 1.5m. The tender's hull (**Figure 3, 4, 5 and 6**) was made of aluminium and was flat bottomed with a gunnel height of approximately 0.6m<sup>7</sup>.

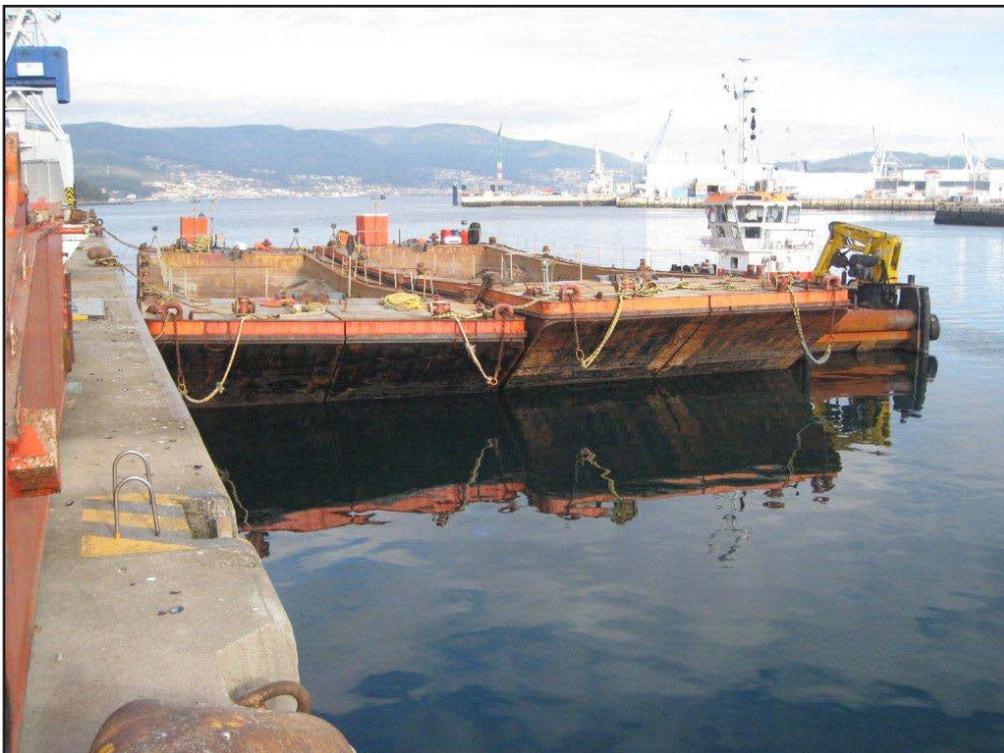
**Figure 7:** *GPS Battler* and barges moored alongside in Marin

At 2110<sup>9</sup> on 5 January 2015, the mate arrived at berth No.0 on the New Commercial Pier in Marin, Spain to join *GPS Battler*, which was moored outboard of two split hopper barges (**Figure 7**). The workboat's master and bosun were also scheduled to re-join the vessel on the same evening.

*GPS Battler* had been moored outboard the two split hopper barges at No. 0 berth on the New Commercial Pier since 22 December 2014. The pier's concrete quay was unfenced, allowing open access to its edge (**Figures 7, 8 and 9**). The quay wall was fitted with a number of vertical ladders to provide access to vessels moored alongside.

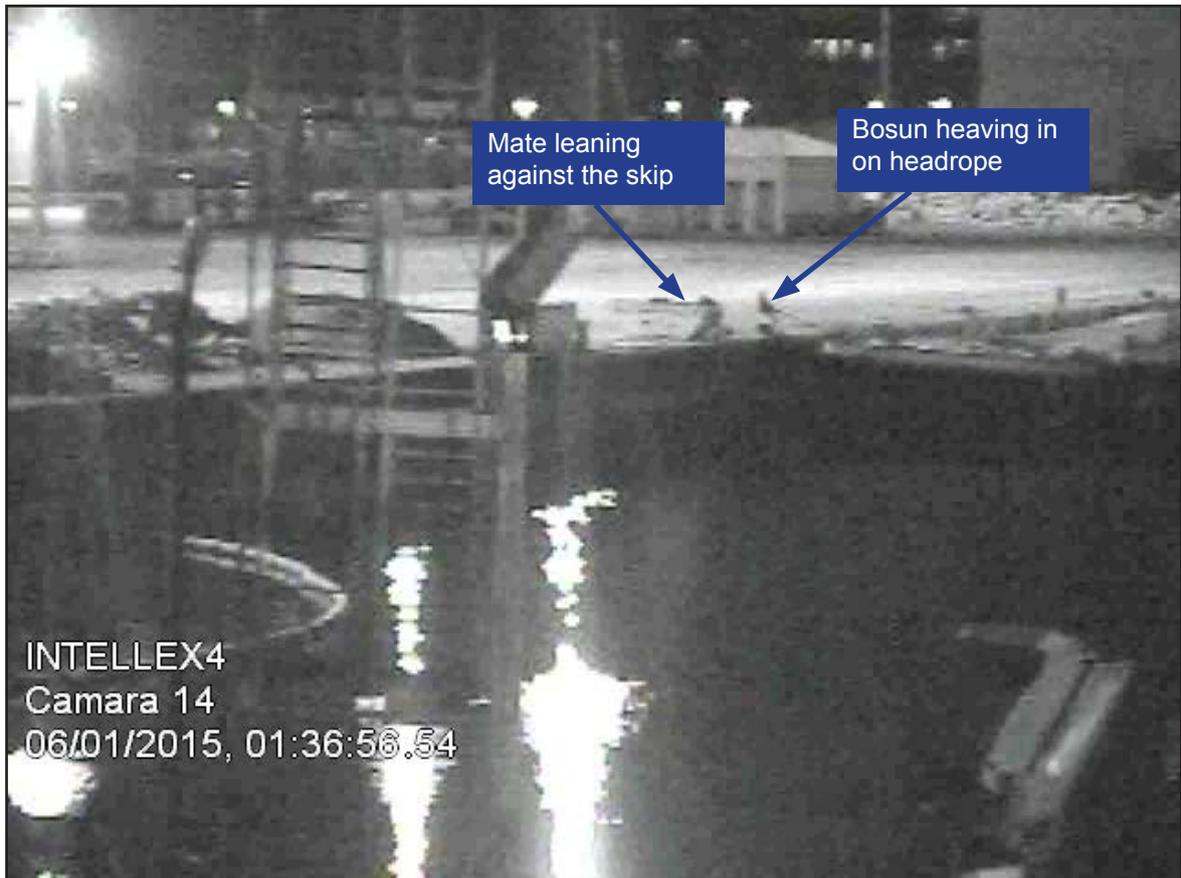
Figure 10: Still from CCTV at 0137 - bosun heaving in on headrope

The bosun left La Farola at 0120 and arrived by the workboat at 0135 to find the mate leaning against the side of the waste skip nearest to the barges. The bosun spoke to the mate but he did not respond, so the bosun told him to stay where he was. By now, the tide had risen and the deck of the inner barge was only a few centimetres below the level of the quay, so the bosun pulled on the inner barge's head rope (**Figure 10**) until the barge was close enough to the jetty to step on board.

Nobody saw the mate fall from the quay into the water. However, CCTV recordings show that he moved in front of the skip (**Figures 10 and 11**) at about the same time as the bosun entered *GPS Battler's* wheelhouse. It is almost certain that he fell from this area as he was below the skip when he was first seen in the water. It is considered that the mate was not moving to step across onto the barge when he fell as he had not moved his bag.

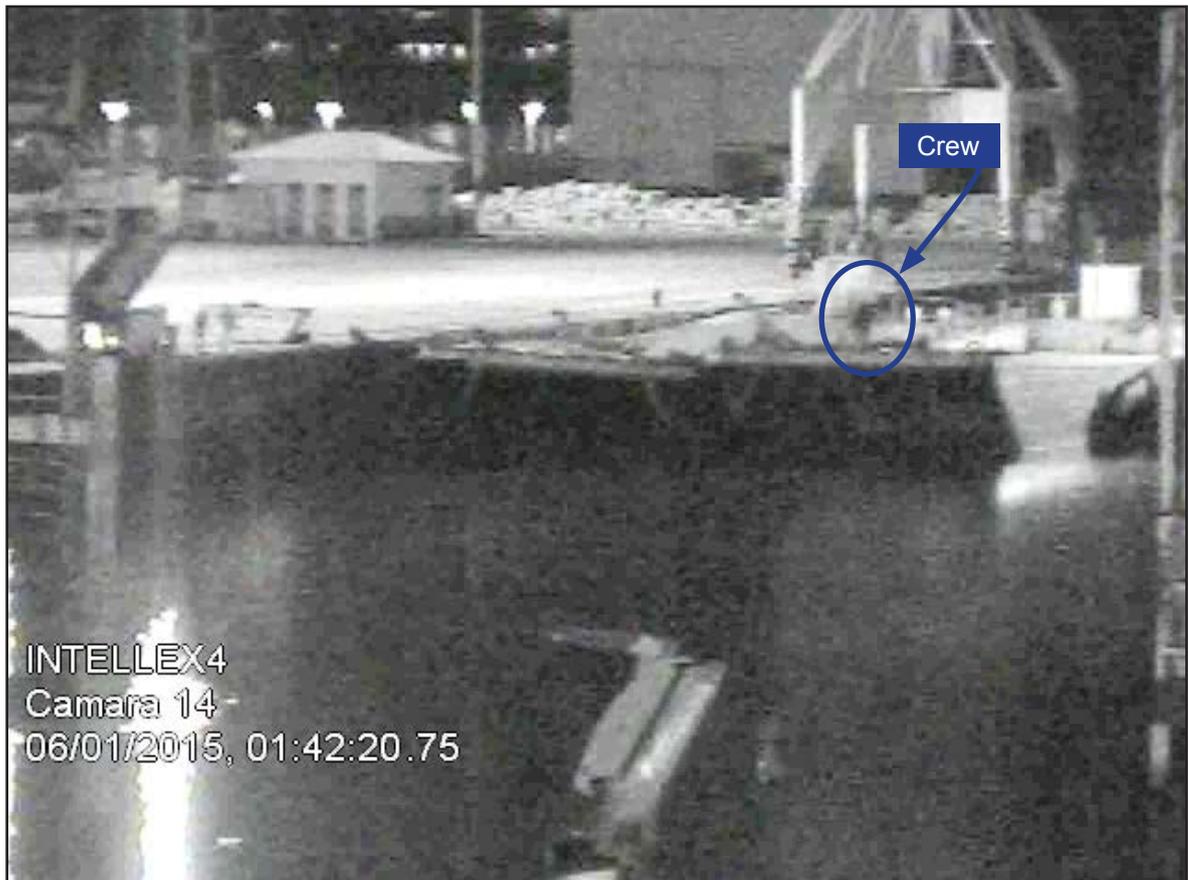
**Figure 12:** Still from CCTV at 0142 - crew searching for the mate

The bosun left the wheelhouse and alerted the engineers inside the accommodation. By 0142, the bosun and the engineers had started searching the water for signs of the mate (**Figure 12**). A short while later the mate was sighted a few metres ahead of the inner barge below the skip; he was floating face-down and was not moving. The bosun and the engineers tried to recover the mate from the

water using a rope, a boat hook and grapples. However, they were unable to catch hold of him due to the barge's freeboard, which was 3m above the waterline. A life-ring and line were available but were not used as the mate was unresponsive.
