Report on the investigation of
the capsizing and foundering of

FV Stella Maris

14 miles east of Sunderland

28 July 2014

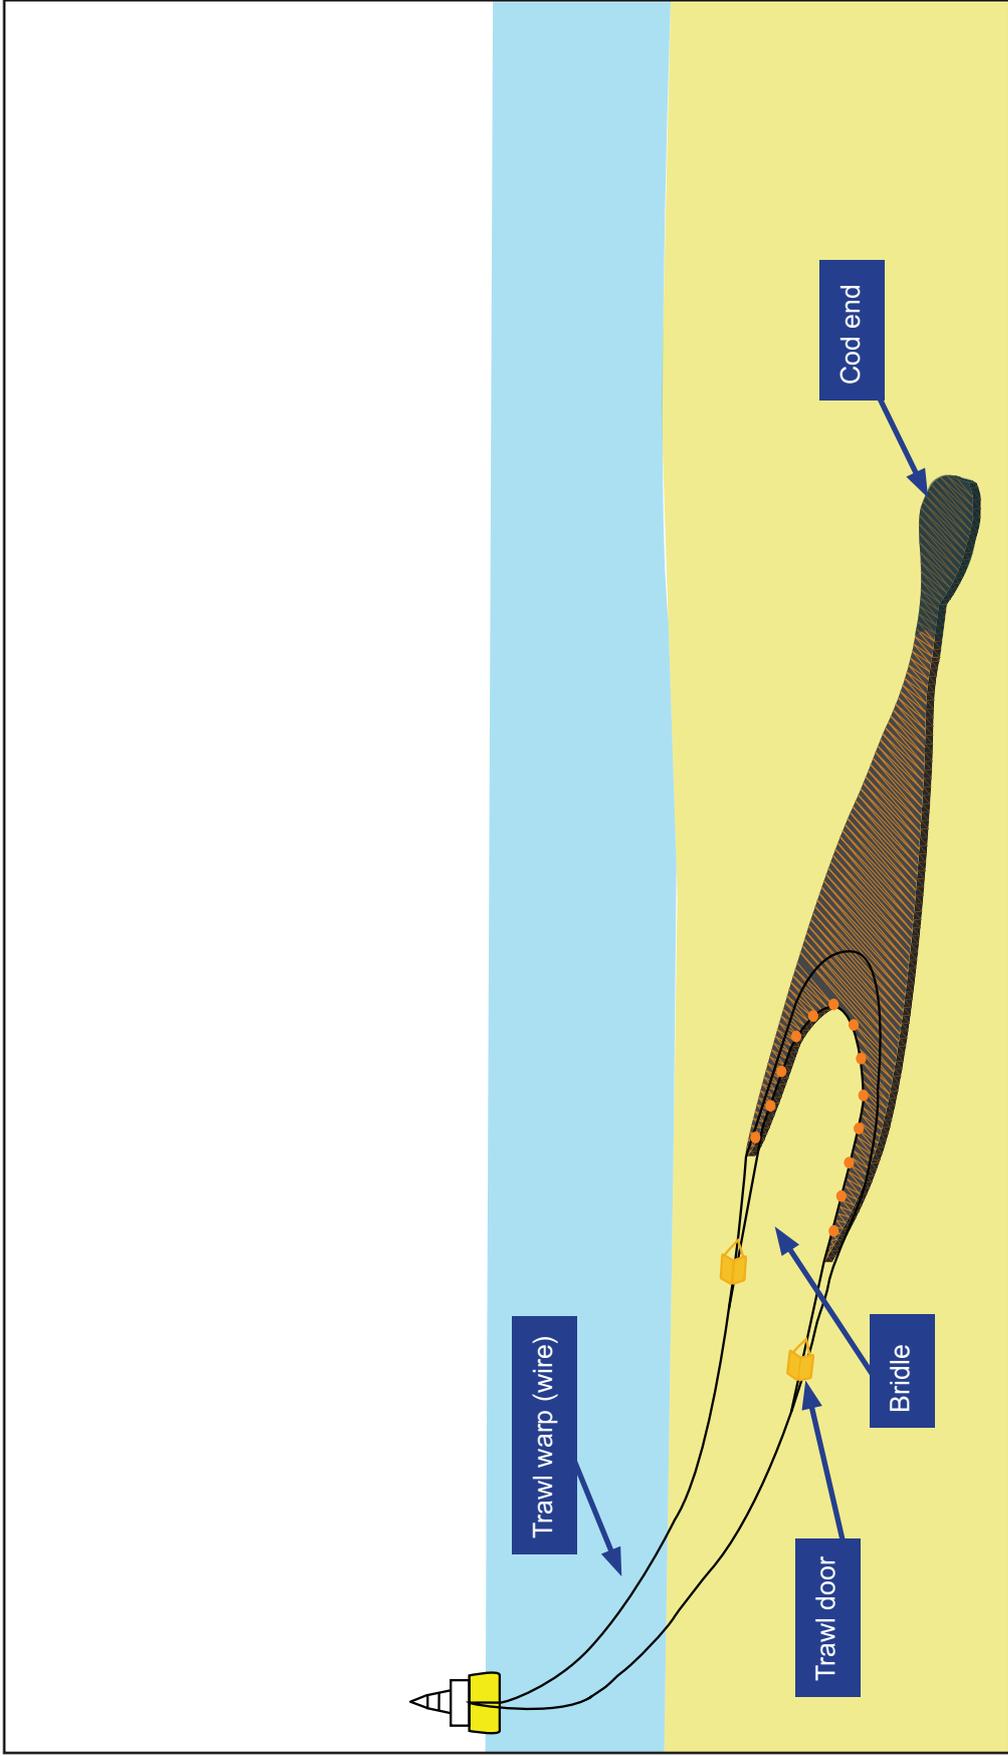
Figure 1: Diagram of *Stella Maris's* trawling gear and components

At about 0415, *Stella Maris* was at the fishing grounds, approximately 6 miles north-east of Hartlepool, when the crew shot away the vessel's demersal trawling gear (**Figure 1**) and began towing in a north-easterly direction. Thereafter, the skipper kept the watch while the deckhand went below to rest.

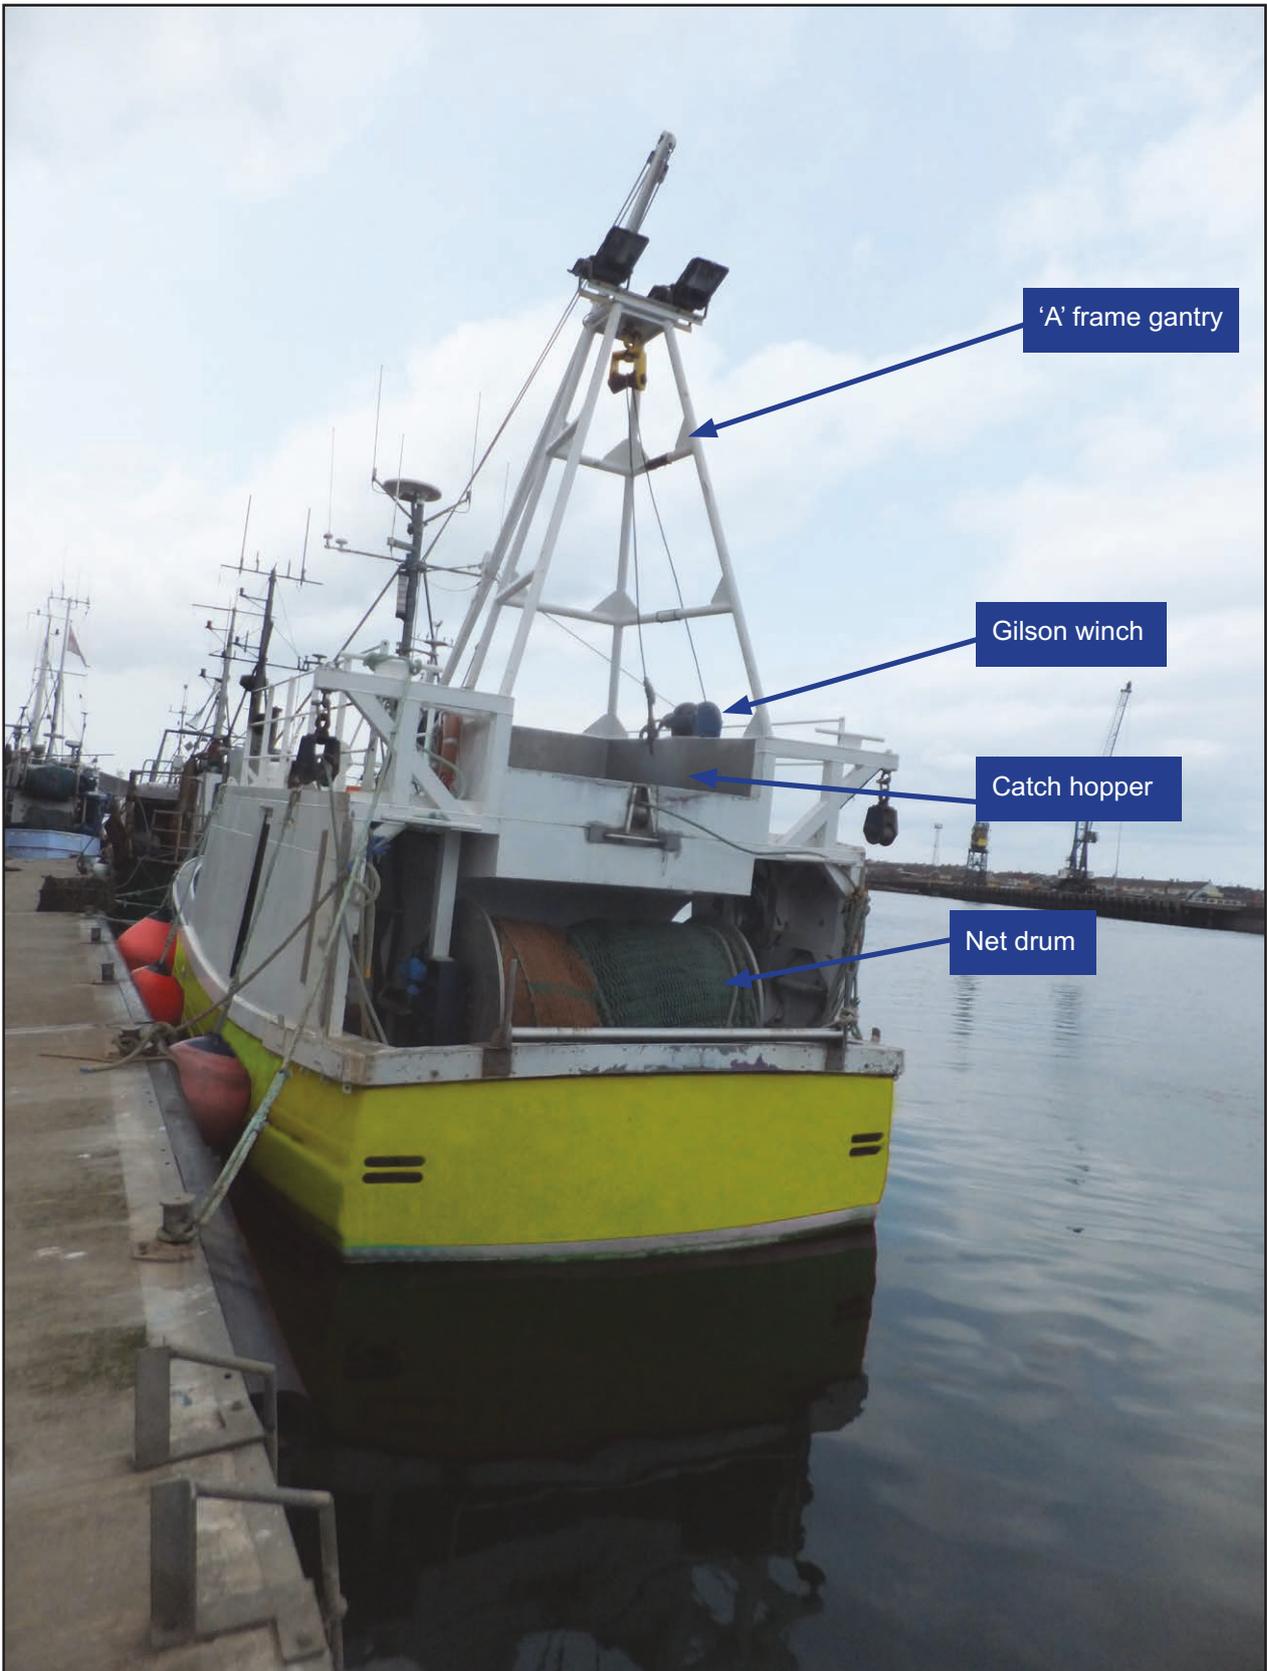
Figure 2: Net drum and gantry arrangement

After the bridles had been hauled, the wing ends of the net were transferred onto the centrally-mounted net drum (**Figure 2**). During this time *Stella Maris* continued to make way, slowly ahead. When transferring the net from the bridles to the net drum, the net would normally float astern of the vessel, but on this occasion the net hung vertically down from the vessel's stern.

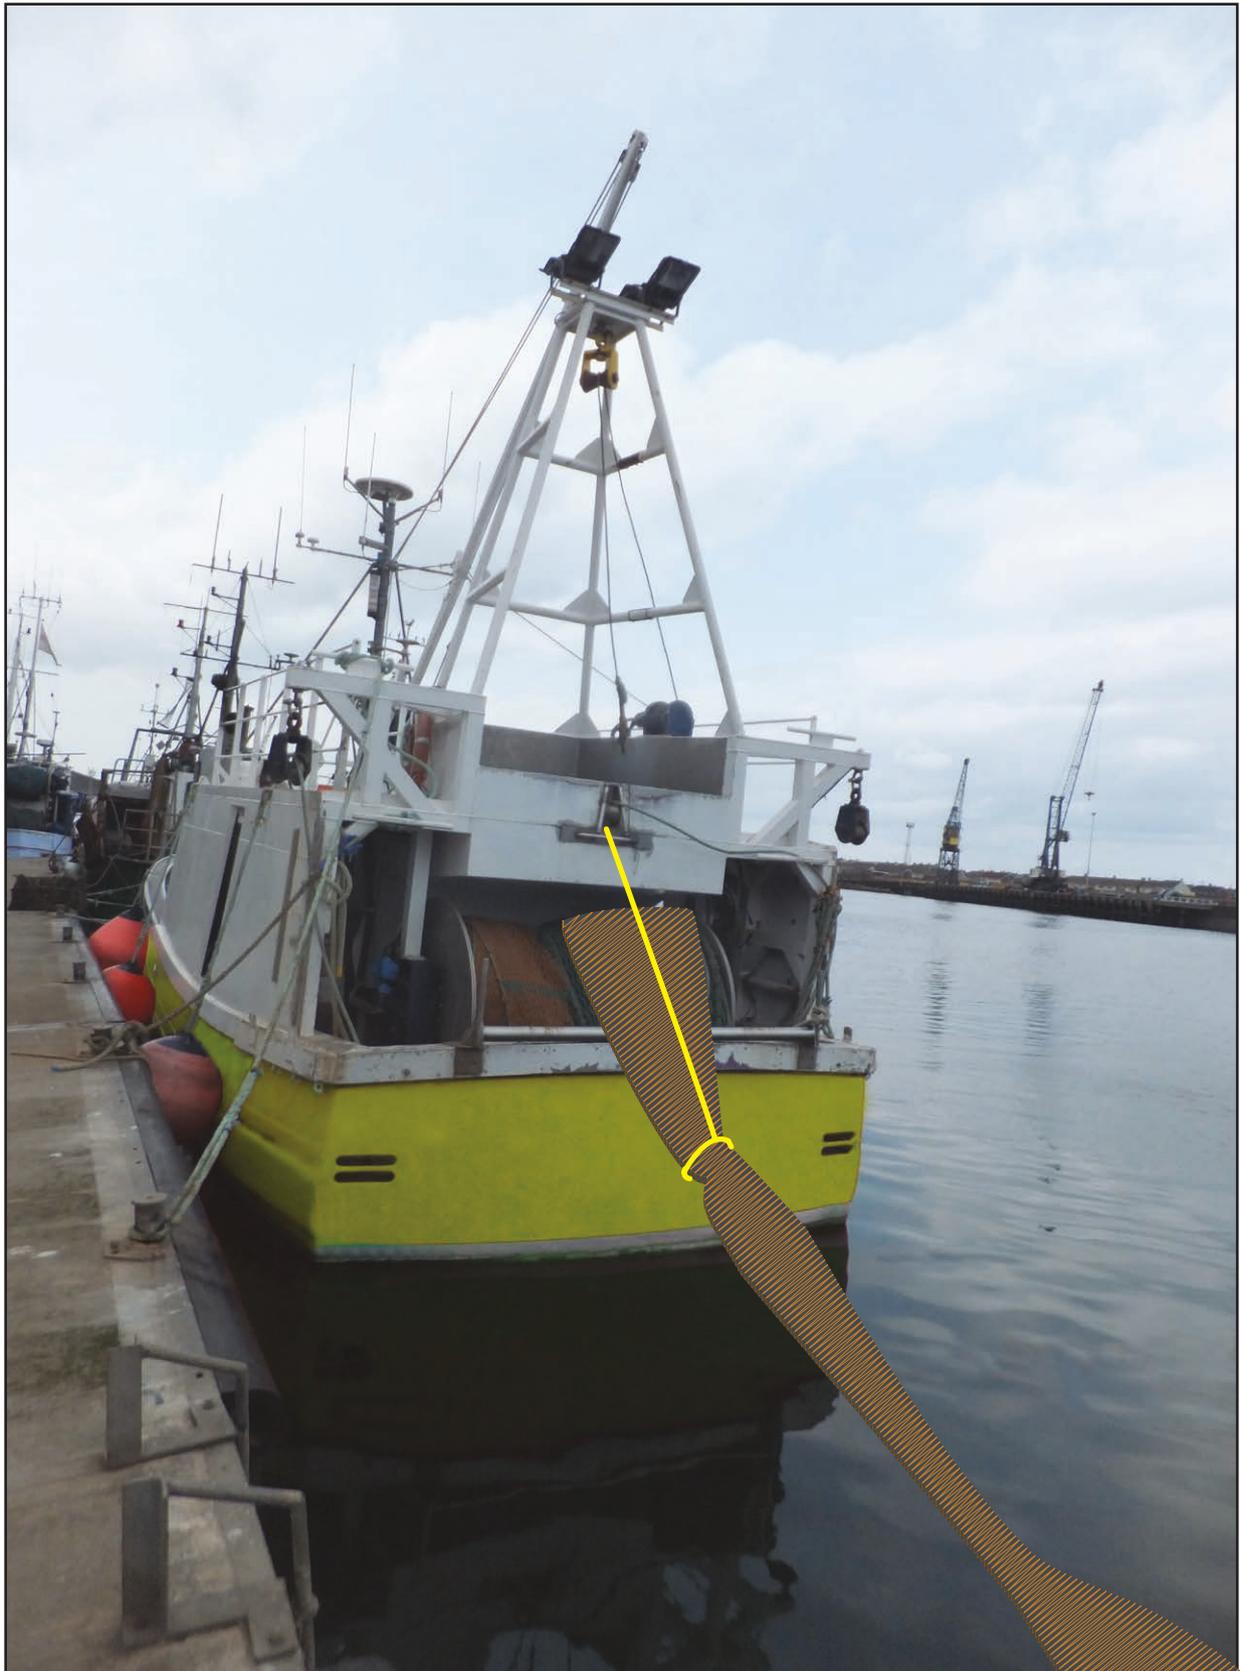
Figure 3: Depiction of cod end being towed to wash out mud

The skipper attempted to clear the cod end of the mud and sand by putting a chain strop around the extension piece (**Figure 3**) before slackening back on both the strop and the net to position the cod end in a turbulent area of the vessel's wake. He then powered *Stella Maris* ahead so as to wash the mud and sand from the cod end. After a few minutes he stopped towing and, although some mud and sand had been removed from the net, it was apparent that there was still a substantial weight in the cod end.

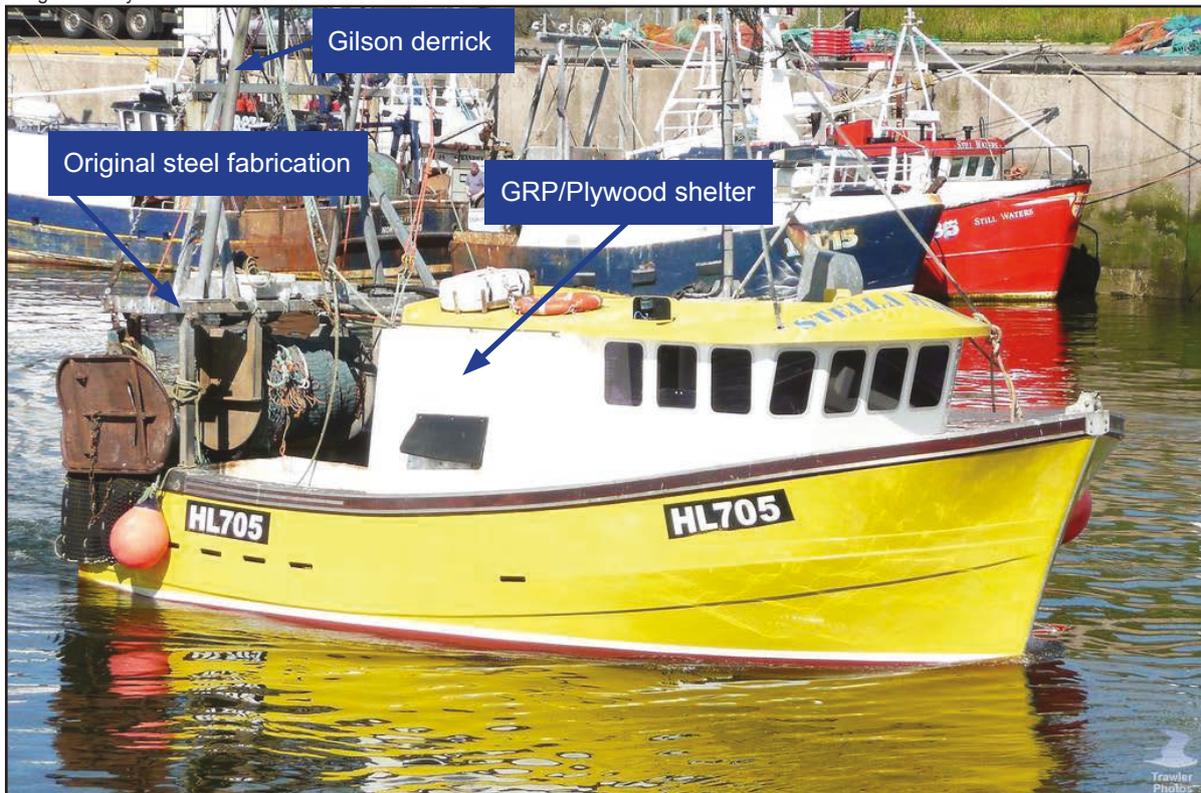
Figure 10: *Stella Maris* before modernisation modifications

As built, *Stella Maris* (**Figure 10**) was arranged as a conventional small stern trawler, with the wheelhouse forward and the working deck aft of the wheelhouse. The hull and deckhouse were constructed of GRP, the gutting shelter was GRP sheathed 25mm thick plywood and all other original fabrications (gallows, gilson derrick, gantry and landing derrick) were made of steel. The air vents for the engine room were built into the bulwarks athwartships of the trawl winch (**Figure 11**) and terminated below top rail height.

- Removal of the starboard side gilson derrick (**Figure 10**), and thus the need to lay broadside on to wind and seas when lifting the cod end on board. This was replaced with an “A” frame gantry aft (**Figure 5**) with a lifting point that was at least 1m higher than the original derrick. This enabled the cod end to be lifted over the stern as the vessel made way slowly ahead.

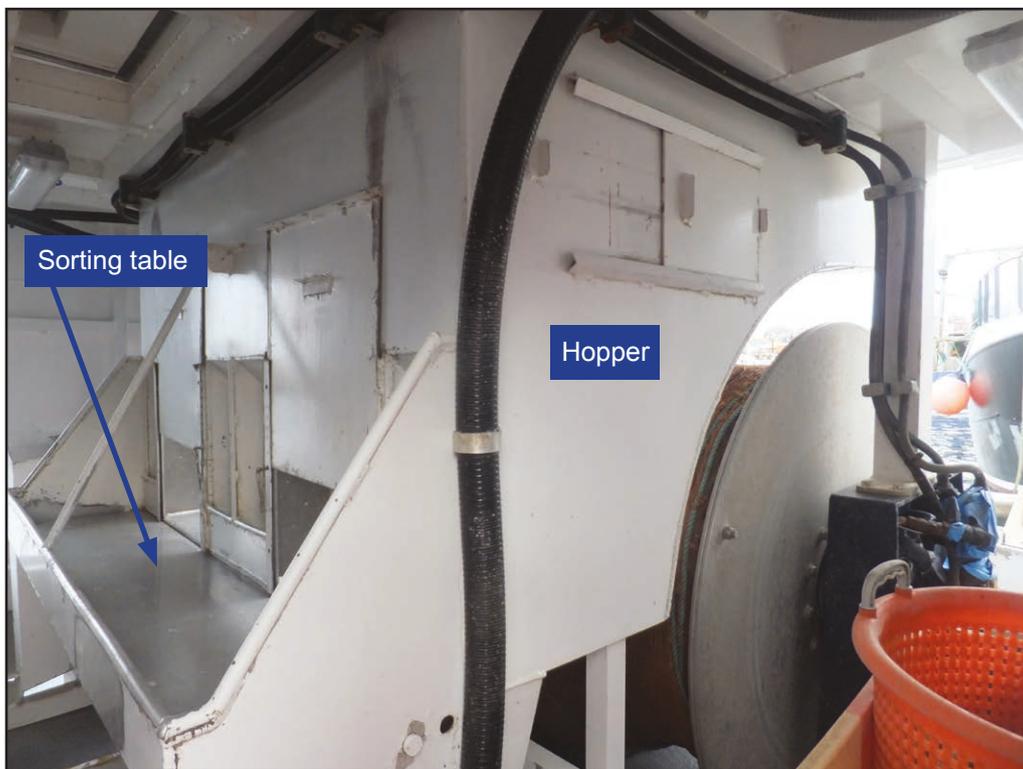
Figure 13: Catch hopper on main deck

- Replacement of the original net drum with a lighter unit, further reducing top weight.
- Installation of a catch hopper (**Figure 12**) below the “A” frame gantry, enabling deposited catch to gravity feed onto a sorting table for processing (**Figure 13**). This removed the previous requirement of manually shovelling the fish from the deck, which was labour intensive and damaged the catch. The catch hopper also enabled faster processing, allowing the fish to be put on ice earlier, further improving their quality.

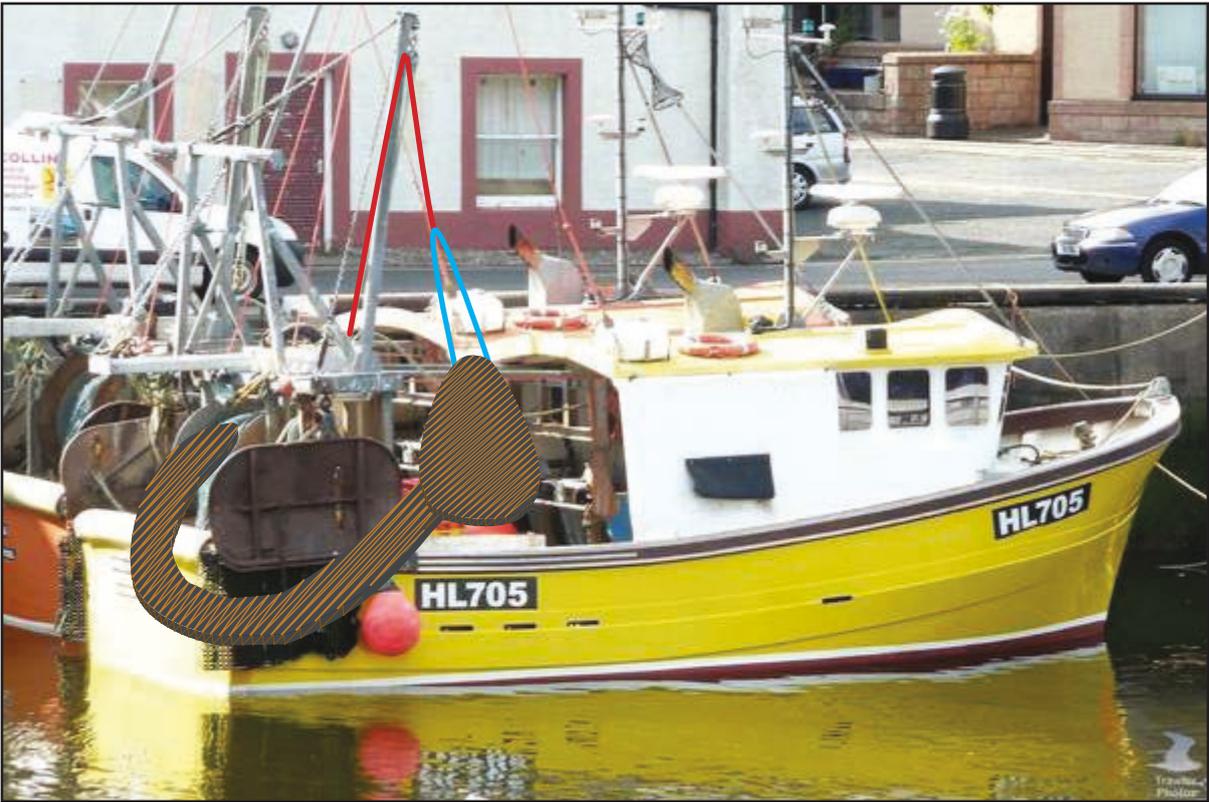
Figure 14: Depiction of cod end being hoisted over the side of the vessel before modernisation

Prior to the modifications, the cod end was hoisted over the bulwark rail using a conventional, stayed gilson derrick (**Figure 14**) and the catch was emptied onto the deck for manual shovelling onto a sorting table. Once inboard of the bulwark, and during periods of heavy rolling, the unopened cod end could be lowered to the deck to relieve weight from the derrick head and to prevent it swinging. If the weight of the cod end was unmanageable, it would be readily apparent from the vessel's list during lifting, and the cod end could be lowered back into the sea before reaching the bulwark.

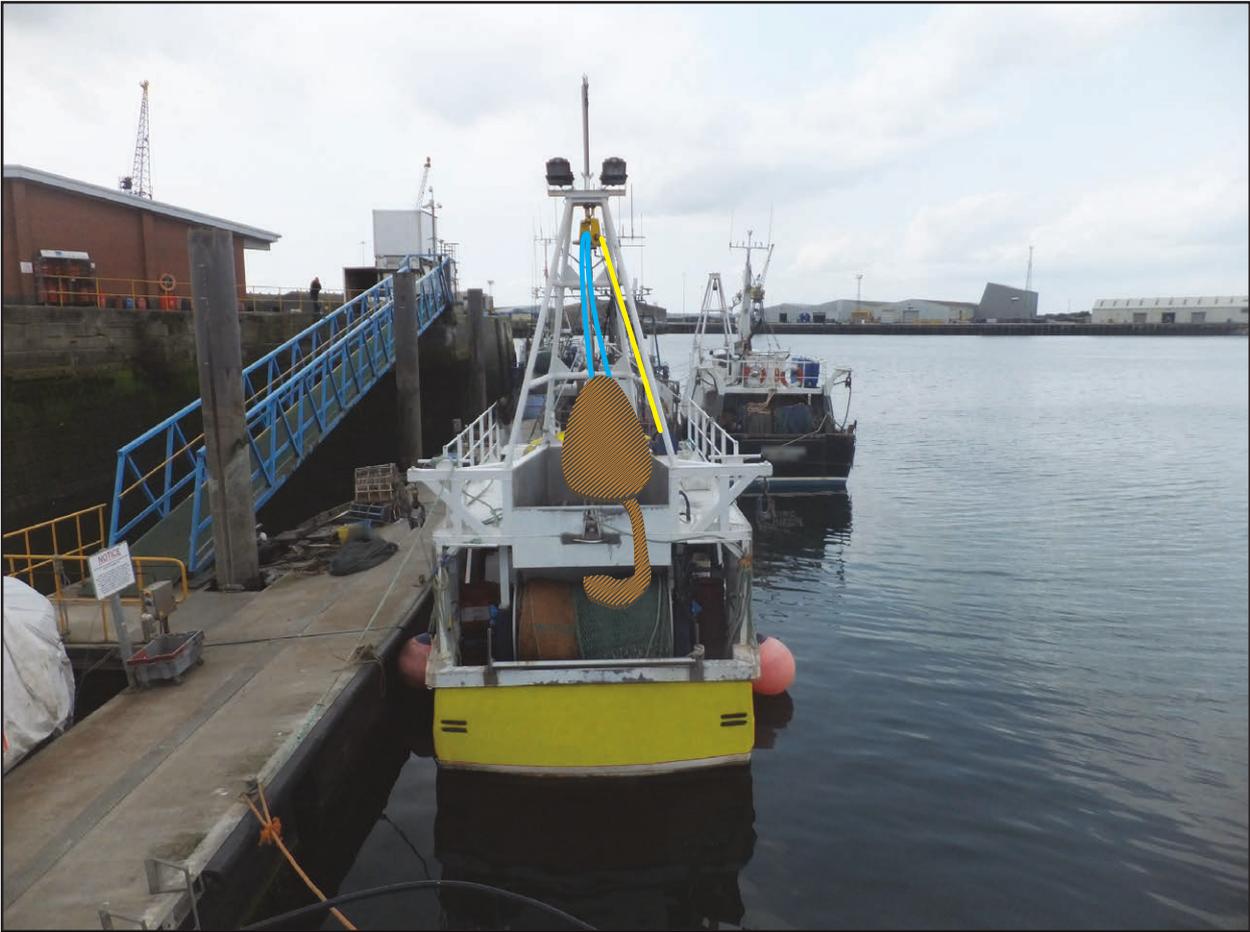
Figure 15: Depiction of cod end being hoisted above the catch hopper

Following modification, *Stella Maris's* cod end was hoisted over the stern from the "A" frame gantry (**Figure 15**). Hoisting directly over the stern acted on the vessel's longitudinal stability, although any lateral movement once the load was suspended would act upon transverse stability. Once clear of the sea, the cod end was then lifted over the bulwark and then by a further 1.65m to clear the lip of the catch hopper (**Figure 15**). Once above the hopper, the cod end was emptied into the hopper where the catch was retained, gravity feeding onto the sorting table for processing. The bottom of the hopper was situated about 1m above deck level. A normal full cod end typically held 0.5t of catch.
