ACCIDENT

Aircraft Type and Registration:	Beech 95-B55 Baron, G-RICK	
No & Type of Engines:	2 Continental Motors Corp IO-470-L piston engines	
Year of Manufacture:	1972 (Serial no: TC-1472)	
Date & Time (UTC):	3 May 2015 at 1113 hrs	
Location:	West of Abernyste, near Dundee, Scotland	
Type of Flight:	Private	
Persons on Board:	Crew - 1	Passengers - 1
Injuries:	Crew - 1 (Fatal)	Passengers - 1 (Fatal)
Nature of Damage:	Aircraft destroyed	
Commander's Licence:	Airline Transport Pilot's Licence	
Commander's Age:	37 years	
Commander's Flying Experience:	3,900 hours (of which 100 were on type) Last 90 days - 60 hours Last 28 days - 33 hours	
Information Source:	AAIB Field Investigation

Synopsis

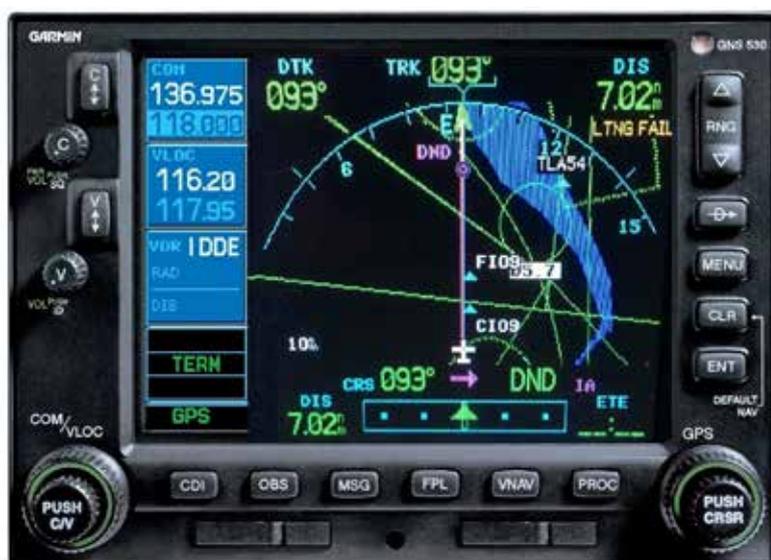
Figure 3
Garmin GNS 530W

The communication section (COM) on the installation (left side of the screen) is used to provide the primary VHF radio frequency selected. ILS or VOR frequencies selected are displayed beneath the radio frequency. If an ILS frequency is selected and the equipment is receiving the correct signal, the equipment displays the identification (IDENT) letters of the selected facility. This does not, however, mean the selected beacon is providing an

output to the HSI. That functionality is determined by the Course Deviation Indicator (CDI) key which is used to toggle between the navigation sources. In G-RICK, the status of the CDI key was also indicated by HSI source annunciator lights, mounted on the instrument panel just above the pilot's main attitude indicator (Figure 4). The illuminated light indicated whether ground-based Nav 1 (VOR/ILS) or GPS was the source of the navigation data being displayed on the HSI.

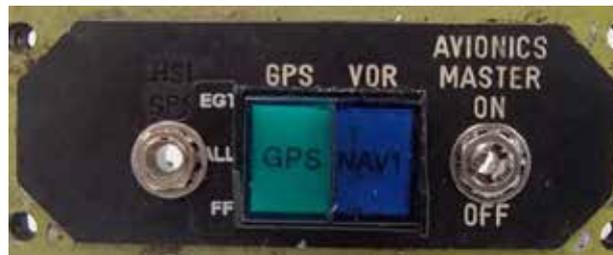
Figure 4

HSI Source Annunciator Lights

The navigation and radio equipment was severely damaged by the impact forces and it was not possible to determine their settings. However, examination of the HSI source annunciator bulb filaments under a microscope showed that the GPS filament had characteristic plastic deformation, indicating that it was illuminated at the time of impact (Figure 5). This indicated that GPS-derived navigation data was being displayed on the HSI at the time of the accident.

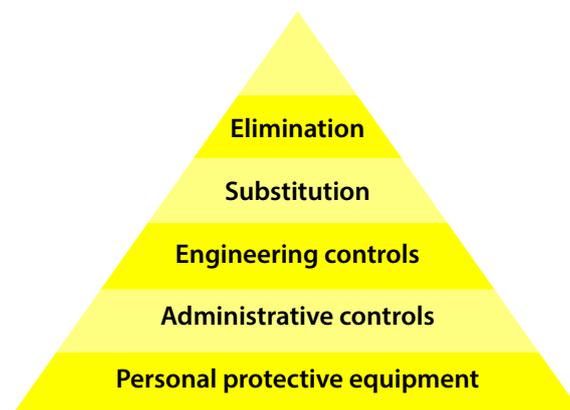
Figure 7
Hierarchy of hazard control

In the Bowtie model for this accident, the controls that failed to prevent the threat escalating into an unsafe condition were related to pilot performance, which can be mitigated by training. However, training is an 'Administrative' control in the hierarchy of hazard control and is therefore not the most effective. A more effective way of minimizing the hazard would be by 'Substitution'; for example, a redesigned instrument approach at Dundee that is more tolerant of human error.
