ACCIDENT

Aircraft Type and Registration:	Agusta Bell 206B Jet Ranger II, G-SUEX	
No & Type of Engines:	1 Allison 250-C20B turboshaft engine	
Year of Manufacture:	1978 (Serial no: 8567)	
Date & Time (UTC):	16 September 2014 at 1241 hrs	
Location:	Flamborough Head, Yorkshire	
Type of Flight:	Public Transport (Helicopter)	
Persons on Board:	Crew - 1	Passengers - 1
Injuries:	Crew - 1 (Fatal)	Passengers - 1 (Fatal)
Nature of Damage:	Destroyed	
Commander's Licence:	Commercial Pilot's Licence (Helicopter)	
Commander's Age:	58 years	
Commander's Flying Experience:	Estimated 4,000 hours (of which n/k were on type) Last 90 days - n/k hours Last 28 days - n/k hours	
Information Source:	AAIB Field Investigation

Synopsis

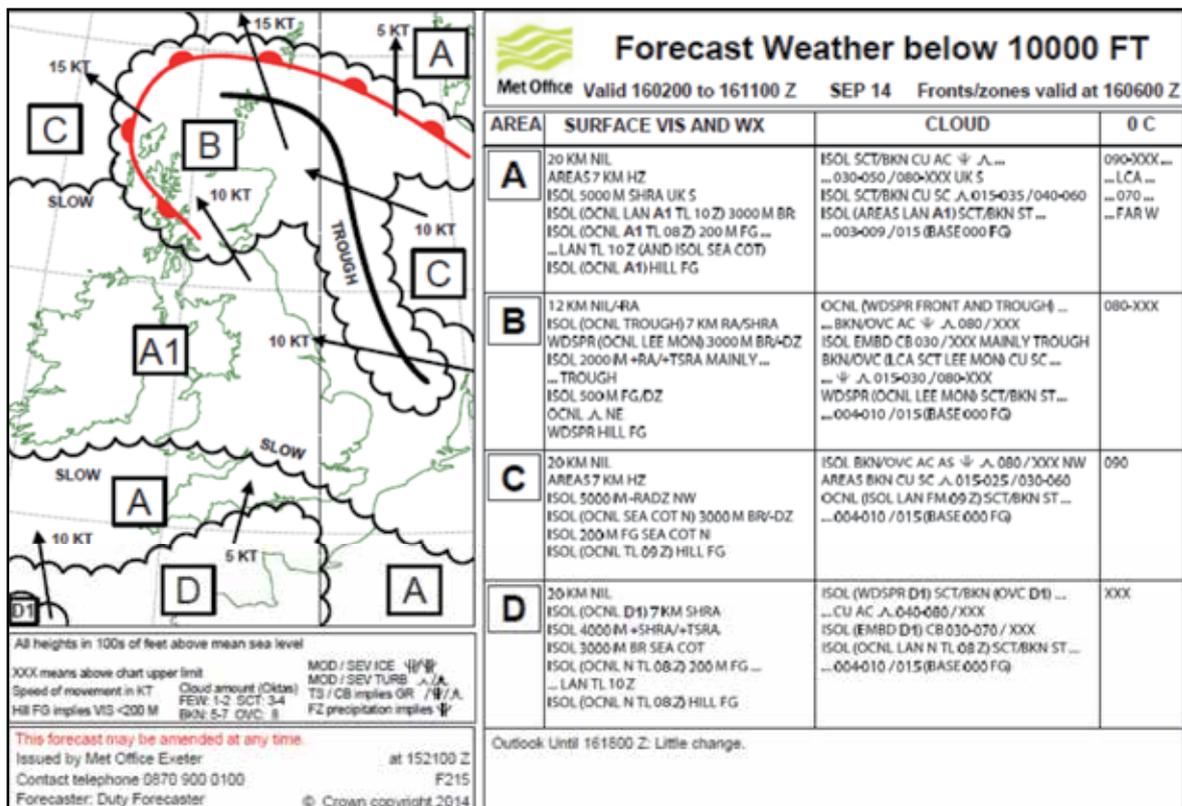
Figure 1

The Metform F215 (see Figure 1) for 16 September 2014, issued at 0300 hrs and valid from 0800 hrs to 1700 hrs, included the following forecast for area A1: generally 20 km visibility, with areas of haze reducing visibility to 7 km; isolated (occasional over land) mist until 1000 hrs with visibility of 3 km; isolated fog with 200 m visibility, clearing over land by 0900 hrs but remaining over the sea and coastline throughout the time of the flight; isolated (occasional until 1100 hrs) hill fog. The cloud was forecast as: isolated, scattered or broken cumulus or stratocumulus, with bases 1,500 ft to 3,500 ft and tops 4,000 ft to 6,000 ft; isolated, but in areas over the land, scattered or broken stratus with bases 300 ft to 900 ft and tops at 1,500 ft, with the cloudbase at the surface in fog.

Metform 215, the flight was within zone A1

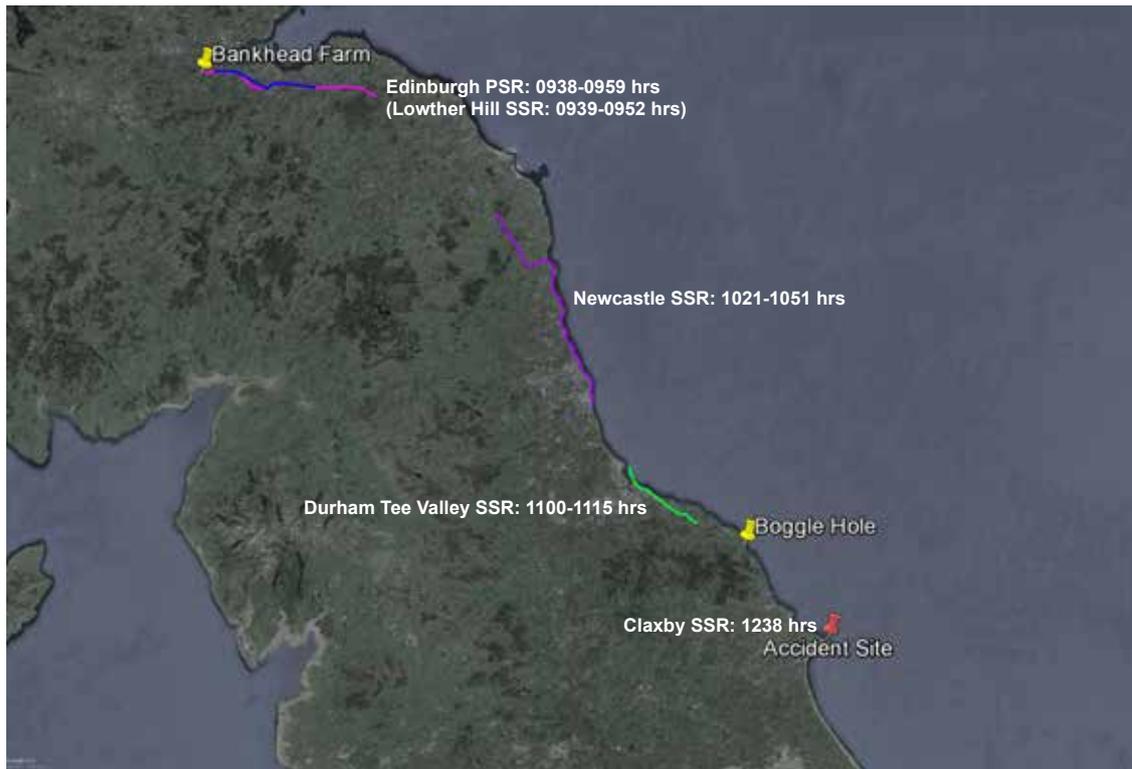
Radar data was recovered from Edinburgh, Newcastle and Durham Tees Valley Airports, together with various elements of the NATS operated en-route system. For significant portions of the flights on 16 September, no radar contact was made with G-SUEX due to line-of-sight limitations when the helicopter was below radar coverage. An overview of the recorded track is at Figure 2

Overview of radar recorded tracks

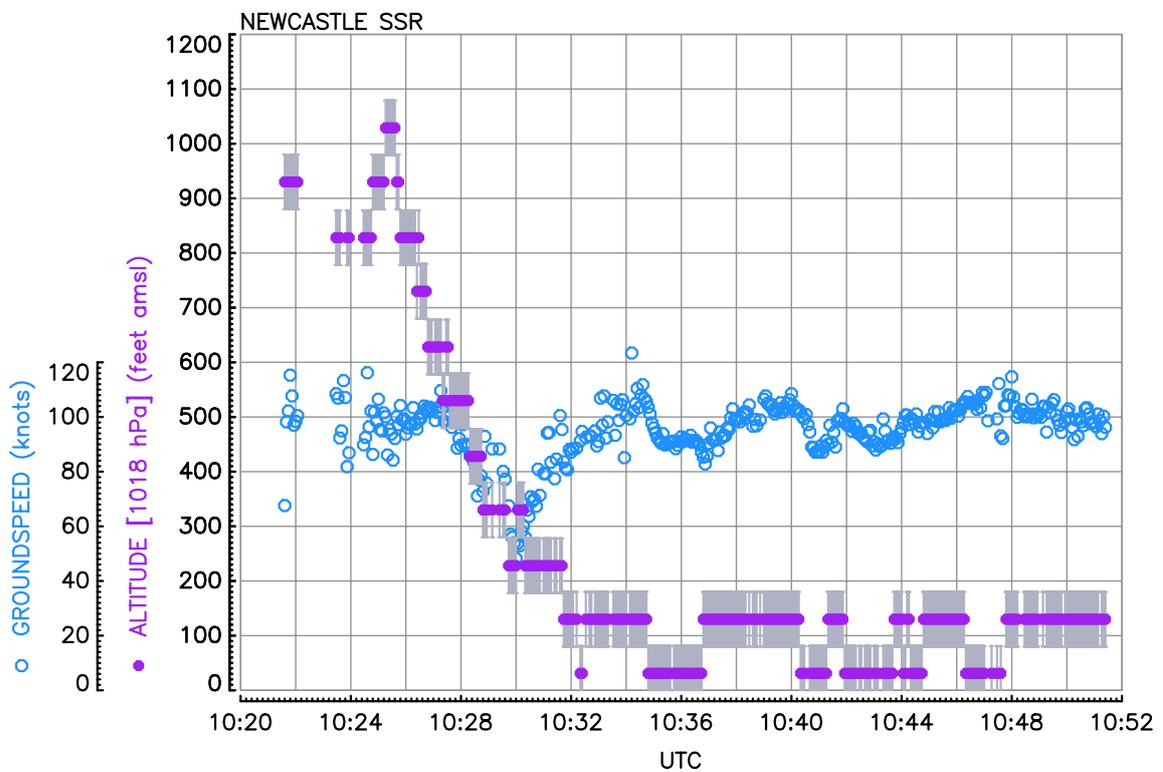
Figure 3

G-SUEX was next detected by Newcastle Airport radar, between 1021 hrs and 1051 hrs (see Figures 2 and 3). At 1025 hrs the helicopter was at 1,000 ft amsl. Then, over the next seven minutes, it descended to below 200 ft amsl. Between 1032 hrs and 1051 hrs the helicopter’s reported altitude varied between 130 ft amsl and 30 ft amsl and the groundspeed was 100 kt ± 10 kt.

Mode C altitudes and calculated groundspeed from Newcastle Airport radar (± 50 ft error bars, indicating Mode C accuracy, are shown)

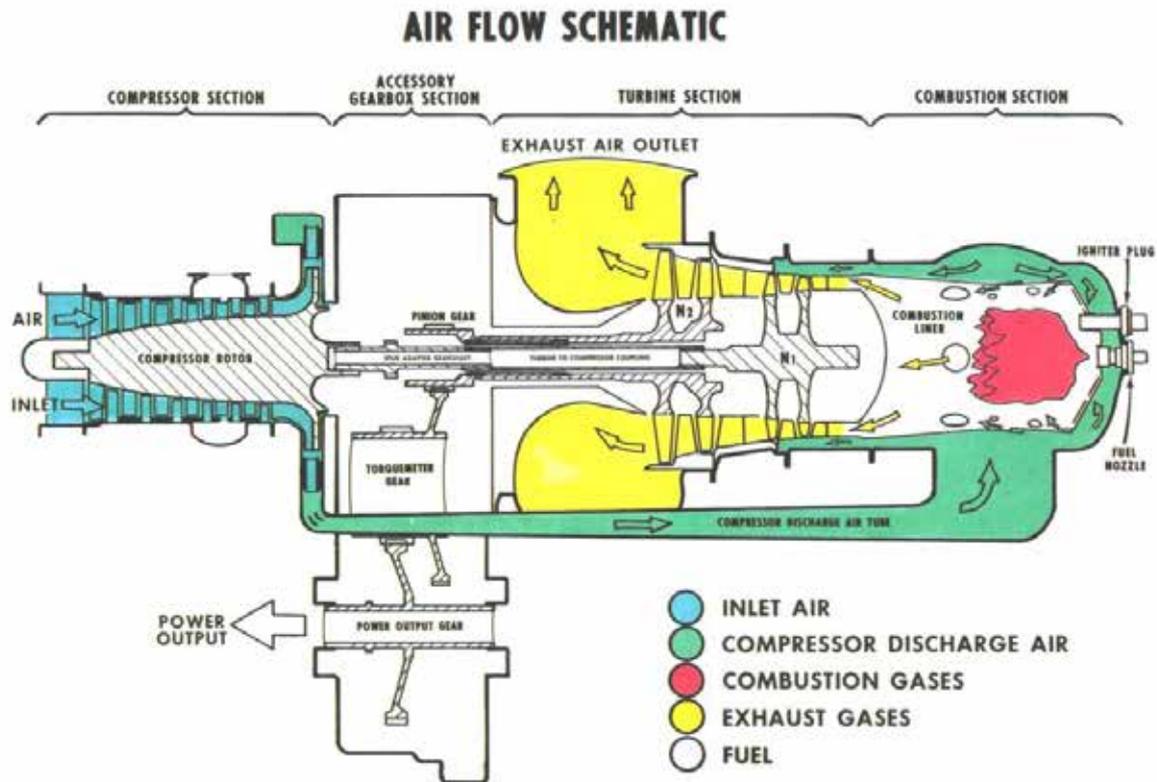
Figure 8

The engine consists of a gas generator assembly, which includes both axial and centrifugal compressor stages, a combustion section and an axial flow turbine section connected to the compressor. The remaining hot gases then pass through an axial flow power turbine assembly which, through the power output gear, provides the power output to the main rotor gearbox via a freewheel device (Figure 8).

General arrangement of engine
