ACCIDENT

Aircraft Type and Registration:	Agusta Bell 206B Jet Ranger III, G-OMDR	
No & Type of Engines:	1 Allison 250-C20B turboshaft engine	
Year of Manufacture:	1981 (Serial no: 8610)	
Date & Time (UTC):	27 June 2014 at 1553 hrs	
Location:	Near Gamston Airport, Nottinghamshire	
Type of Flight:	Private	
Persons on Board:	Crew - 1	Passengers - None
Injuries:	Crew - None	Passengers - N/A
Nature of Damage:	Damage to main rotor transmission driveshaft couplings, isolation mount, transmission stop mount, swashplate support, tachometer generator and freewheeling unit	
Commander's Licence:	Private Pilot's Licence (Helicopters)	
Commander's Age:	44 years	
Commander's Flying Experience:	850 hours (of which 500 were on type) Last 90 days - 32 hours Last 28 days - 12.5 hours	
Information Source:	AAIB Field Investigation

Synopsis

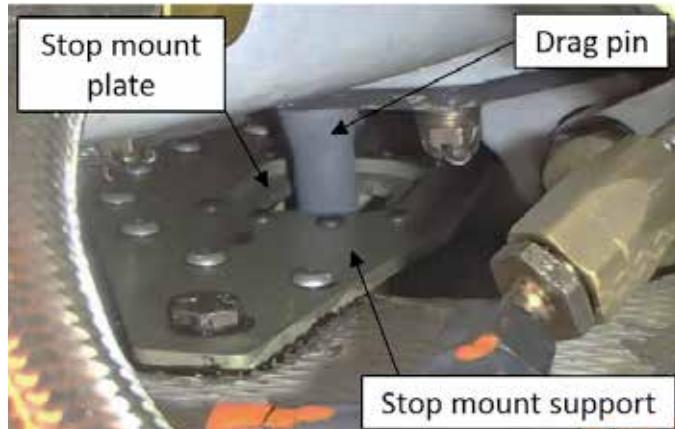
Figure 1
Transmission stop mount assembly (not accident aircraft)

The bottom of the transmission housing features a vertical steel drag pin that projects through an opening in a stop mount assembly (see Figure 1). The stop mount assembly consists of a stop mount plate that is attached to a stop mount support by eight rivets. These rivets are intended to fail in shear and the stop mount plate to detach from the support plate when heavy contact with the drag pin occurs during extreme movement of the main rotor transmission.

The transmission drag pin had made heavy lateral contact with the stop mount plate and the rivets attaching the stop mount plate to the support plate had failed in shear, releasing the stop mount plate which was found lying loose beneath the support plate. The drag pin's paint finish had been abraded, revealing the bare metal surface beneath.

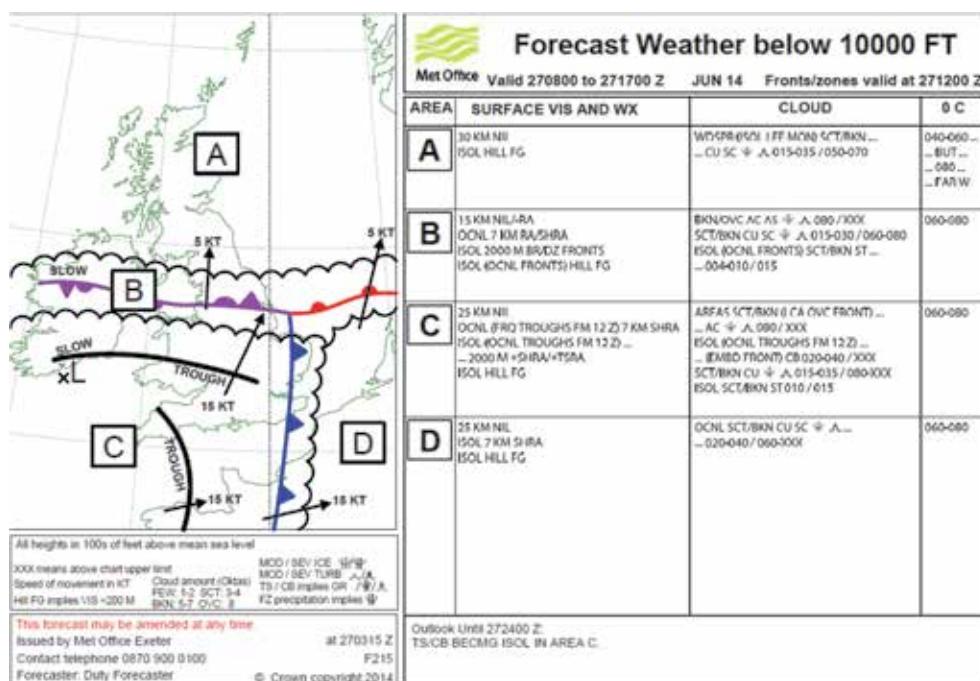
Figure 4

The forecast Metform F215 (see Figure 4), issued at 0317 hrs on 27 June 2014 and valid between 0800 hrs and 1700 hrs, showed an occluded front located across the pilot's planned route. In the overall area of the front (Area B), the visibility was forecast to be generally 15 km, with about 50% of the area having 7 km visibility in moderate rain or showers of rain.

F215 valid for flights between 0800 hrs and 1700 hrs on 27 June 2014

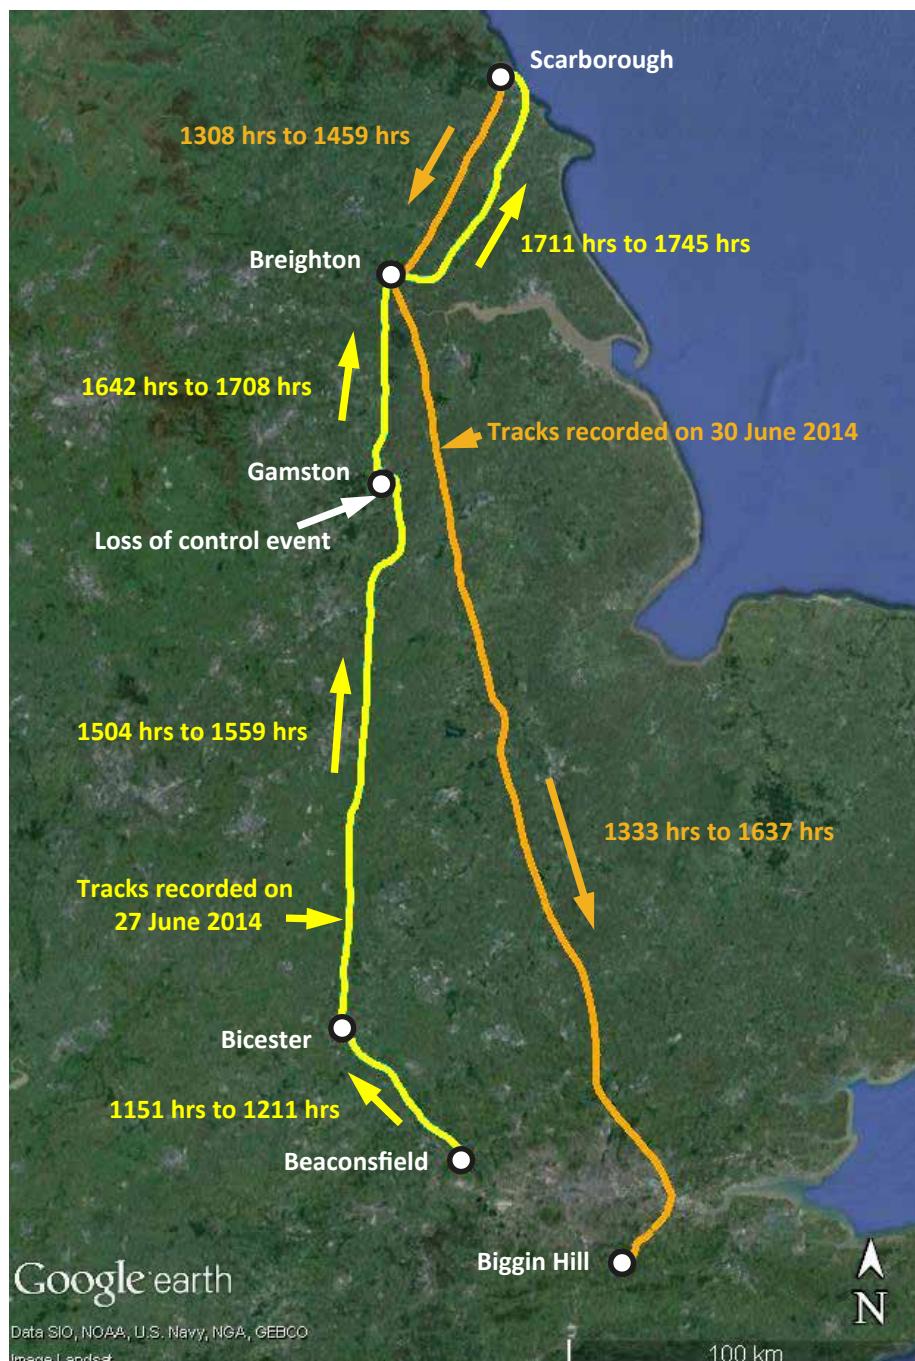
Figure 5
Tracks recorded on the iPad for 27 June 2014 and 30 June 2014

The pilot was using an iPad navigation application during the four flights on the day of the event and the two return flights three days later. The application recorded tracks for all these flights (see Figure 5).
