INCIDENT

Aircraft Type and Registration:	British Aerospace 146-200, D-AMGL	
No & Type of Engines:	4 Avco Lycoming ALF502R-5 turbofan engines	
Year of Manufacture:	1986 (Serial no: 2055)	
Date & Time (UTC):	16 August 2015 at 1736 hrs	
Location:	London City Airport	
Type of Flight:	Passenger Transport	
Persons on Board:	Crew - 4	Passengers - 77
Injuries:	Crew - None	Passengers - None
Nature of Damage:	Damage to right main gear shock-absorber and hole in right main gear door	
Commander's Licence:	Airline Transport Pilot's Licence	
Commander's Age:	N/A	
Commander's Flying Experience:	4,900 hours (of which 4,500 were on type)	
Information Source:	AAIB Field Investigation

Synopsis

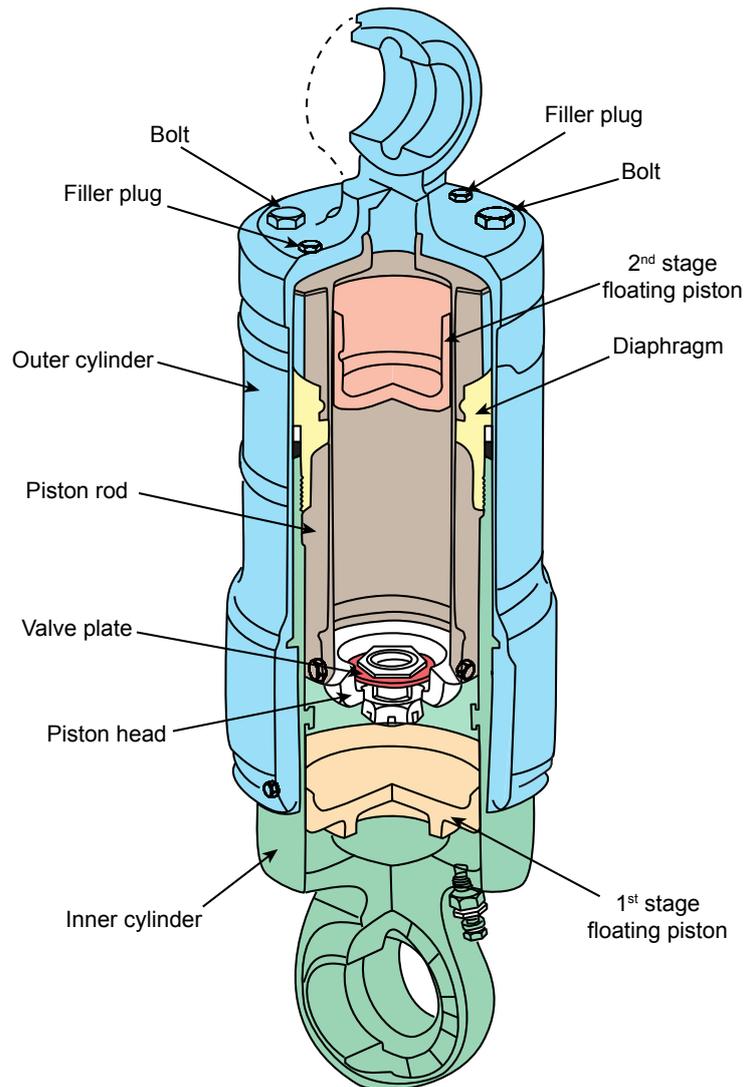
Figure 7

The BAe 146 is a four-engined, high-wing passenger transport aircraft. The aircraft has two main landing gear legs mounted on the fuselage inside two fairings. Mounted on each main gear leg is a shock-absorber, which features a two-stage floating piston with four chambers. Nitrogen is contained in the lower outer and the upper inner chambers, and oil is contained in the upper outer and the lower inner chambers (Figure 7). The overhaul period for the shock-absorber is 15,000 landings (for European operations) or 12 years.

Cutaway drawing of the shock-absorber
