ACCIDENT

Aircraft Type and Registration:	Folland Gnat T Mk 1, G-TIMM	
No & Type of Engines:	1 Rolls-Royce Orpheus 101 turbojet engine	
Year of Manufacture:	1962 (Serial no: FL519)	
Date & Time (UTC):	1 August 2015 at 1302 hrs	
Location:	Approx 1 mile north of Oulton Park, Cheshire	
Type of Flight:	Aerial Work	
Persons on Board:	Crew - 1	Passengers - None
Injuries:	Crew - 1 (Fatal)	Passengers - N/A
Nature of Damage:	Aircraft destroyed	
Commander's Licence:	Private Pilot's Licence	
Commander's Age:	39 years	
Commander's Flying Experience:	706 hours (of which 218 hours were on type) Last 90 days - 6 hours Last 28 days - 2 hours	
Information Source:	AAIB Field Investigation

Synopsis

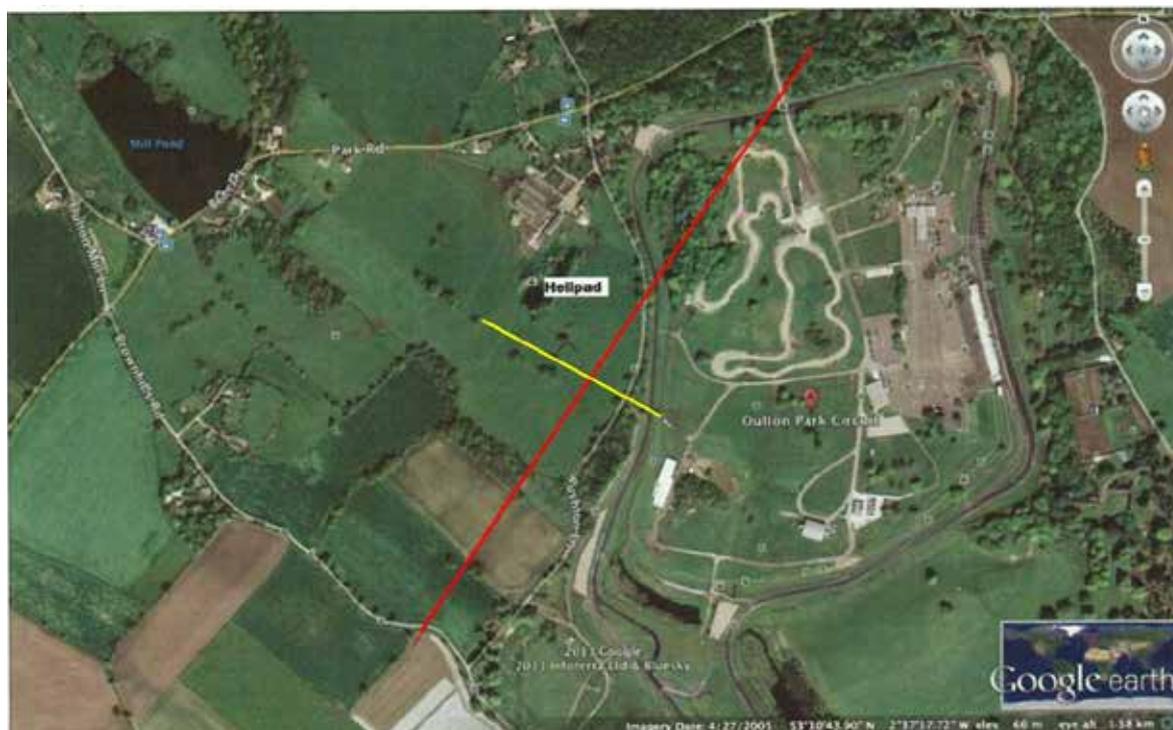
Figure 1

Display line depicted in the Display Pilots' Notes
(Display line in red and display datum line in yellow)

Figures 1 and 3 show that the display line contained within the display pilots' notes passed through an area marked 'event activity'. The CAA Permission changed the display line but the amended line was not the one used by the display pilots because they were unaware of the change. The day visitor car park and camping site were not included in the information provided to the CAA or display pilots because there was an expectation that they would not be accessible while flying was taking place. The images of G-TIMM provided by the witnesses who were standing in the car park suggests otherwise but it was not determined whether the campsite was also in use. Figure 5 shows that the display line in the CAA Permission passed over the car park and the camping site.

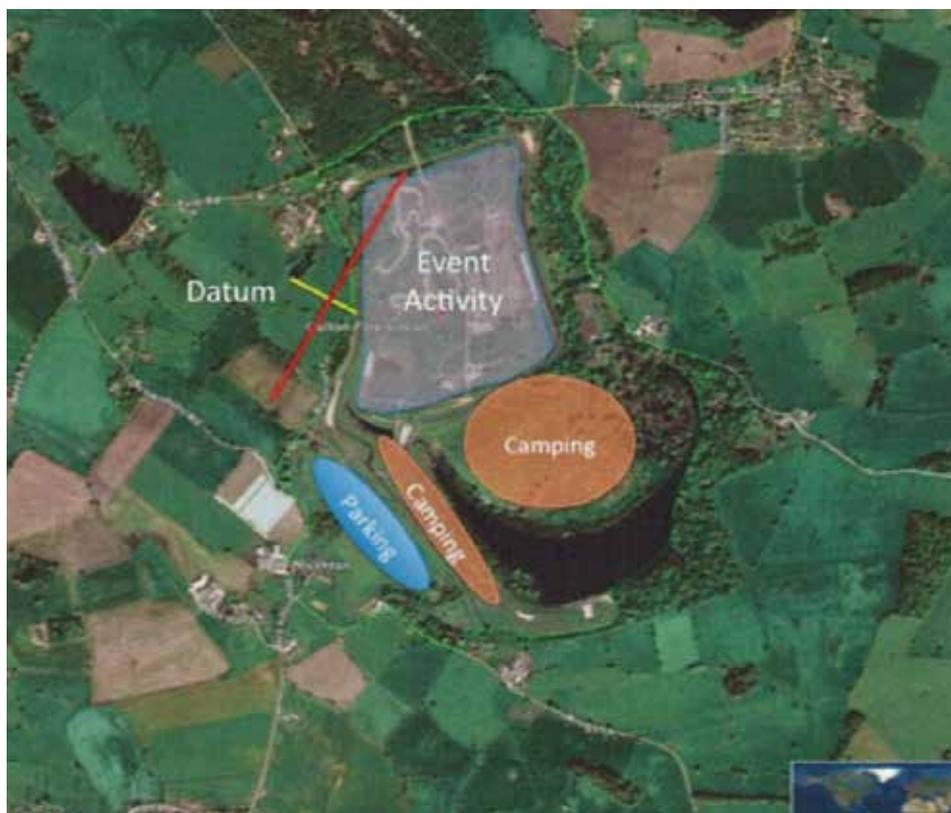
Figure 3

Overall site activity and enclosures

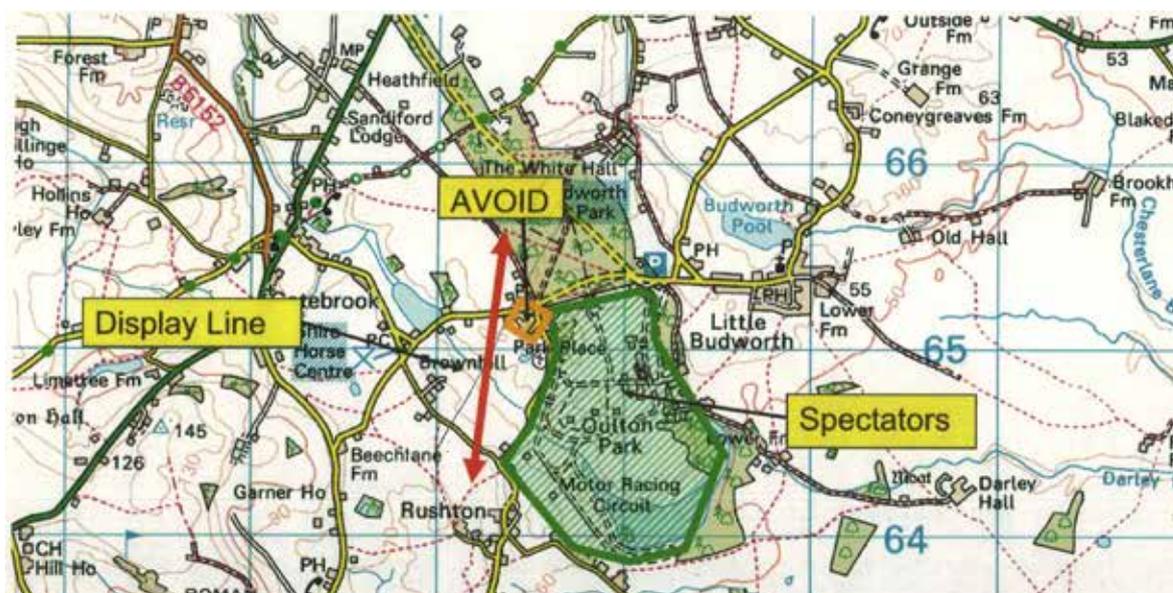
Figure 4

Amended display line from the CAA Permission

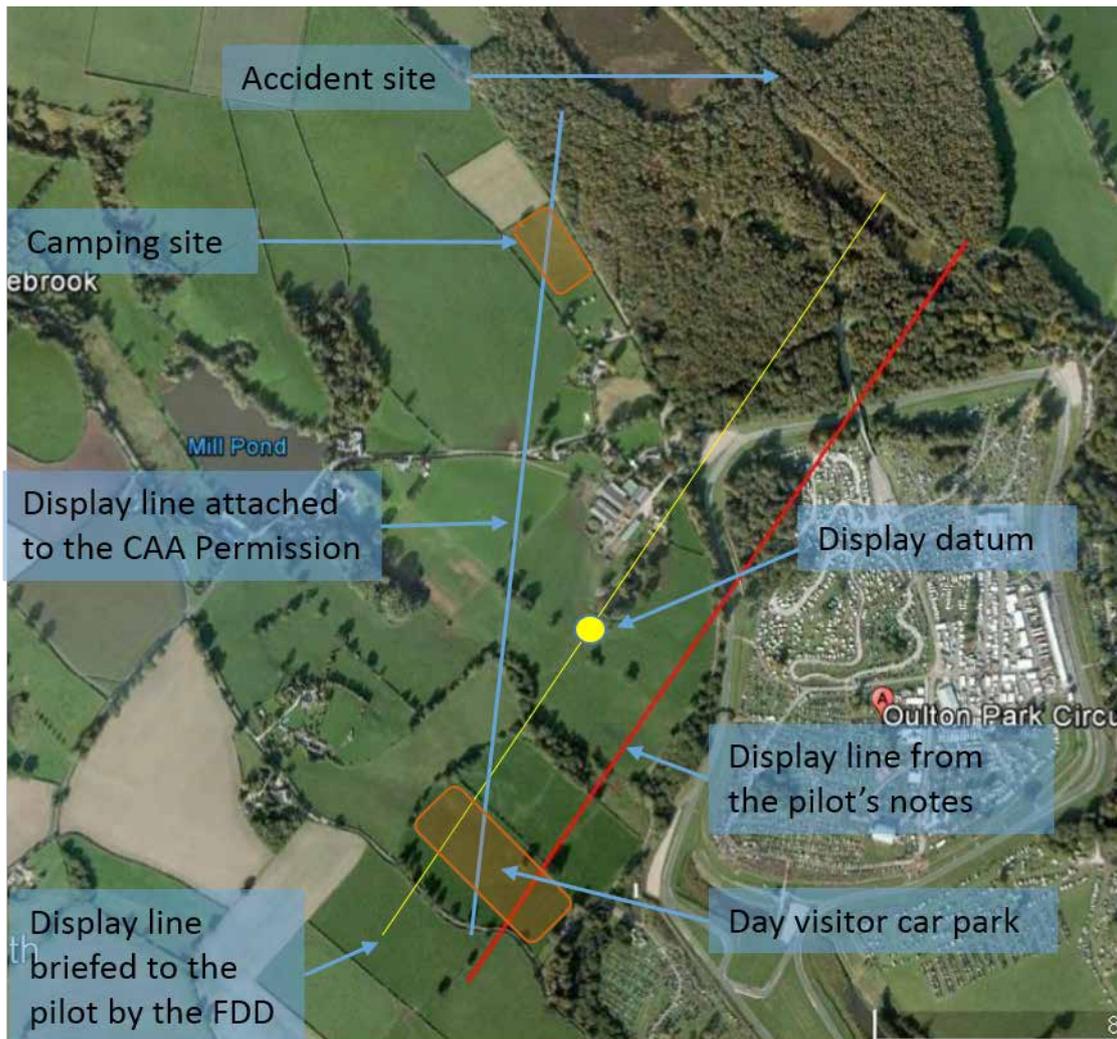
Figure 5

Display line briefed to the pilot of G-TIMM

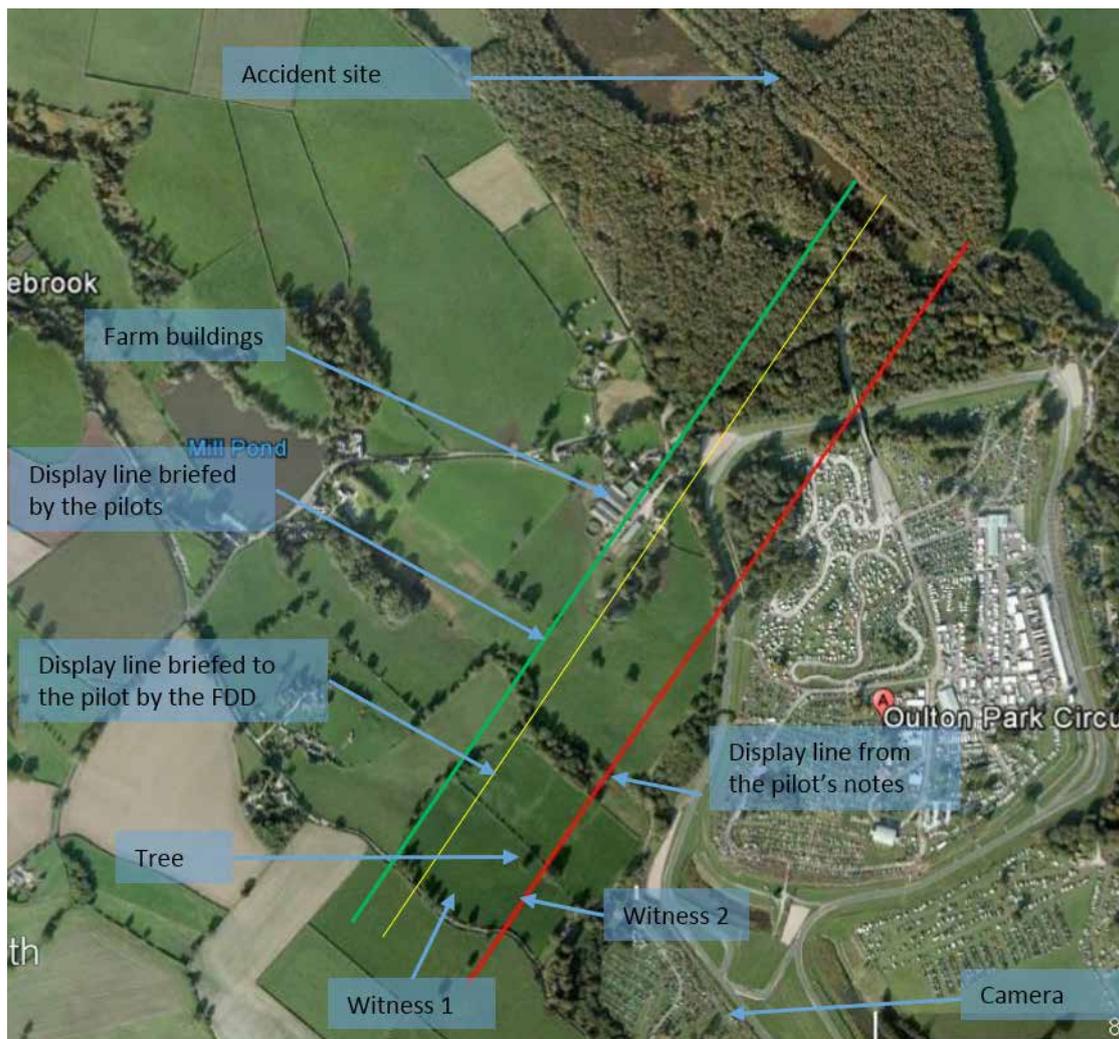
line, made them a good feature to use from the air. Figure 6 also shows the location of a camera which recorded the accident and two witnesses who were standing in the car park referred to earlier. A tree, the relevance of which is discussed in the next section, is also highlighted in Figure 6.

Display line briefed by the pilots

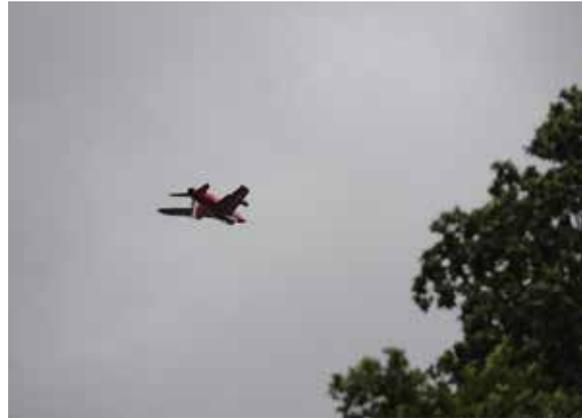
Figure 8 (right)

Witness 2 took the image shown in Figure 8. He stated that “G-TIMM did not fly directly overhead ... but further to the west of my position, and indeed, from the angle of the photos, some way to the west”. The tree in the image is marked in Figure 6.

Image taken by Witness 2

The MOD analysed the still image in Figure 8 and determined that the aircraft was approximately 390 m ± 25 m from the camera used by Witness 2.

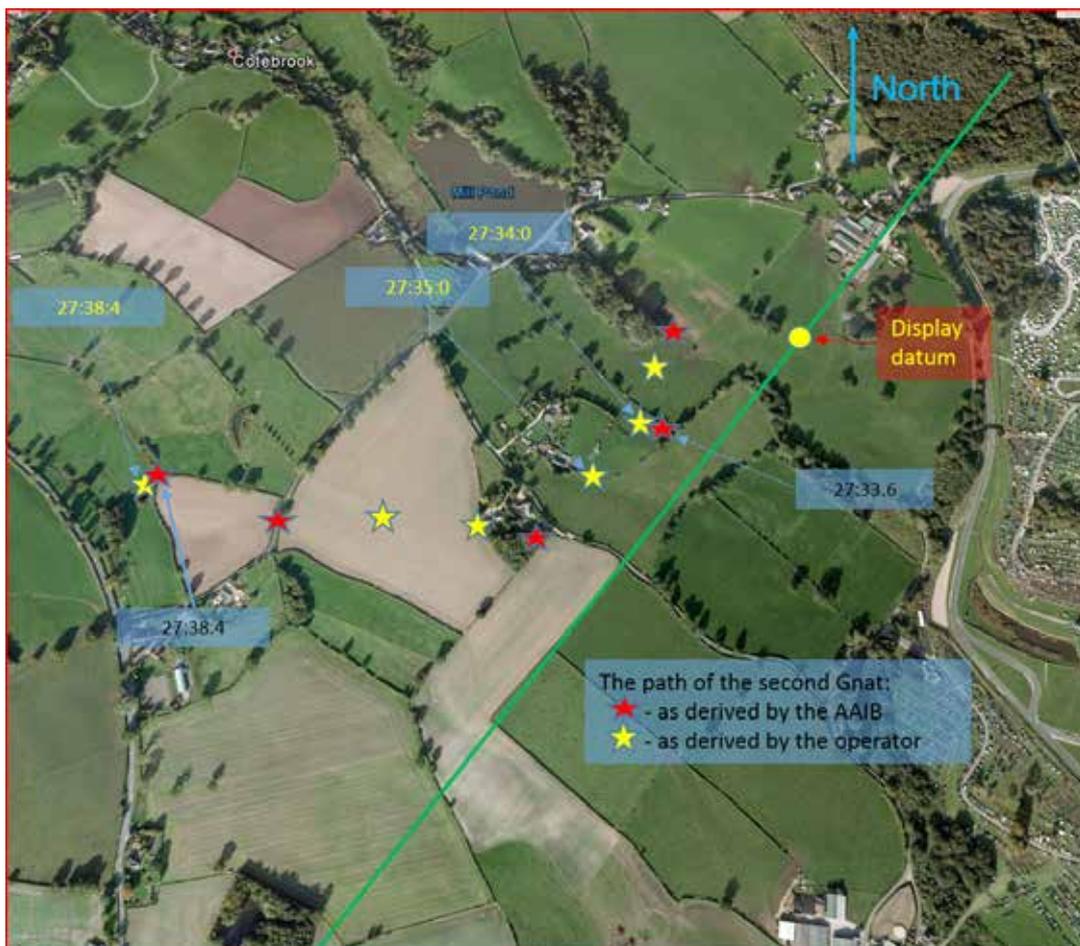
Figure 15

The AAIB and the operator of the Gnat carried out independent analyses of an on-board video recording taken from the second Gnat to establish the aircraft's ground track during the time that G-TIMM was being positioned for its final pass in the area south-west of the display line (Figure 15). The position fixes were established by comparing features on the ground, seen from the on-board video recording, with the same features seen in an overhead view in Google Earth. The associated times were taken from the video and relate to the beginning of the recording. The red and yellow stars represent locations identified by the AAIB and operator respectively.

Ground track of the second Gnat

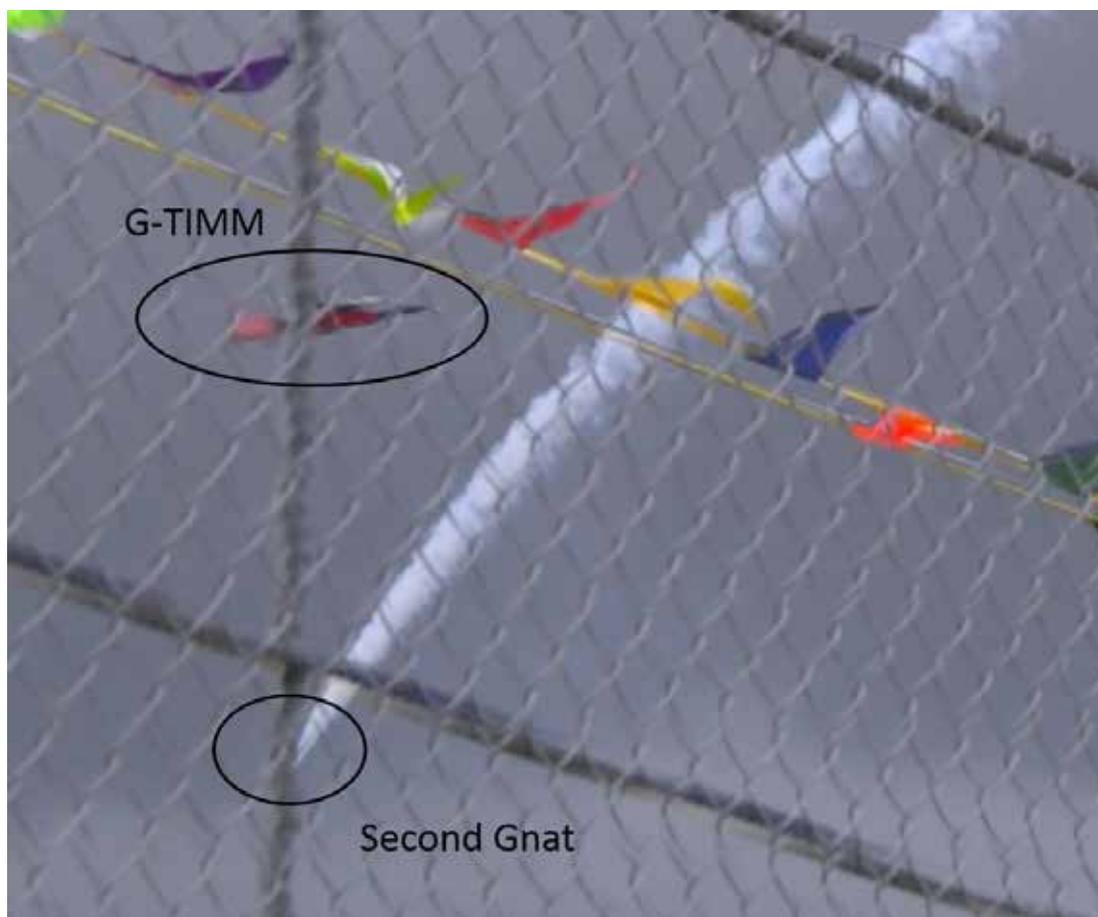
Figure 16 is an image, taken at 27:38.4, of G-TIMM and the second Gnat crossing the line of sight of a ground-based camera (the ground-based camera which provided the video discussed earlier)¹³. At 27:38.4, the operator and AAIB analyses of the second Gnat's

Image of both aircraft at 27:38.4 as G-TIMM commenced its final pass

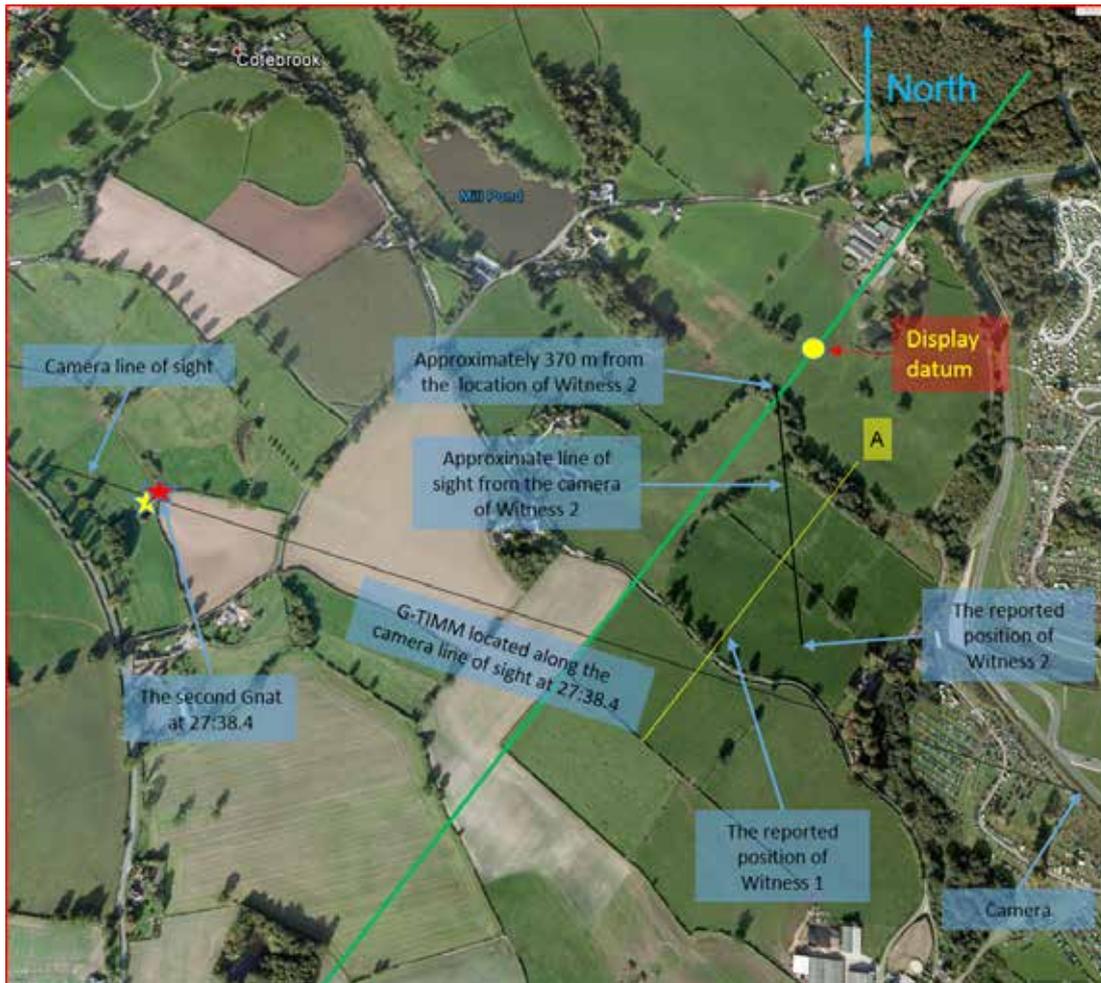
Figure 17 shows a sight line from the camera of Witness 2 passing the tree shown in Figure 8 and the MOD measured the distance of G-TIMM along this line to be approximately 390 m. Using the last known height of G-TIMM (375 ft above the display datum), this is equivalent to a ground distance of approximately 370 m which suggested that G-TIMM was flying close to the display line (Figure 17). Evidence from Witness 1 suggested that the aircraft's location was bounded by a south-easterly limit shown by the yellow line 'A' in Figure 17.

The camera line of sight at 27:38:4

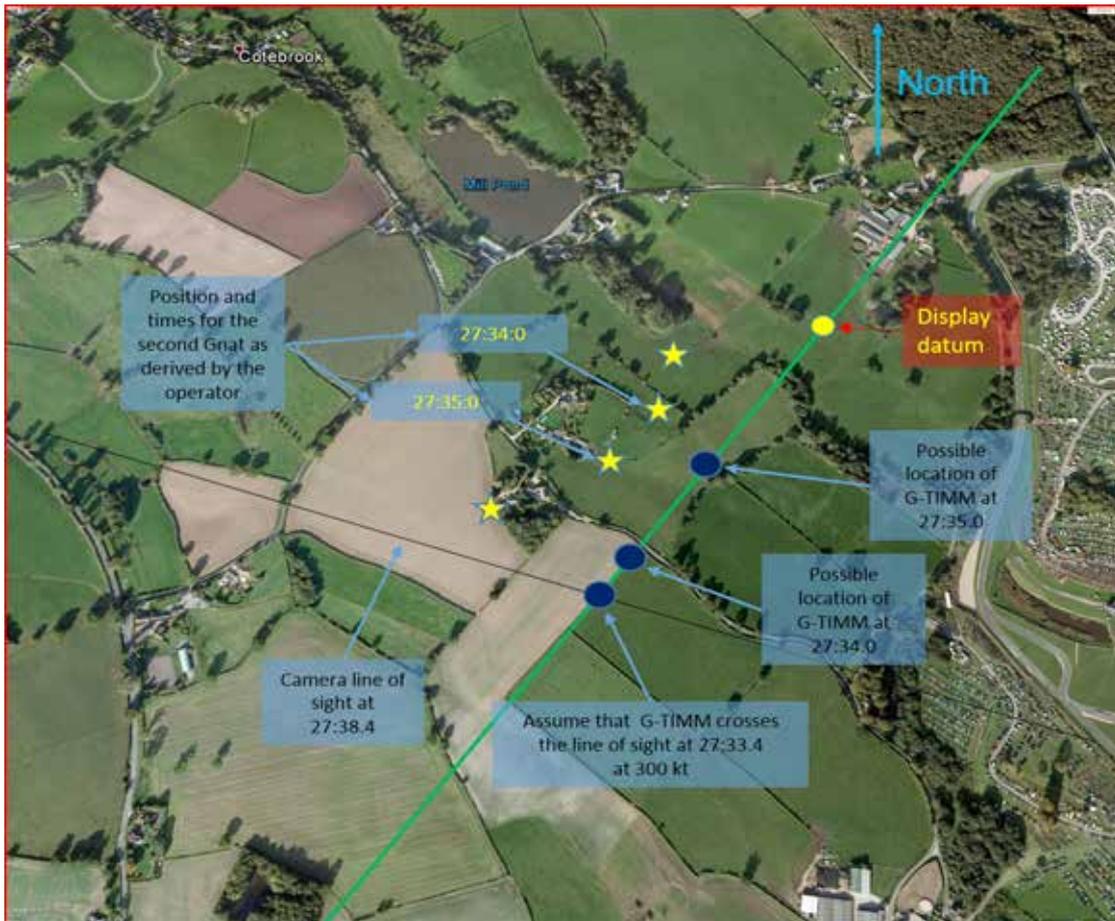
Figure 18 shows the relative locations of G-TIMM and the second Gnat, had G-TIMM arrived on the camera sight line five seconds earlier than it actually did, travelling at 300 kt²⁰. Although the Figure shows the outcome of a hypothetical set of circumstances, it suggests that, had G-TIMM not slowed down, the possibility existed that it would have reached the display line before the second Gnat had vacated it. This would have been contrary to the 'contract'²¹ used by the operator to ensure safe separation on the display line and, if anticipated by the pilot of G-TIMM, provides a plausible reason for him to slow down. The second Gnat was flying a manoeuvre with vertical extent and it was unlikely that the pilot of G-TIMM perceived that there might be a risk of collision near the display line. Nevertheless, it was possible that G-TIMM was flown slower than usual, at least in part, to delay its arrival on the display line.

Hypothetical plan view of the aircraft had G-TIMM crossed the camera sight line at 27:33.4
