INCIDENT

Aircraft Type and Registration:	Sikorsky S-92A, G-VINL	
No & Type of Engines:	2 General Electric Co CT7-8A turboshaft engines	
Year of Manufacture:	2014 (Serial no: 920226)	
Date & Time (UTC):	22 August 2014 at 1805 hrs	
Location:	Golden Eagle complex, North Sea	
Type of Flight:	Commercial Air Transport (Passenger)	
Persons on Board:	Crew - 2	Passengers - 1
Injuries:	Crew - None	Passengers - None
Nature of Damage:	None	
Commander's Licence:	Airline Transport Pilot's Licence	
Commander's Age:	49 years	
Commander's Flying Experience:	5,700 hours (of which 401 were on type) Last 90 days - 70 hours Last 28 days - 18 hours	
Information Source:	Aircraft Accident Report Form submitted by the pilot

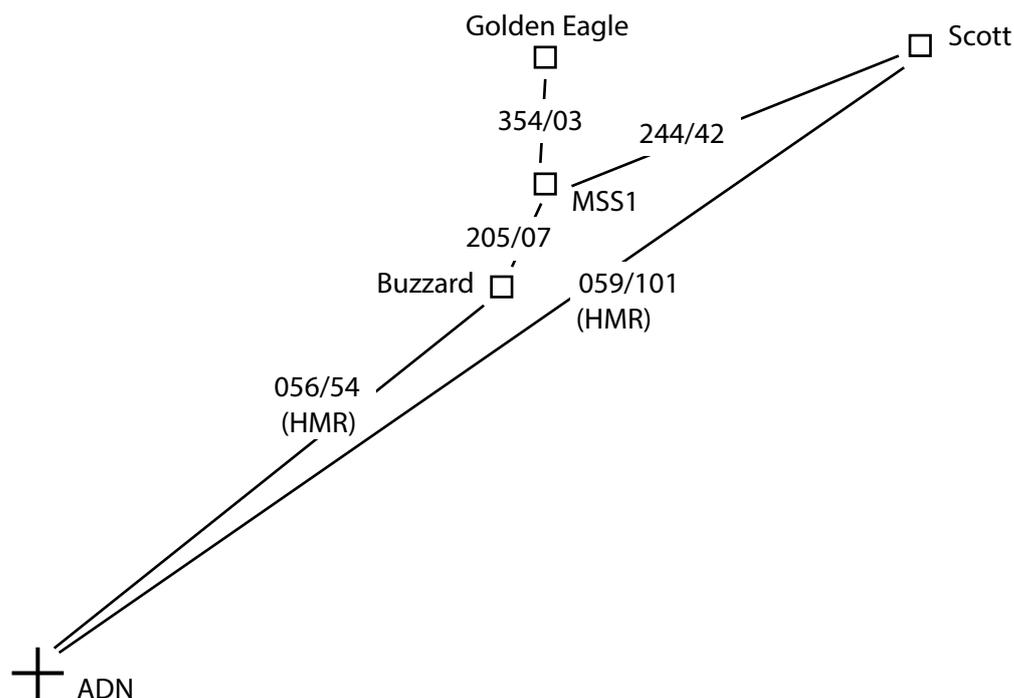
Figure 1

Helicopter routing with bearing and distances ($^{\circ}$ M/nm) to the next waypoint.
(For illustration purposes only and not drawn to scale: HMR = Helicopter Main Route)
