Accidents Investigation Branch

**Report on the accident to
Bell 212 G-BIJF**

**in the North Sea, south east
of the Dunlin Alpha platform,
on 12 August 1981**

Aircraft Accident Report No. 10/82
(EW/C762)

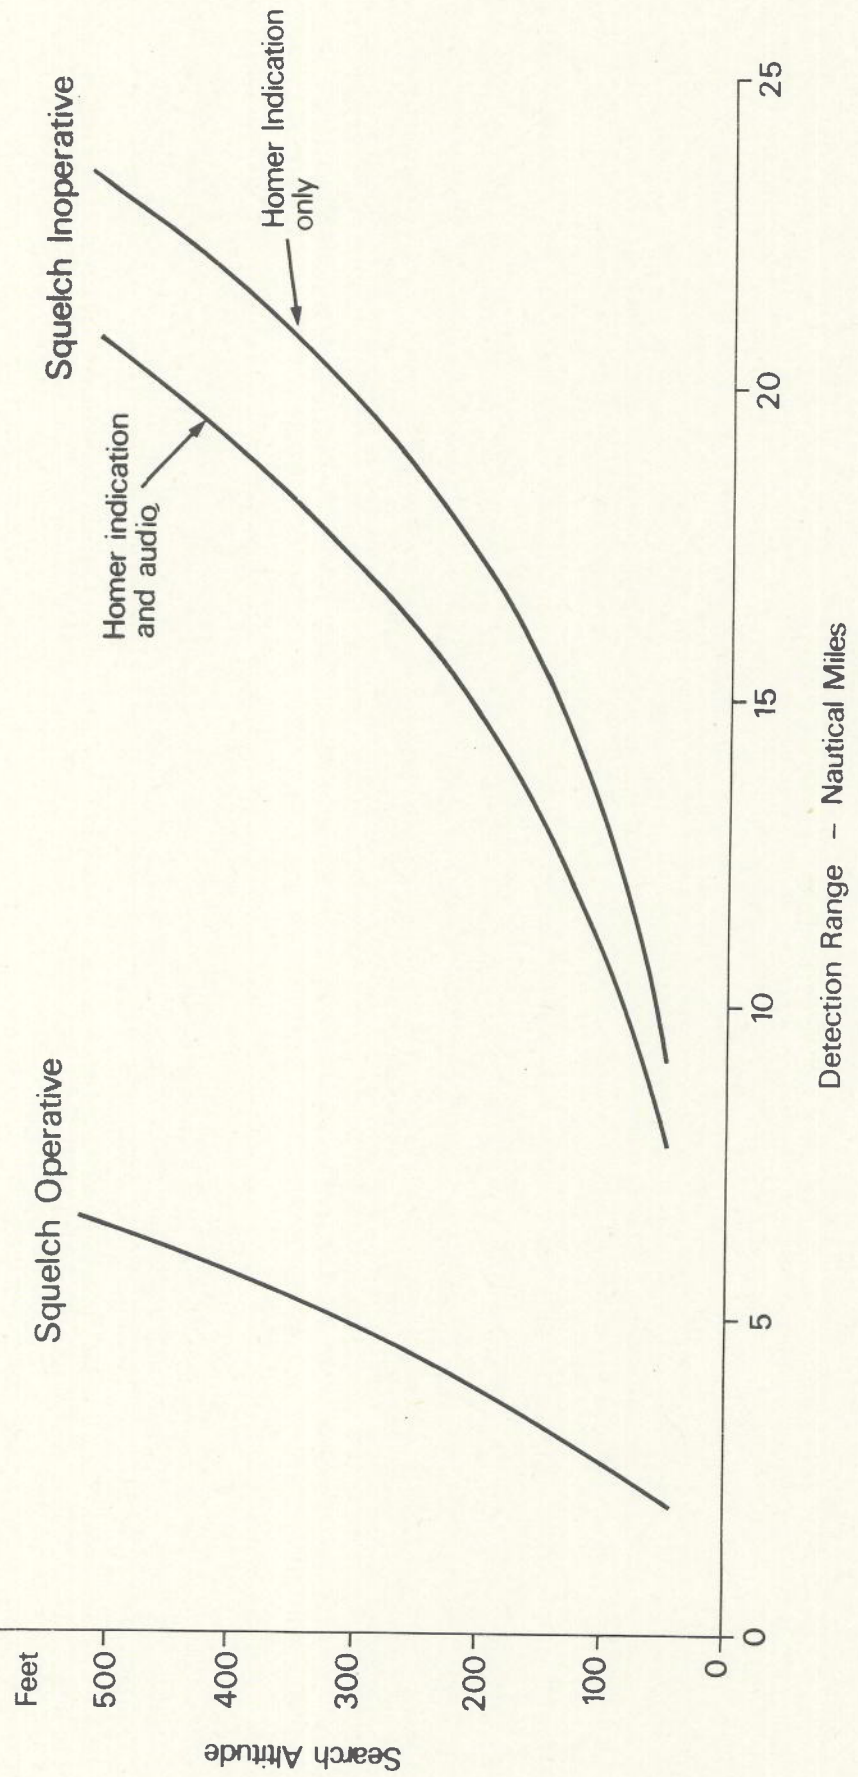
Sarbe Detection Range v Search Aircraft Altitude

BELL 212 G-BARJ
Sarbe Mk5 BE375
North Sea-Brent Field
One metre wave height
