ACCIDENT

Aircraft Type and Registration:	MW6-S (Modified) Merlin, G-MYIE
No & Type of Engines:	1 Rotax 532 piston engine
Year of Manufacture:	1993
Date & Time (UTC):	21 September 2008 at 1430 hrs
Location:	4 miles from City Airport Manchester
Type of Flight:	Private
Persons on Board:	Crew - 1 Passengers - 1
Injuries:	Crew - 1 (Minor) Passengers - 1 (Minor)
Nature of Damage:	Damage to nose landing gear and fuselage
Commander's Licence:	National Private Pilot's Licence
Commander's Age:	49 years
Commander's Flying Experience:	180 hours (of which 9 were on type) Last 90 days - 3 hours Last 28 days - 3 hours
Information Source:	Aircraft Accident Report Form submitted by the pilot

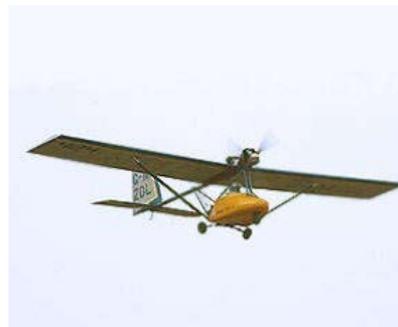
The MW6-S is a conventional three axis aircraft fitted with ailerons, rudder and an elevator with an anti-balance/trim tab. It has a rigid structure with fabric-covered flying surfaces.
