Andreasson BA4B, G-JEDS

AAIB Bulletin No: 7/2004	Ref: EW/G2004/04/03	Category: 1.3
Aircraft Type and Registration:	Andreasson BA4B, G-JEDS	
No & Type of Engines:	1 Lycoming O-235-C2C piston engine	
Year of Manufacture:	1993	
Date & Time (UTC):	3 April 2004 at 1333 hrs	
Location:	White Waltham Airfield, Berkshire	
Type of Flight:	Private	
Persons on Board:	Crew - 1	Passengers - None
Injuries:	Crew - None	Passengers - N/A
Nature of Damage:	Propeller damaged and engine shock loaded	
Commander's Licence:	Private Pilot's Licence	
Commander's Age:	51 years	
Commander's Flying Experience:	Approximately 500 hours (of which 20 were on type)	
	Last 90 days - 5 hours	
	Last 28 days - 0 hours	
Information Source:	Aircraft Accident Report Form submitted by the pilot

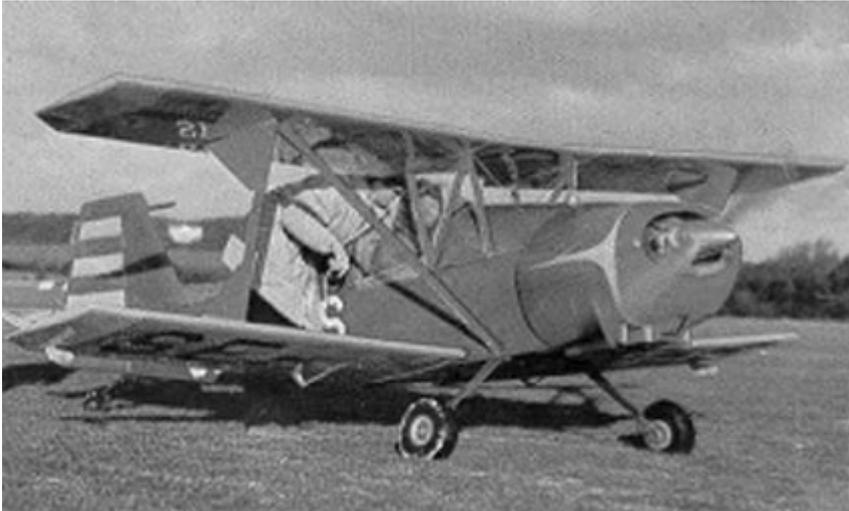
The Andreasson BA4B is a small, homebuilt, biplane aircraft with a tailwheel configuration and a maximum take-off weight of 460 kg.
