ACCIDENT

| Aircraft Type and Registration: | Cirrus SR22, N450CD | |

Synopsis

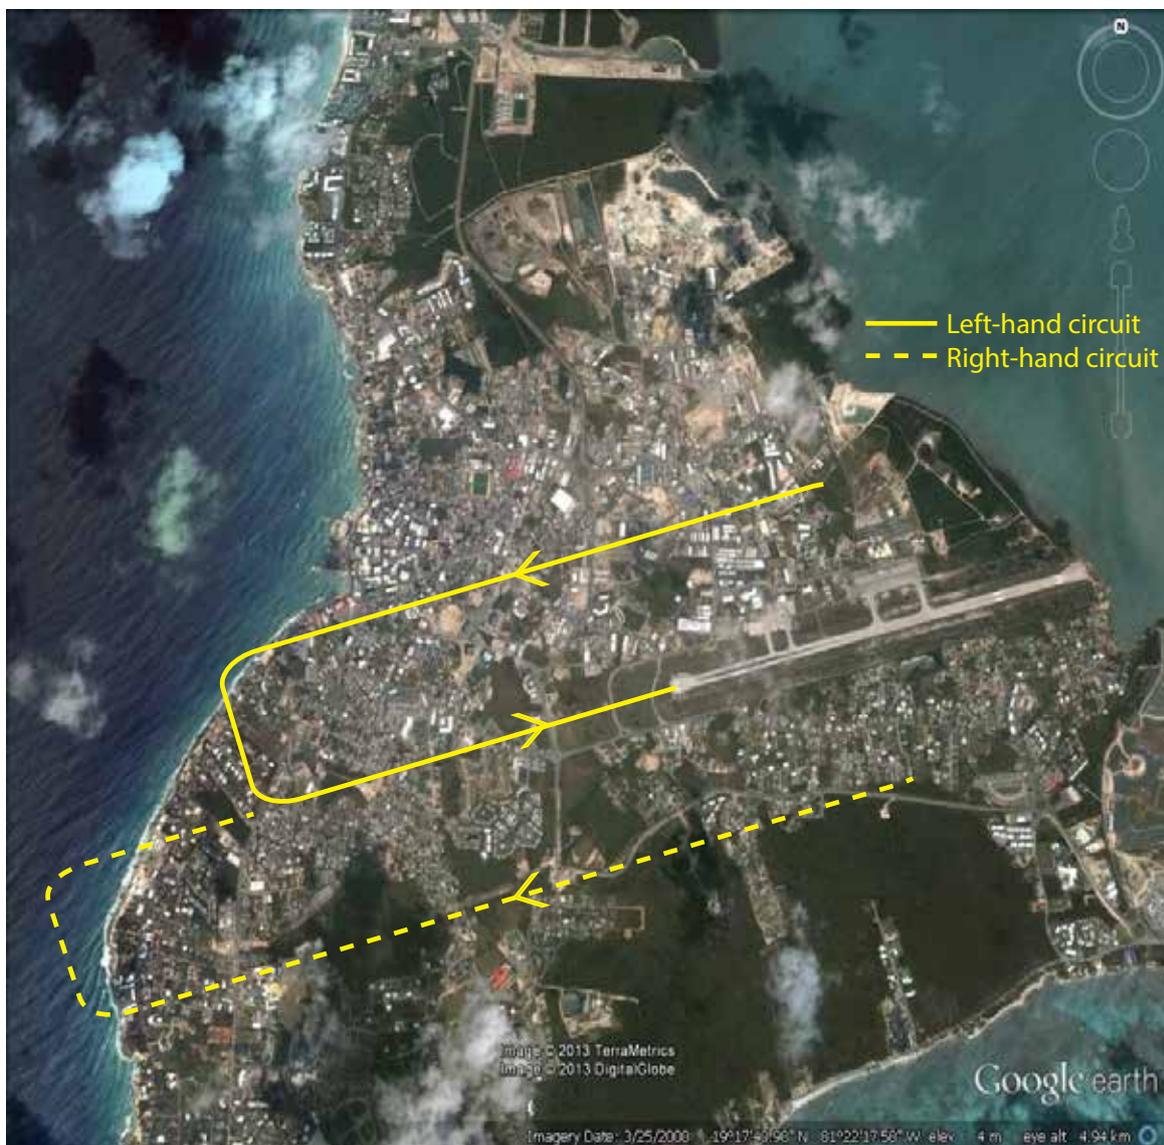
Figure 1

Aerial view of Owen Roberts Airport with left-hand circuit, and right-hand circuit more normally flown by the pilot of N450CD

The aircraft arrived at Grand Cayman, following a flight from Edward Bodden Airport on Little Cayman. First contact was made with the control tower at Owen Roberts Airport (Figure 1) when the aircraft was at 30 miles DME at an altitude of 6,000 ft on an IFR flight plan. Two minutes later the pilot cancelled the IFR

runway as soon as possible since there had been much traffic waiting to land and take off. In addition, he was used to arriving 'right downwind' and turning over the coast (shown in Figure 1). He had employed the same technique with the 'left downwind' pattern but, because of the geography of the coastline, this put him about half a mile closer to the runway threshold. He believes that the propeller strike occurred on the second bounce and that he should have gone around after the first.
